# **KENT UNDERGROUND RESEARCH GROUP**

# **CHALK MINING** and associated industries of **FRINDSBURY**

# Research Report 3

# 1987

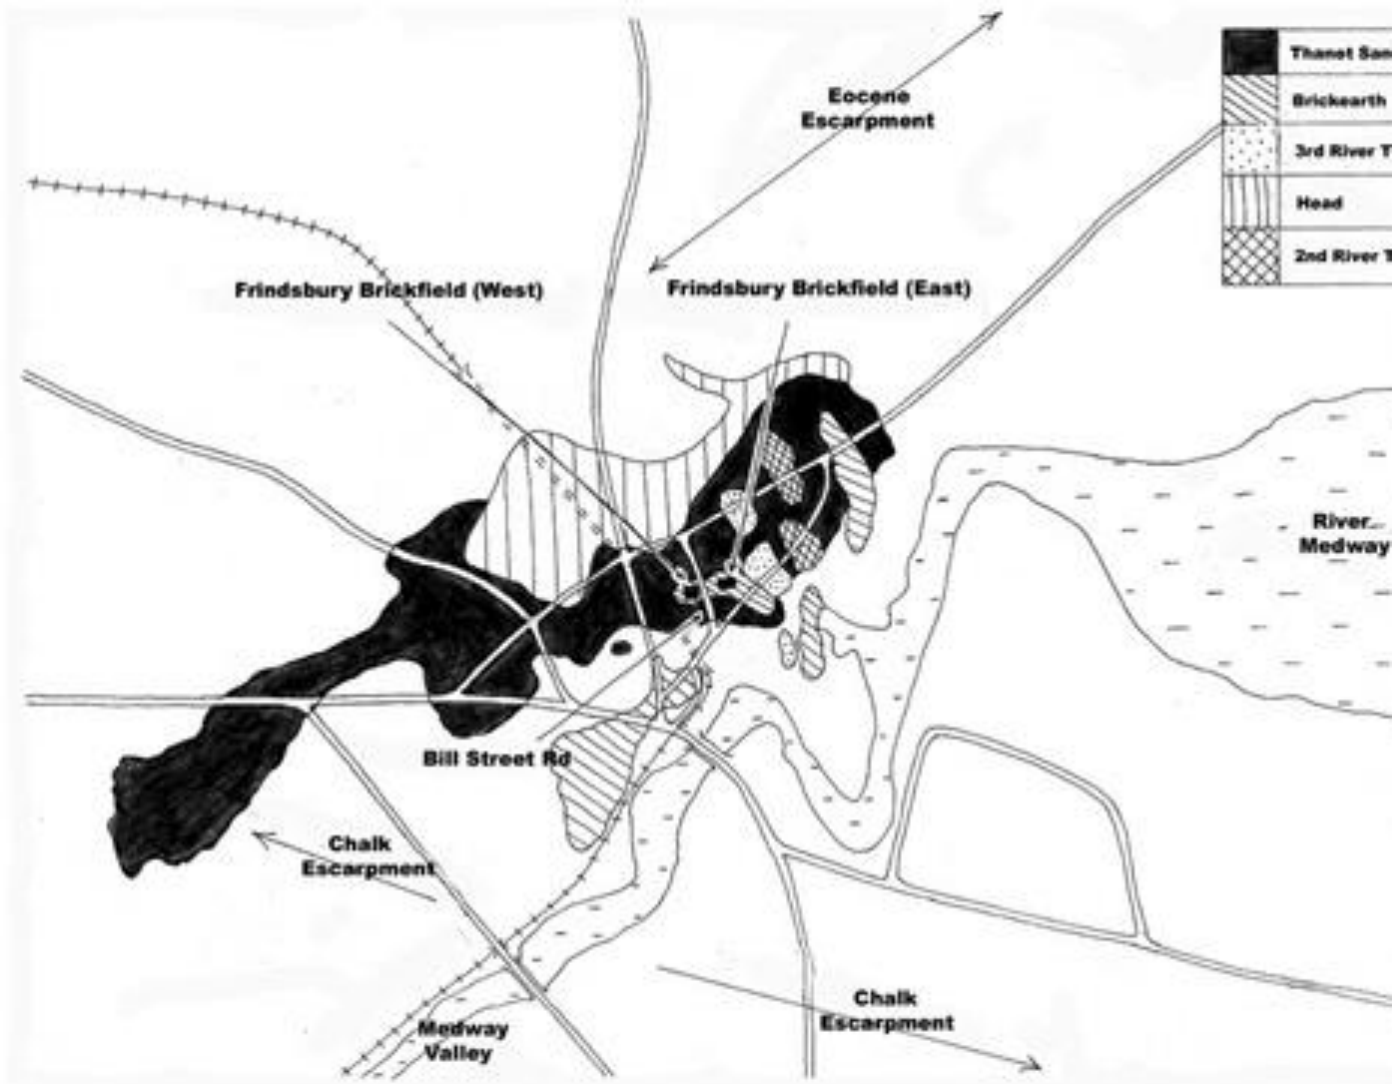
**Fig.7 Geological Sketch Map of Frindsbury**

It can be seen that the Brickearth deposits are of Recent origin and this dates them back no more than 1 million years. This table can be used in conjunction with the geological sketch map (see Fig.7). The strata found in the area of study are :-

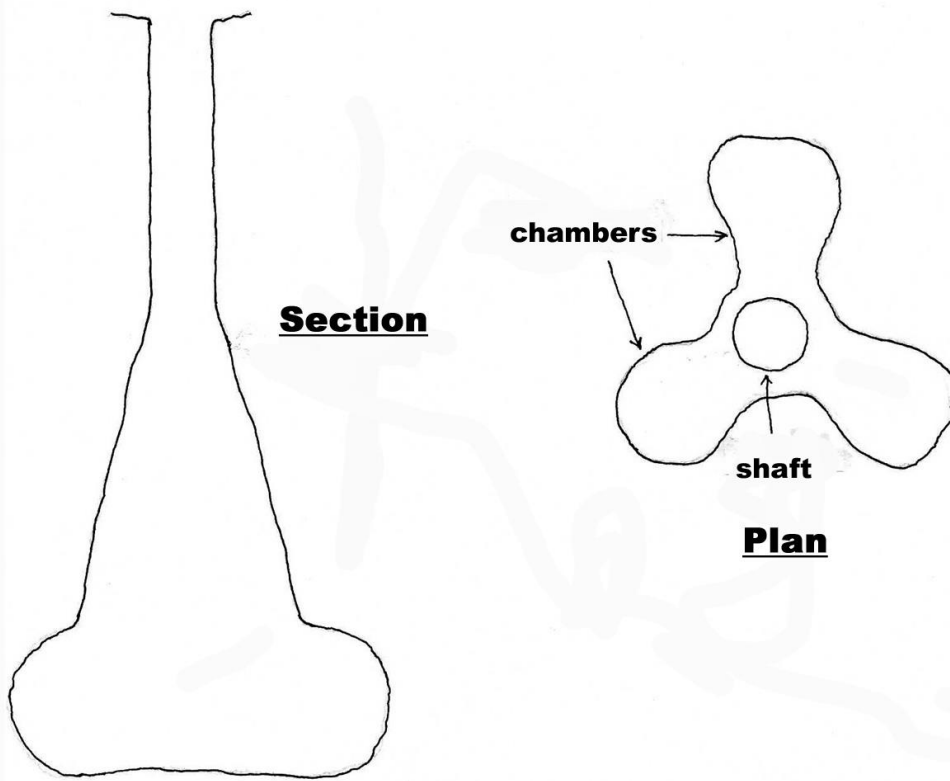
Fig.11 Chalkwell

occur in areas with a clay/clay with flints overburden. The main difference is that the double trefoil chamber shape is no longer found and there are usually only 3 chambers at the bottom, although some examples have been found with 2, 4 or 5 chambers. A later development was widening out of the shaft from part way down to form a beehive-shaped space (see Fig.11). This represented a significant technological advance since more chalk could be obtained from a single excavation and it allowed more daylight to reach the working chambers as well as reducing rope friction when drawing up the baskets of chalk. The wider shafts, however, meant that it was no longer possible to climb down with footholds and the miners must have been lowered by rope.

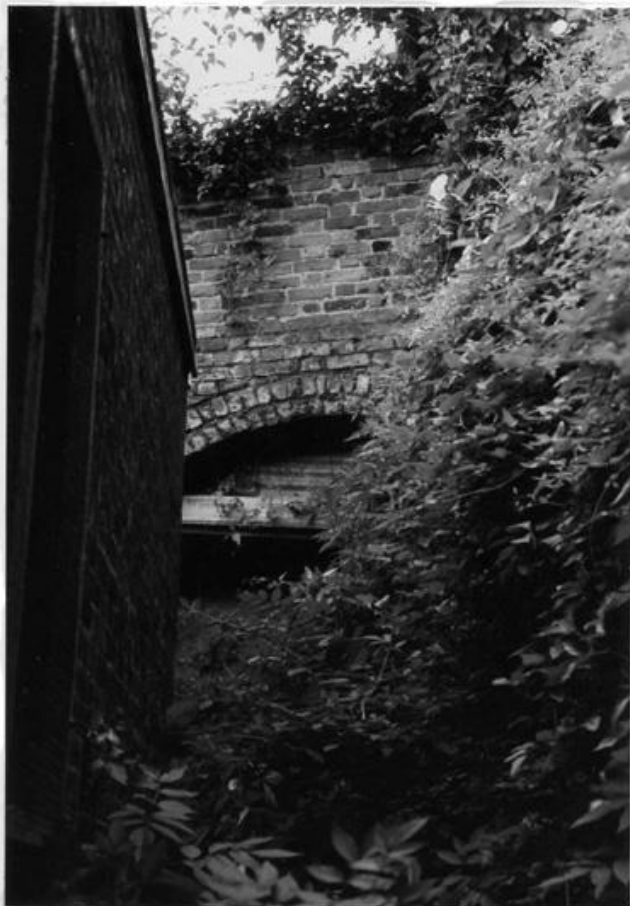
### **Frindsbury Road Chalkpit**

**The rear left hand arch of the retaining wall that exposes the Thanet Sand. This side shows signs of many repairs over the years due to lateral pressure**

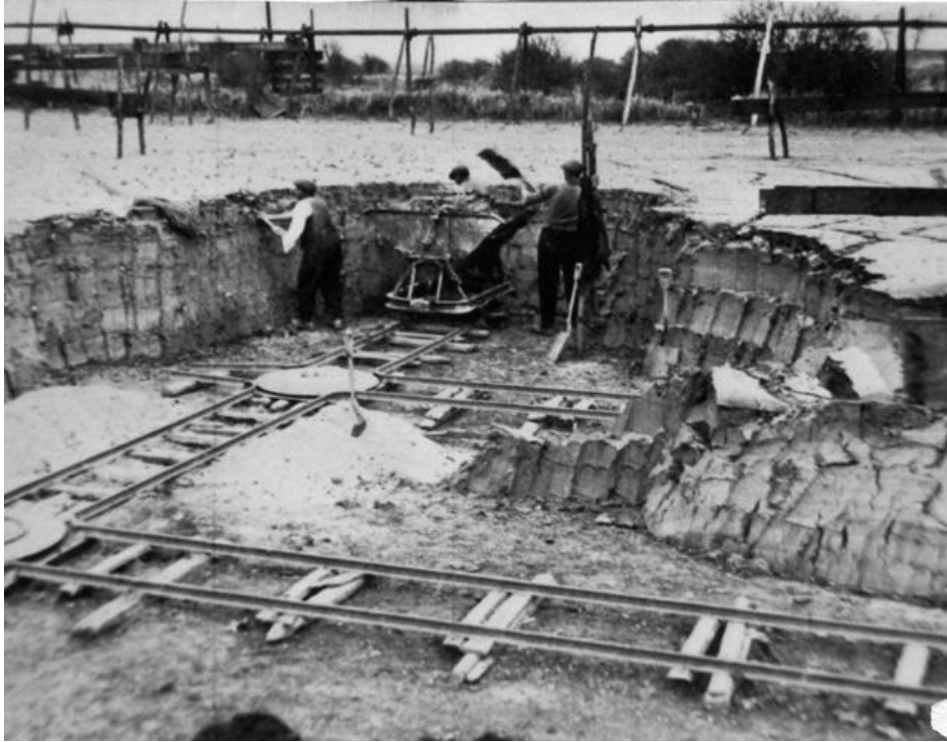
Excavating a washback in one of the larger Eastwood brickfields in the 1900s. The slurry launders can be seen in the background.

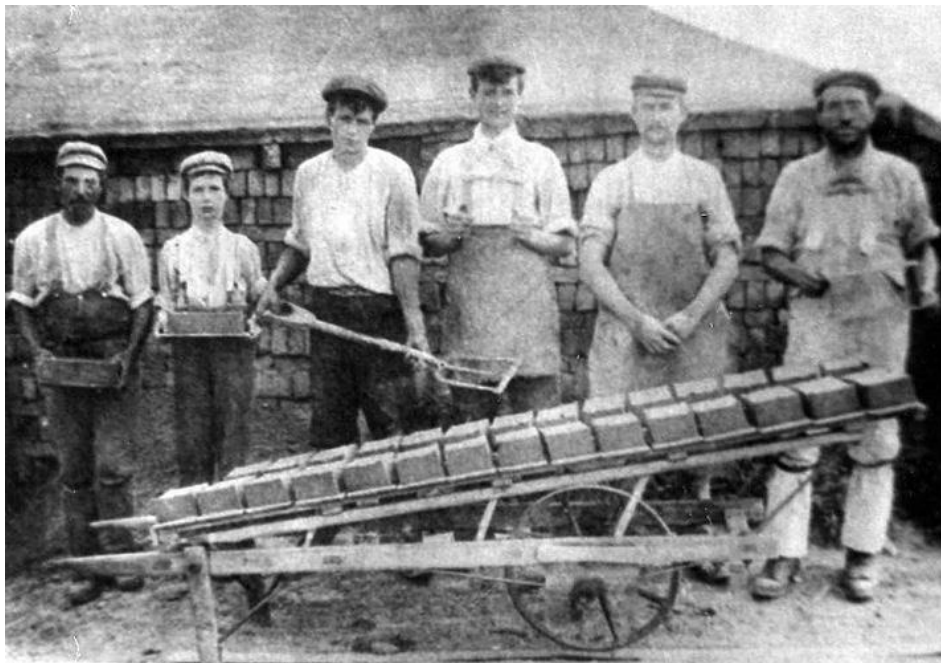
A brickmaking gang at Rainham in 1890 standing in front of a hack. Note the moulds, large cuckle and brick barrow.

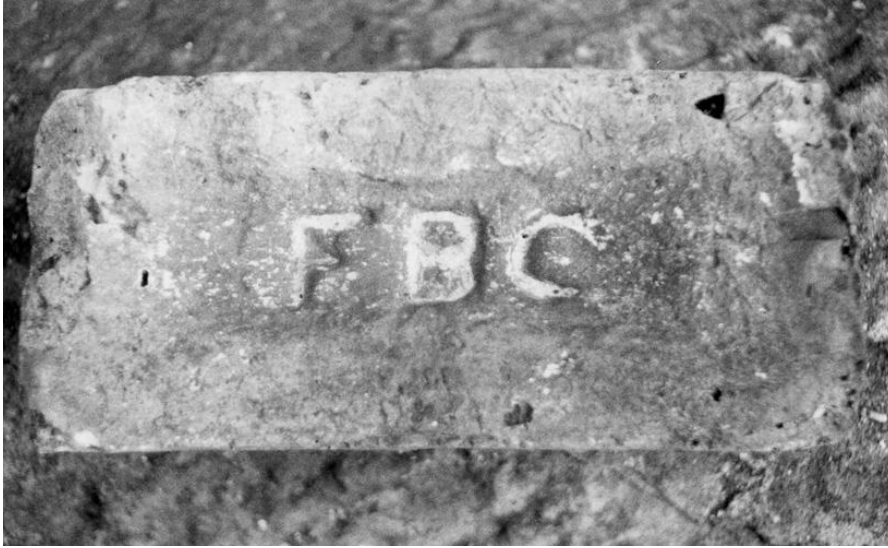
**A hand-made yellow stock brick showing the initials “FBC” (Frindsbury Brickfield Company) on the frog. A great many of the older buildings in this area are likely to be built from these.**

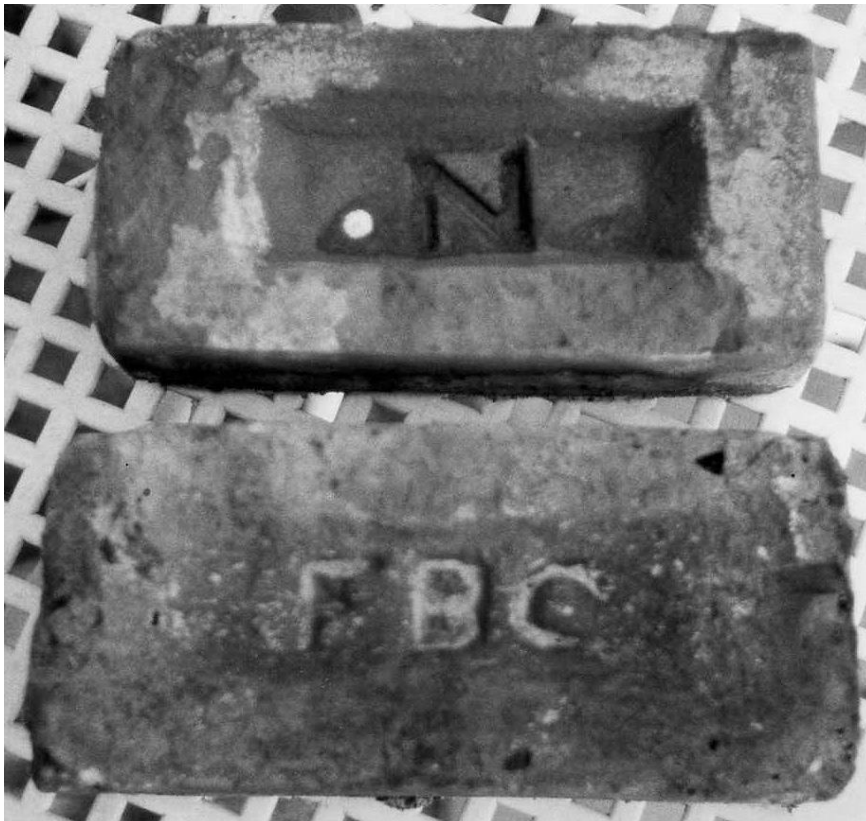
**The same brick compared to a red brick from Newington Brickworks. It can be seen that the latter is slightly smaller and more uniform since it was not hand-made. The Newington Brickworks were owned by the same Ivory who was a partner of Frindsbury Brickfield before it closed.**

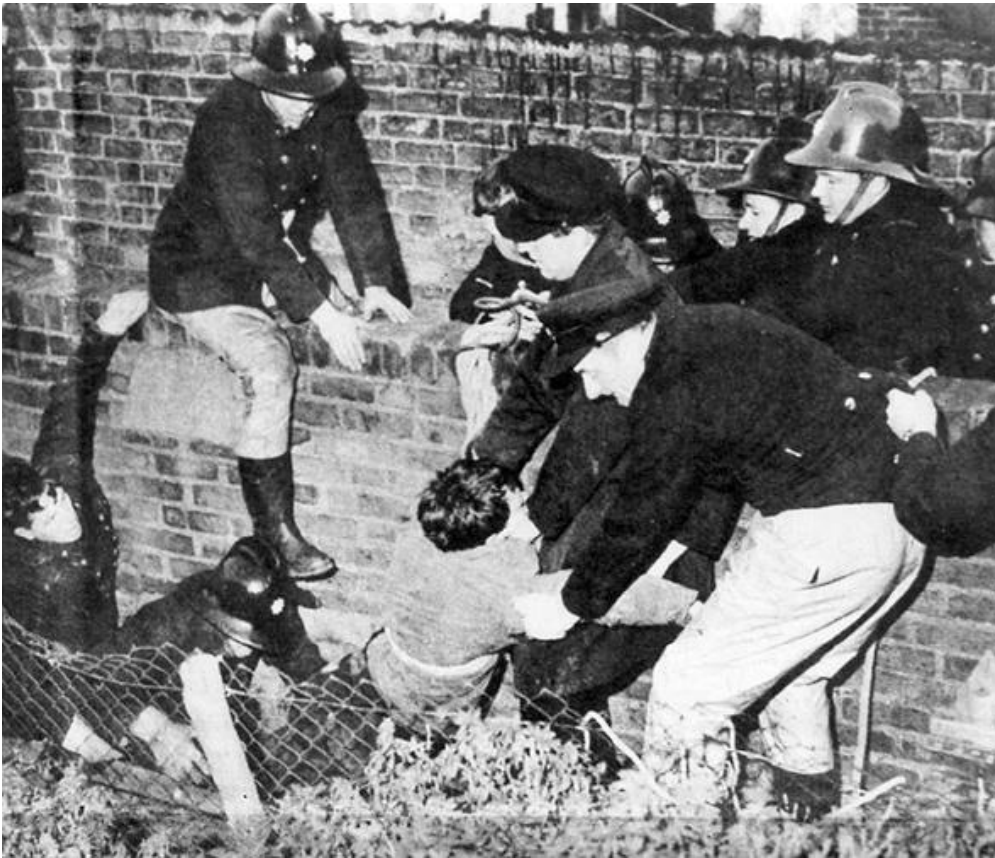
**The first abortive rescue attempt by firemen whilst the top of the shaft was still relatively narrow.**

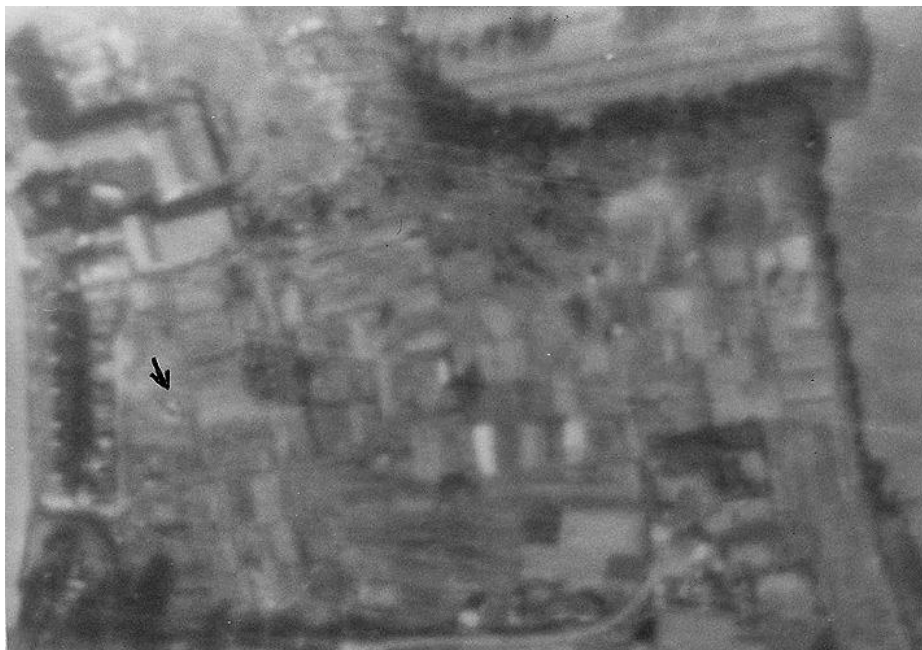
**Nursery Brickfield – now divided into allotments. The well can be identified to the right of a row of houses on the left hand side.**

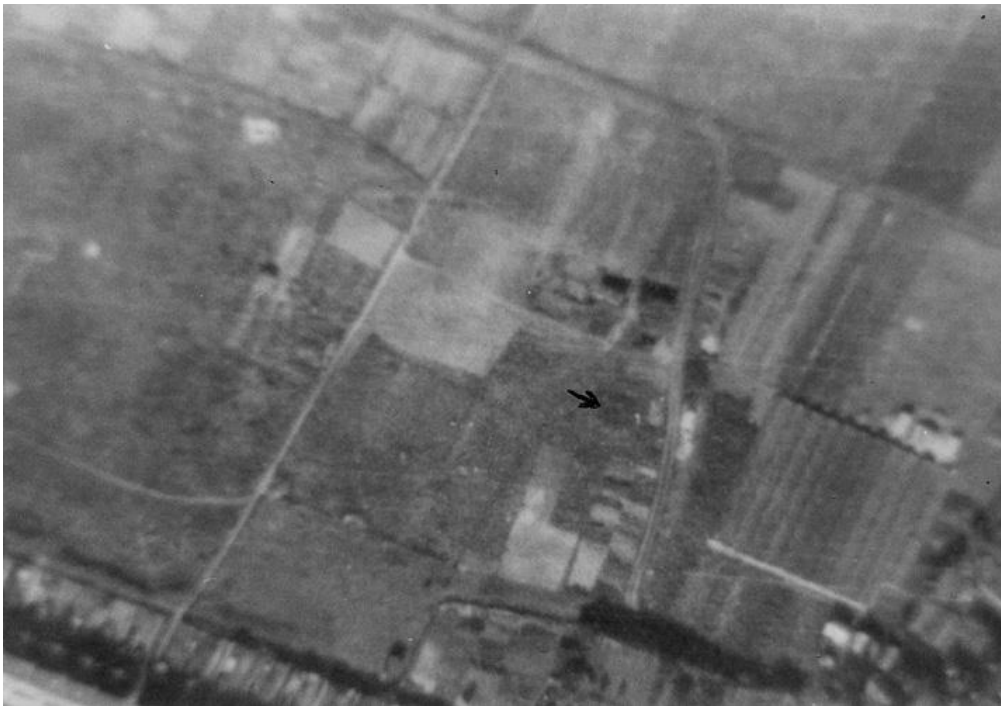
**Frindsbury Brickfield (East) – the mine shaft appears as a slightly darker patch just right of centre and the engine shed, etc is above this.**

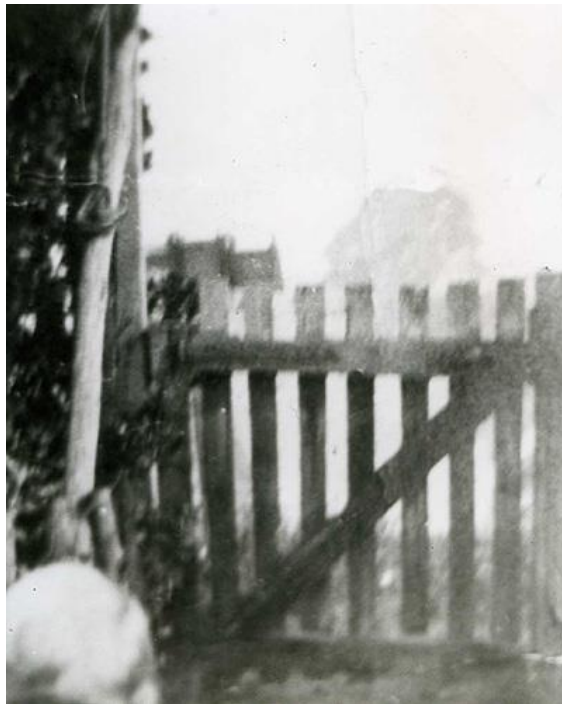
**Looking north across brickfield from rear of 6, Bingham Road.  
Two hacks can be seen in the background with their wooden caps.**
