REPORT

MAJOR J. W. PRINGLE, R.E., ON THE FATAL COLLISION
THAT OCCURRED ON THE 2ND SEPTEMBER, 1913,
BETWEEN TWO PASSENGER TRAINS NEAR AIS
GILL, ON THE MIDLAND RAILWAY.

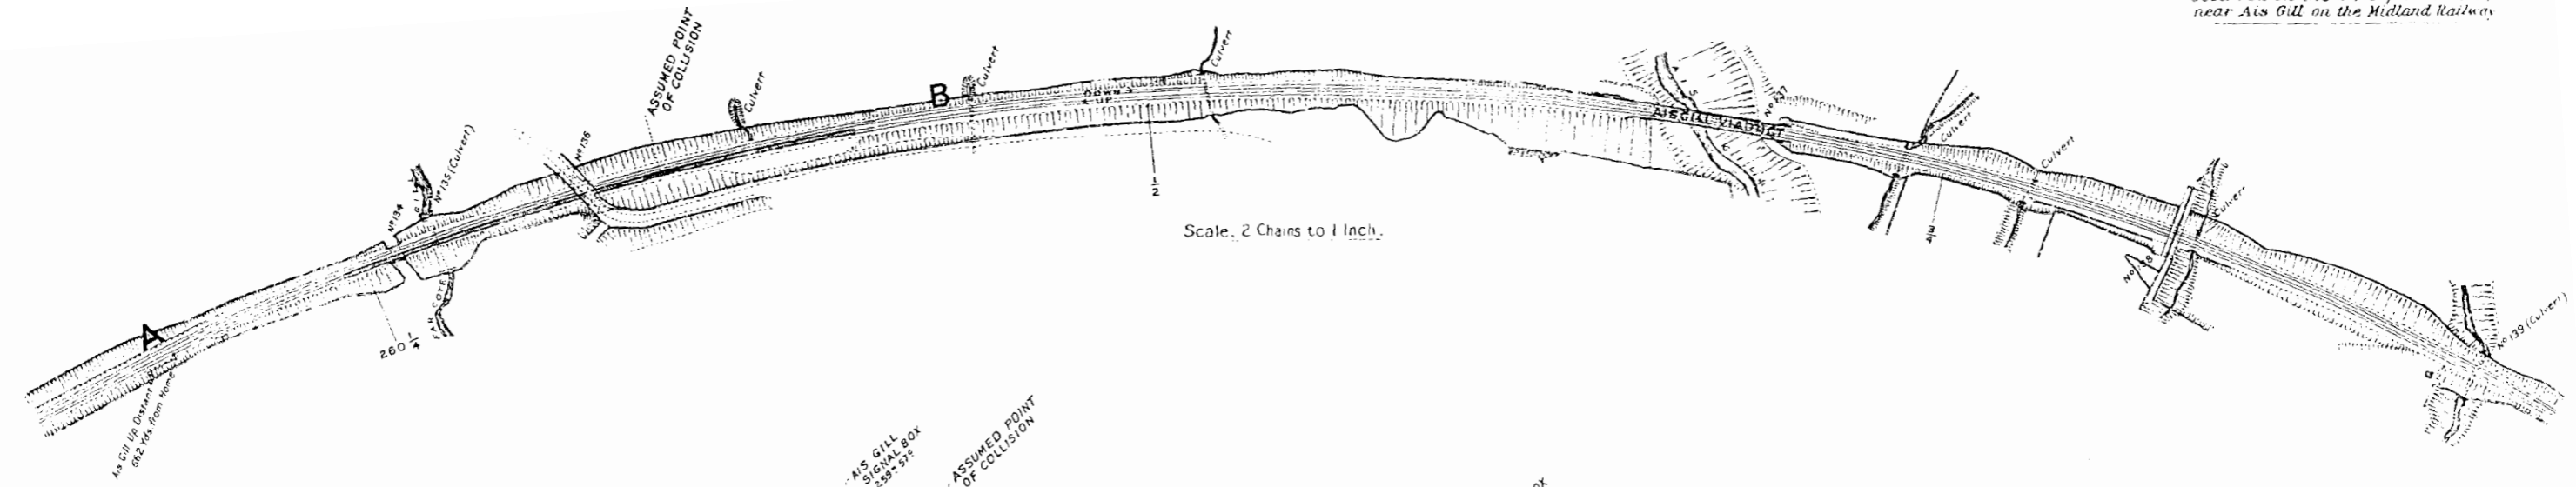
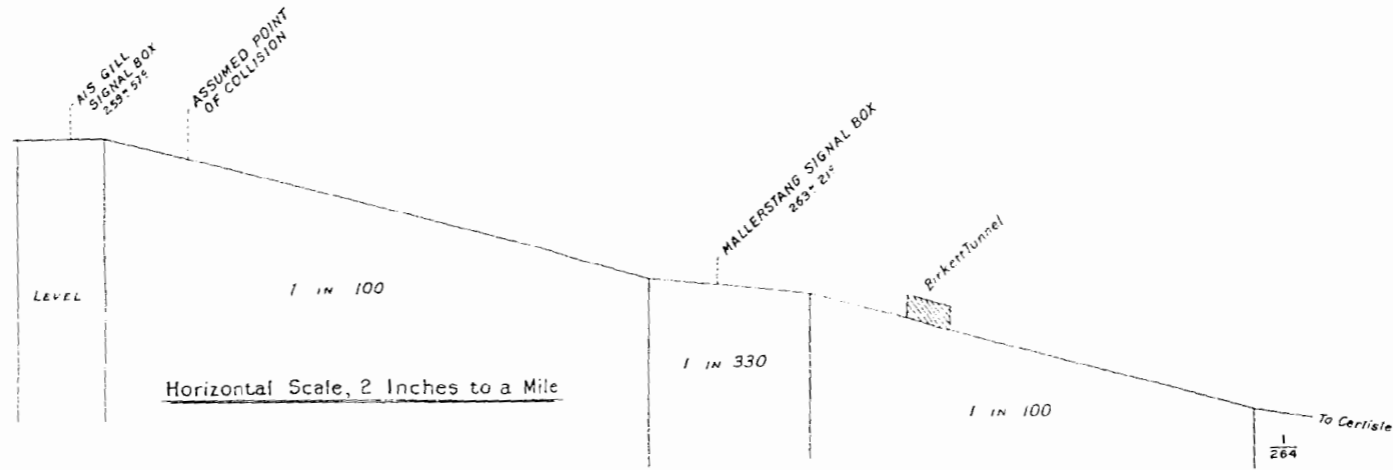
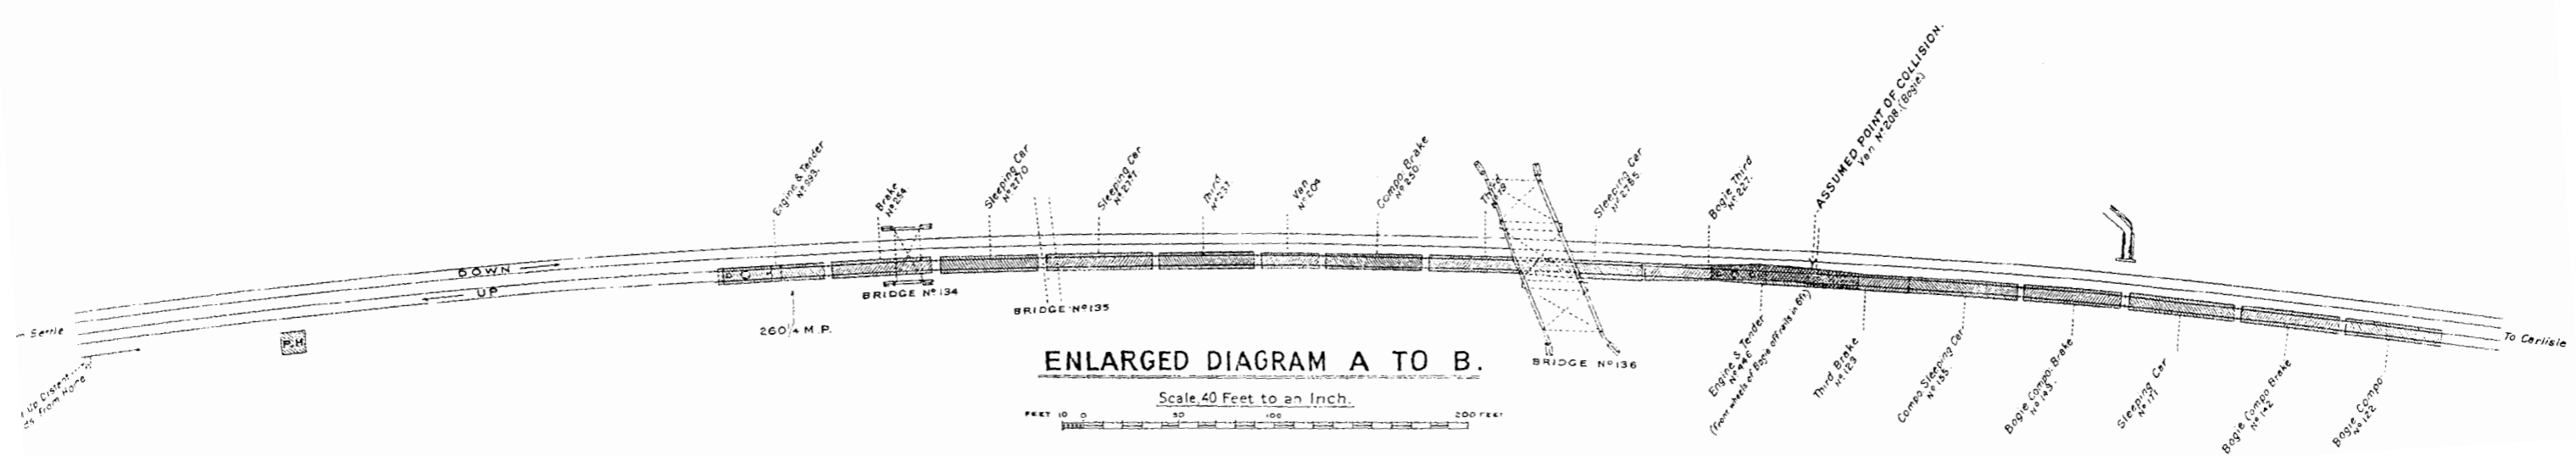
Plate II.
 To accompany the Report by Major Pringle, R.E., on the collision that occurred on the 2nd September 1913, near Ais Gill on the Midland Railway
