NUMBER: 08-037-19 REV. B

Rear Window Defroster Inoperable

This bulletin involves inspecting and possibly repairing the terminal of the rear defroster circuit.

2017 - 2018	(JK)	Jeep Wrangler
2018 - Current	(JL)	Jeep Wrangler

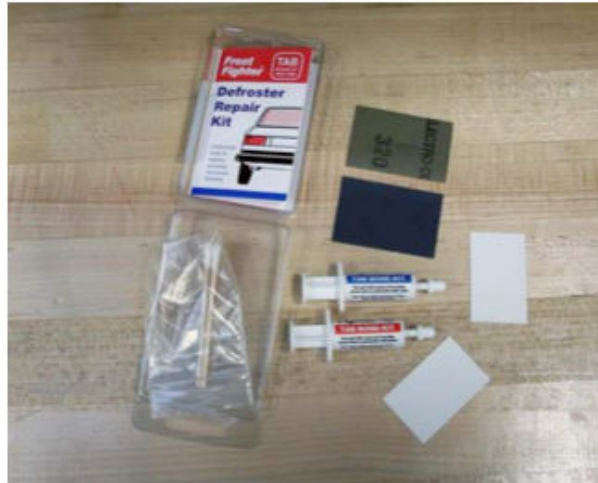
Fig. 1
Frost Fighter 2000 Defroster Repair Kit

For these vehicles it is recommended to use a Frost Fighter 2000® Defroster Repair Kit (Fig. 1) and if necessary Mopar #68428688AA, Tab.

NOTE: **FCA US has not determined any other product meets its specifications for electrical tab retention to glass.**

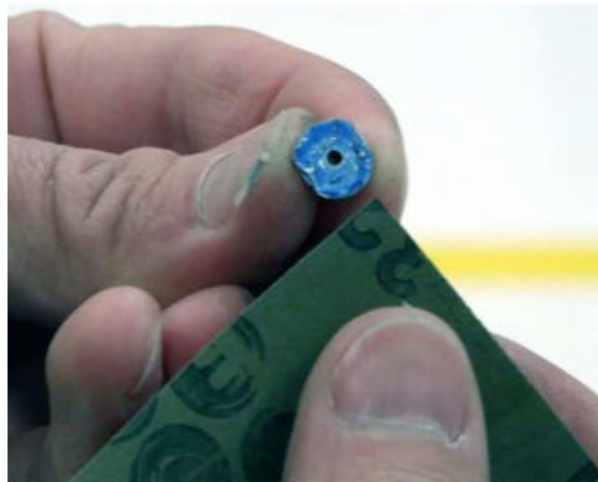
Fig. 2
Rear Defroster Tab

NOTE: The flux that is pre-coated on the tab will cause adhesion issues with the epoxy. Remove before applying epoxy to contact point (Fig. 2) .
