(54) **METHOD TO DETECT TERMITE INFESTATION IN A STRUCTURE**
(75) Inventor: **Peng Lee**, Oxford, MS (US)
(73) Assignee: **University of Mississippi**, University, MS (US)
(*) Notice: Subject to any disclaimer, the term of this patent is extended or adjusted under 35 U.S.C. 154(b) by 57 days.

A method for confirming the presence of termites in a structure, involving a preliminary infrared scan of a structure and confirmation of termite infestation with at least one detector in order to quickly locate potential areas of termite infestation.

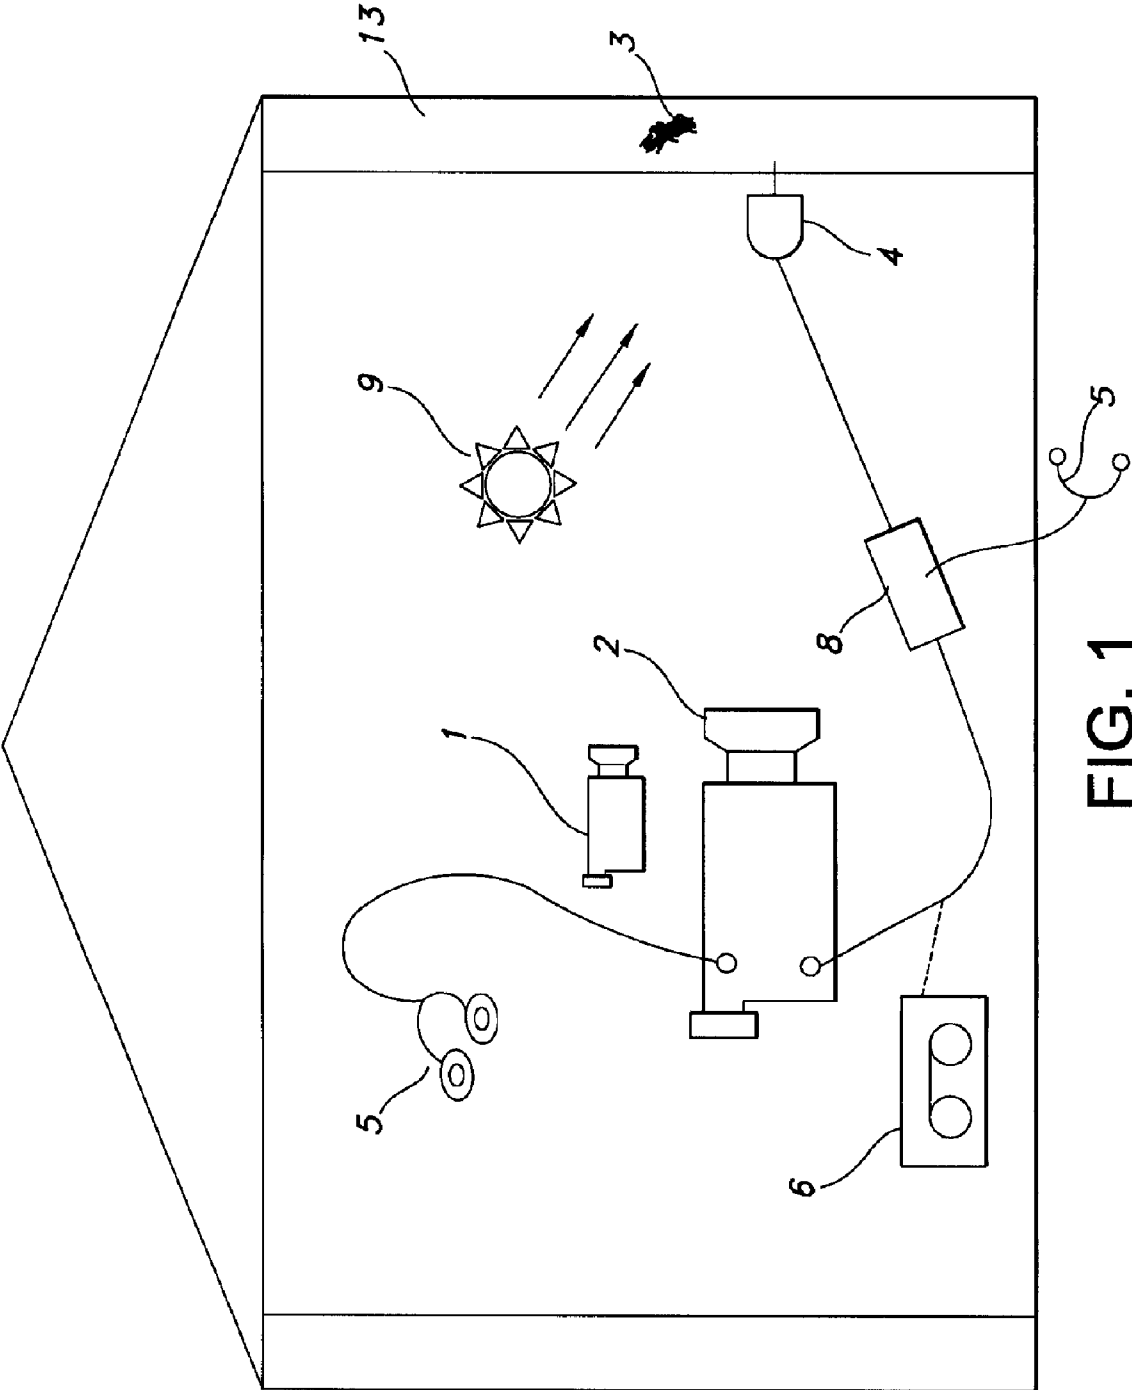
FIG. 1 is a schematic illustration of a termite detection system assembled in accordance with the principles of a preferred embodiment of the invention.

As schematically depicted in FIG. 1, a preferred embodiment of the apparatus and method of the present invention includes a thermal imaging camera 1 for performing a preliminary scan of a structure 13 in order to locate potential termite infestations sites 3. A thermal imaging camera 1 is used to perform an infrared scan. The structure 13 can be a wooden object, such as a wall stud, paneling or in one embodiment a live tree. Termite infestation sites 3 can be the result of subterranean termite or dry-wood termite activity. In the case of a subterranean termite infestation, the moisture brought in by the subterranean termites will show up as a "suspicious cold or hot spot" in a thermal imaging scan. In the case of a dry-wood termite infestation, a heat or cold source 9 is needed to increase or decrease the temperature of a targeted structure 13. This heat source 9 can be an electric, gas or oil heat source as well as an incandescent or infrared light source. The areas in the targeted structure 13 that contain a cavity created by dry-wood termites will show up as "suspicious warm or hot spots." The correspondent video images of the potential termite infestation are recorded by the camcorder 2 or by the thermal imaging camera if it is equipped with recording capability 6.

Thermal imaging camera 1 may be any of a number known, commercially available infrared cameras conventionally used by structural engineers, police and the military. In order to improve the accuracy by which the thermal imaging camera 1 detects potential areas of termite infestation, the thermal imaging camera may further include termite infestation recognition software, such as matched filtering software which compares the frequency spectrum of a thermal image with frequency spectra of a reference images known to indicate termite infestation, thereby reducing the level of skill required of the camera operator, reducing time required and increasing termite identification effectiveness. This database of infestation images of suspicious thermal images can be built by one skilled in the art.

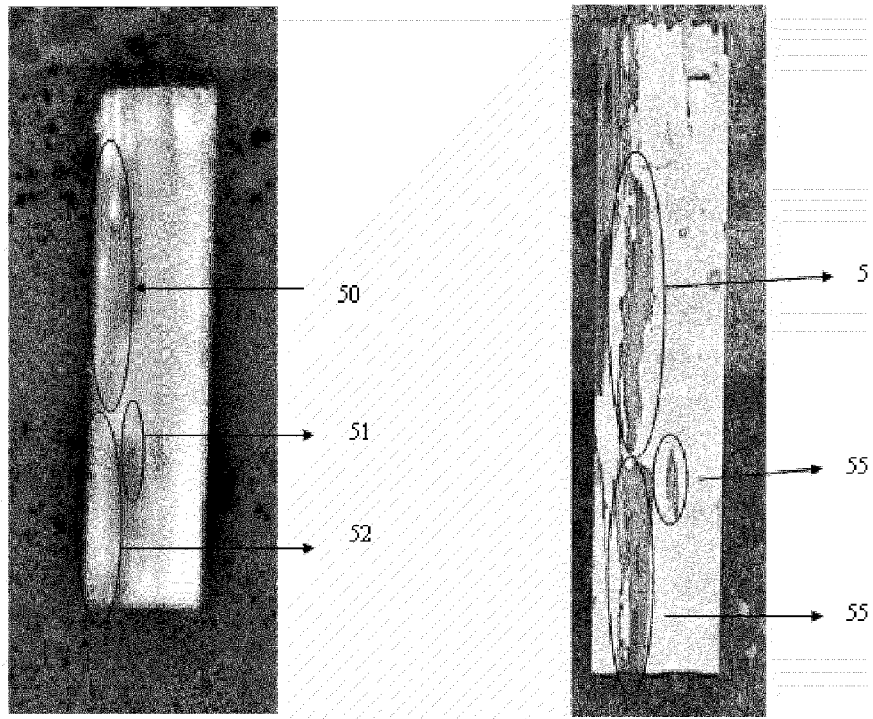
FIGURE 2A

FIG. 2A is an infrared scan of a structure showing drywood termite infestation.

FIG. 2B is a photo of a wood structure with the surface material removed.

Referring now to FIGS. 2A and 2B, an infrared scan of a wall shows potential termite damage at 50, 51 and 52. The surface material was removed in FIG. 2B to show termite damage at 53, 54 and 55.

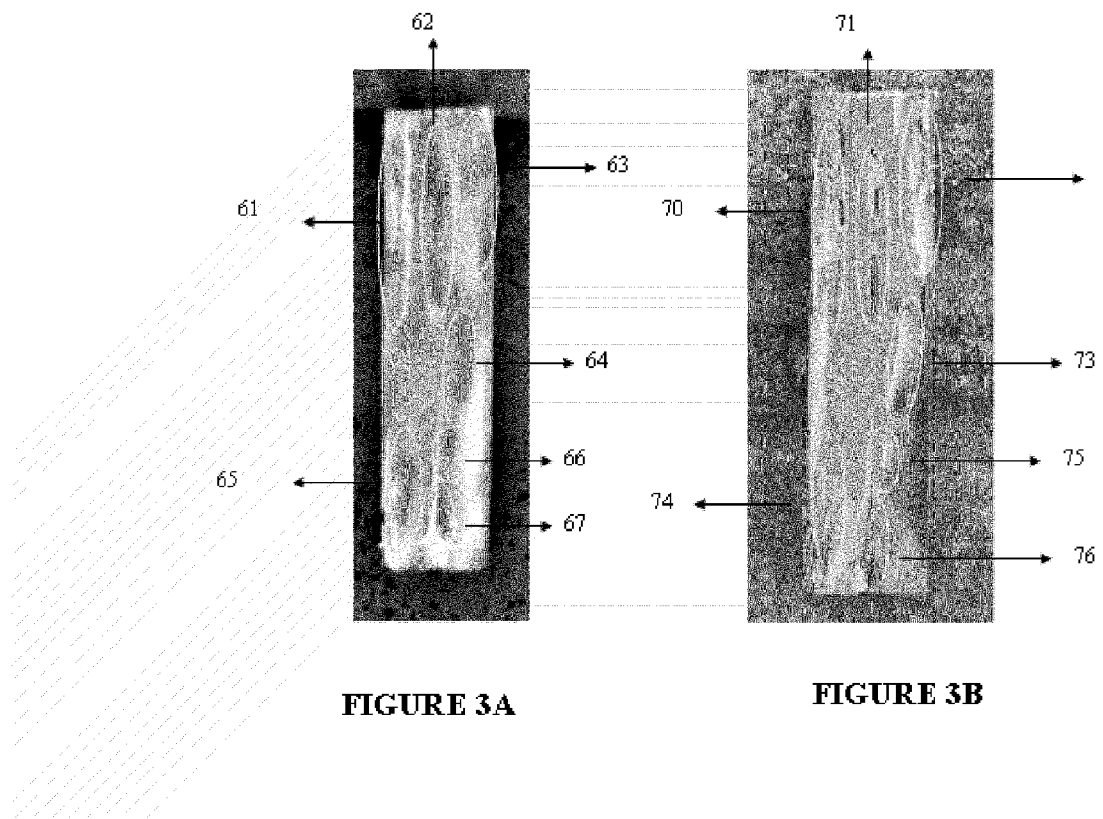
FIGURE 3A

FIG. 3A is an infrared scan of a structure showing drywood termite infestation.

FIG. 3B is a photo of a wood structure with the surface material removed.

Referring now to FIGS. 3A and 3B, an infrared scan of a wall shows potential drywood termite damage at 61-67. The surface material was removed in FIG. 2B to show termite damage at 70-76.

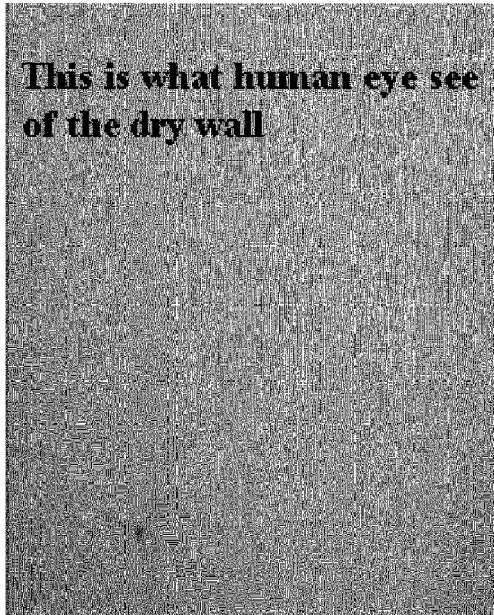
FIGURE 4A

FIG. 4A is a photograph of a wall.

FIG. 4A-4C show additional preliminary infrared detection. In FIG. 4A, a photograph of a wall is shown. This is what a human eye sees. In FIG. 4B, a preliminary infrared scan shows suspicious black spots which might be subterranean termite infestation. Subterranean termite infested areas contain very high moisture content, as the moisture evaporates infested areas appear as cold spots. In FIG. 4B, when the wall is removed, actual termite damage is shown at 60 and 61. However, it would be better to confirm wood damaging termite damage or infestation prior to destructive of the dry wall.

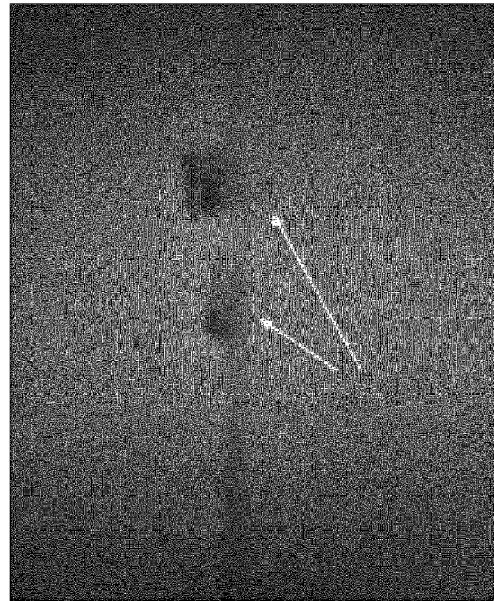
FIGURE 4B

FIG. 4B is an infrared scan of the wall.

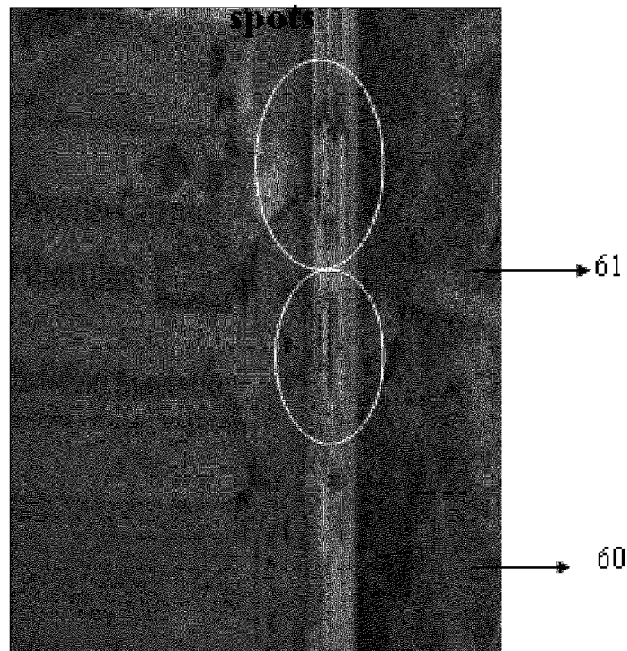
FIGURE 4C

When dry wall was removed

FIG. 4C is a photograph of the wall with the dry wall removed, it shows the 2x4 stud damaged by subterranean termite.
