(19) **United States**  
(12) **Patent Application Publication**  
Addis

(10) **Pub. No.: US 2008/0193280 A1**  
(43) **Pub. Date: Aug. 14, 2008**

(54) **HOLE LINERS FOR REPAIR OF VANE COUNTERBORE HOLES**

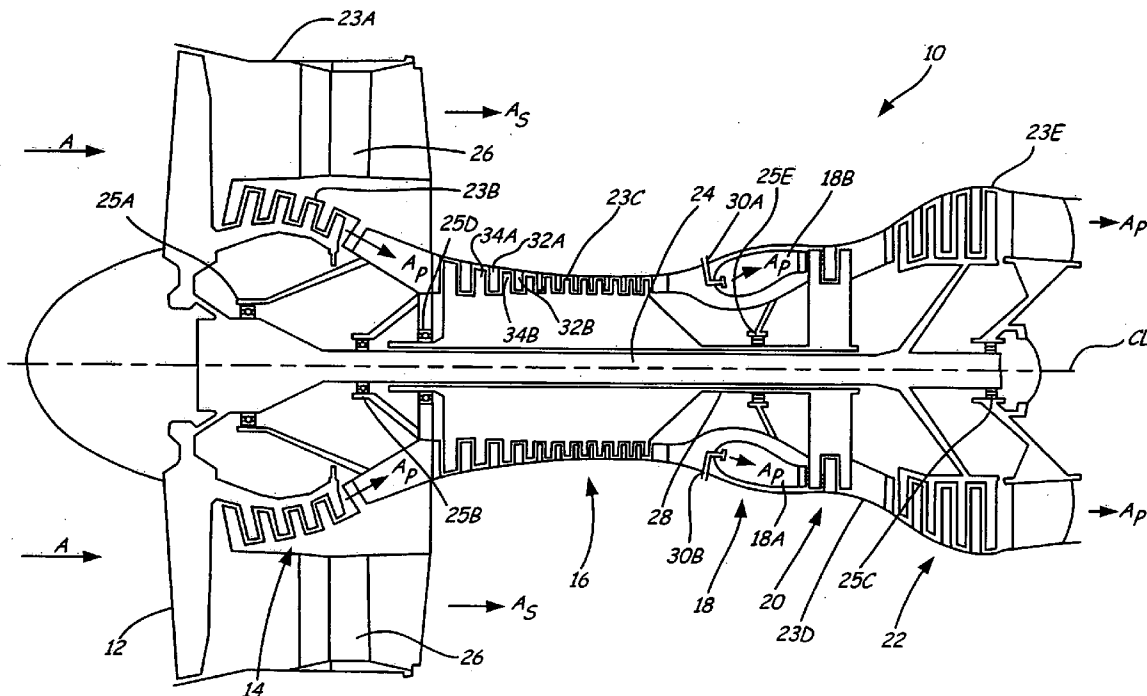
A variable vane shroud for a gas turbine engine comprises a cylindrically shaped body, a hole arranged at a circumference of the body, and a counterbore arranged concentrically around the hole on a radially inward facing surface of the body. The hole is for receiving a trunnion from a variable vane and the counterbore is for receiving a hub from the variable vane. A liner is inserted into the hole and counterbore such that the trunnion and hub are provided with a contact surface. The invention also provides a method for repairing a damaged counterbore in a variable vane shroud. A liner having a shape corresponding to a layer of material removed from the shroud is inserted into the void left by removing damaged material such that the counterbore is restored to pre-damaged dimensions.

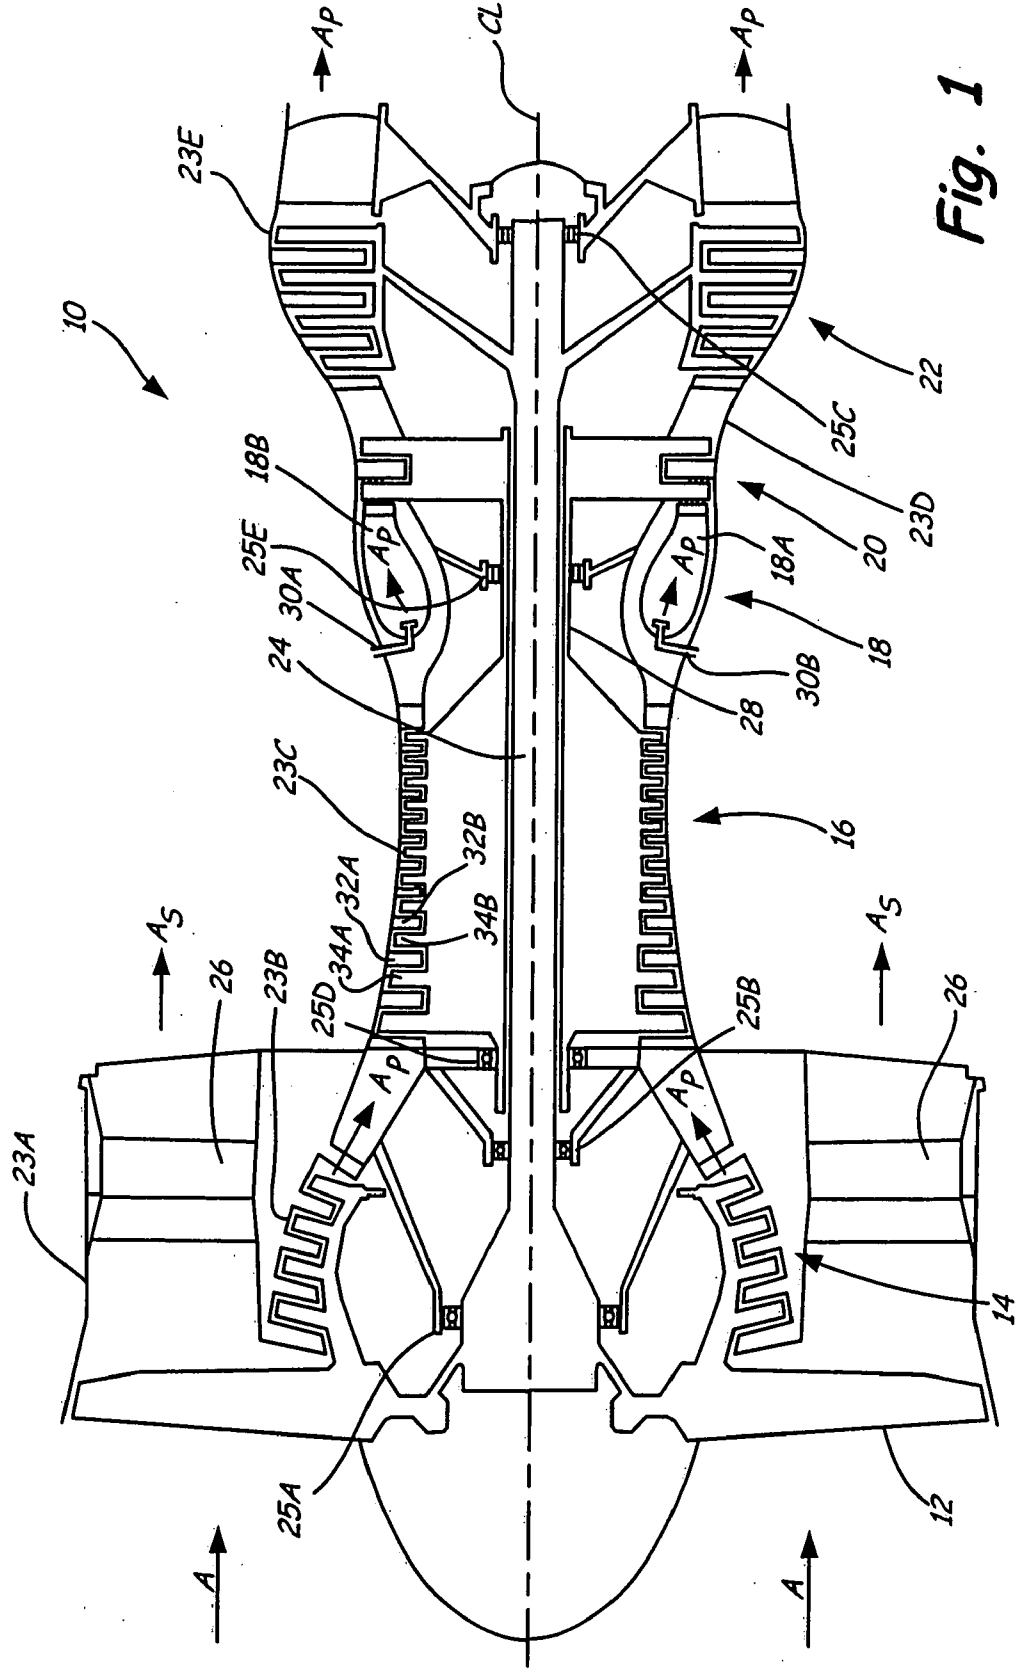
Fig. 1

[0006] FIG. 1 shows a schematic of a gas turbine engine in which the variable vane hole liners of the present invention are used.

[0014] FIG. 1 shows gas turbine engine 10, in which variable vane hole liners are used. Gas turbine engine 10 comprises a dual-spool turbofan engine having variable stator vanes for which the advantages of the hole liners are particularly well illustrated. Gas turbine engine 10 comprises fan 12, low pressure compressor (LPC) 14, high pressure compressor (HPC) 16, combustor section 18, high pressure turbine (HPT) 20 and low pressure turbine (LPT) 22, which are each concentrically disposed around longitudinal engine centerline CL. Fan 12 is enclosed at its outer diameter within fan case 23A. Likewise, the other engine components are correspondingly enclosed at their outer diameters within various engine casings, including LPC case 23B, HPC case 23C, HPT case 23D and LPT case 23E such that an air flow path is formed around centerline CL.

[0015] Inlet air A enters engine 10 and it is divided into streams of primary air  $A_p$  and secondary air  $A_s$  after it passes through fan 12. Fan 12 is rotated by low pressure turbine 22 through shaft 24 to accelerate secondary air  $A_s$  (also known as bypass air) through exit guide vanes 26, thereby producing a major portion of the thrust output of engine 10. Shaft 24 is supported within engine 10 at ball bearing 25A, roller bearing 25B and roller bearing 25C. Primary air  $A_p$  (also known as gas path air) is directed first into low pressure compressor (LPC) 14 and then into high pressure compressor (HPC) 16. LPC 14 and HPC 16 work together to incrementally step up the pressure of primary air  $A_p$ . HPC 16 is rotated by HPT 20 through shaft 28 to provide compressed air to combustor section 18. Shaft 28 is supported within engine 10 at ball bearing 25D and roller bearing 25E. The compressed air is

delivered to combustors **18A** and **18B**, along with fuel through injectors **30A** and **30B**, such that a combustion process can be carried out to produce the high energy gases necessary to turn turbines **20** and **22**. Primary air  $A_p$  continues through gas turbine engine **10** whereby it is typically passed through an exhaust nozzle to further produce thrust.

**[0016]** In order to expand the performance range of engine **10**, variable stator vanes are used in high pressure compressor **16**. For example, HPC **16** comprises variable vanes **32A** and **32B**, which are stationary and extend radially inward from fan case **23C**. Blades **34A** and **34B**, which rotate with HPC **16** on shaft **28**, are positioned adjacent vanes **32A** and **32B**. Vanes **32A** and **32B** form part of an array of vane stages arranged circumferentially around the engine centerline between HPC case **23C** and an inner diameter vane shroud. Blades **34A** and **34B** sequentially push primary air  $A_p$  past vanes **32A** and **32B** within HPC **16** to increase the pressure of primary air  $A_p$ . Vanes **32A** and **32B** rotate about their radial axis to adjust the incidence of the air  $A_p$  onto subsequent blades, including blade **34B**, during different operation modes, or speeds, of engine **10**. In order to ensure optimal operation of engine **10**, it is preferable that vanes **32A** and **32B** are able to rotate freely about their axis within HPC case **23C** and the inner diameter vane shroud.

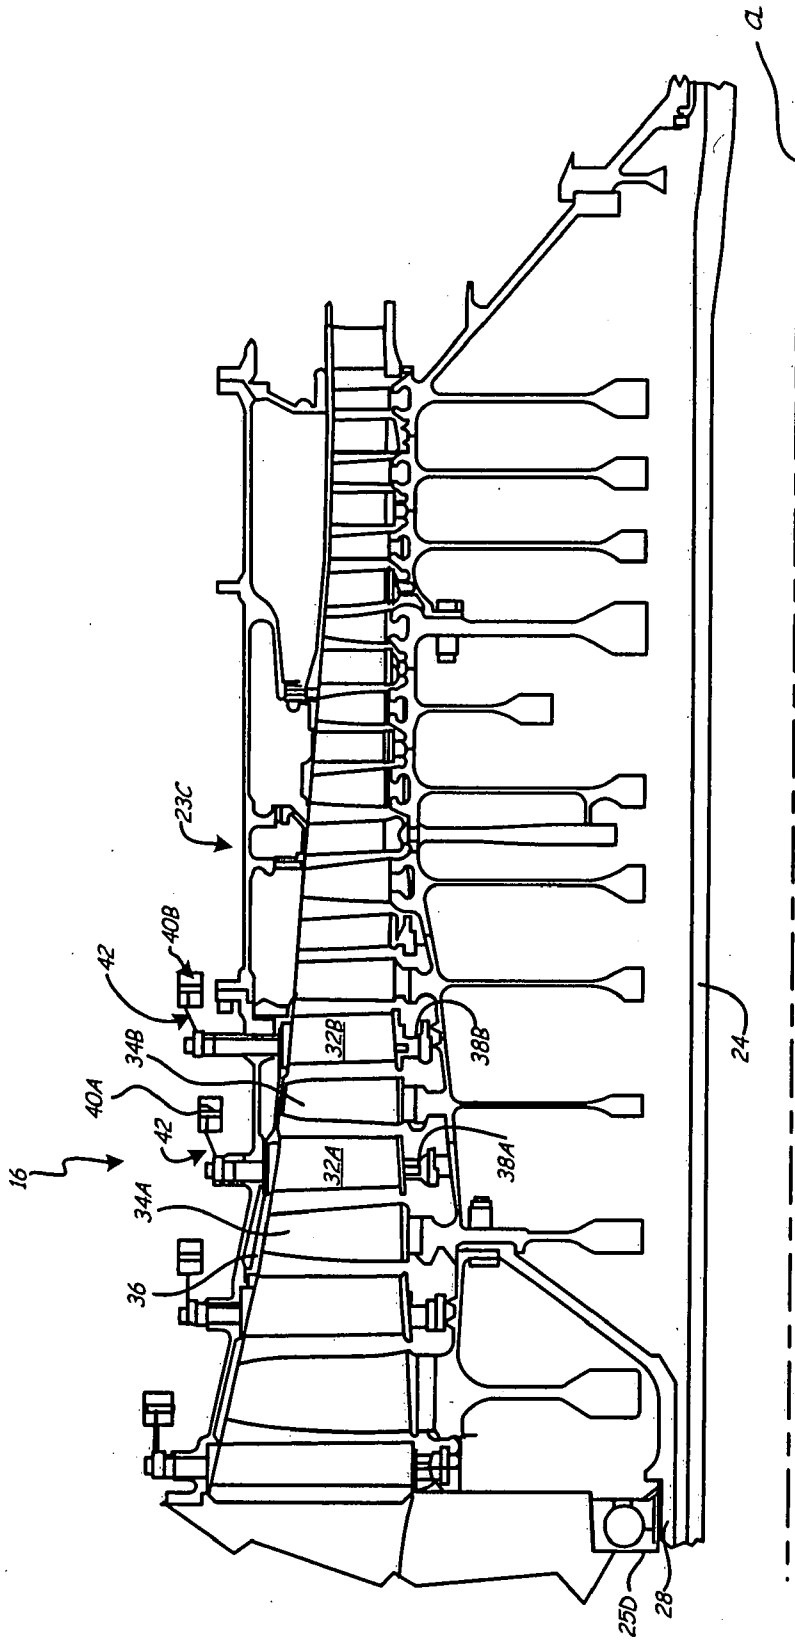
Fig. 2

[0007] FIG. 2 shows a high pressure compressor section of the gas turbine engine of FIG. 1 showing the interaction between variable stator vanes and a high pressure compressor (HPC) front case.

**[0017]** FIG. 2 shows the sequential arrangement of the various stages of high pressure compressor **16** about centerline CL of gas turbine engine **10**. For the embodiment of engine **10** shown, HPC **16** is divided into stages **S5** through **S15**, with LPC **14** of FIG. 1 comprising stages **S1** through **S4**. Vanes **32A** and **32B** and blades **34A** and **34B** comprise stages **S6** and **S7** of HPC **16**, respectively. The variable vanes rotate between HPC case **23C** and a plurality of inner diameter vane shrouds. Specifically, vanes **32A** and **32B** rotate between HPC outer shroud **36**, which is a component of case **23C**, and HPC inner shrouds **38A** and **38B**, respectively. In order to rotate vanes **32A** and **32B** within outer shroud **36**, vanes **32A** and **32B** are connected to sync rings **40A** and **40B**, respectively, through a plurality of sync arms **42**. Sync rings **40A** and **40B** are connected to, for example, a hydraulic actuator to adjust the pitch of vanes **32A** and **32B** such that airflow through HPC **16** is optimized for different operating levels of engine **10**. In order that vanes **32A** and **32B** rotate freely within outer shroud **36** and inner shrouds **38A** and **38B**, vanes **32A** and **32B** include inner and outer diameter trunnions.

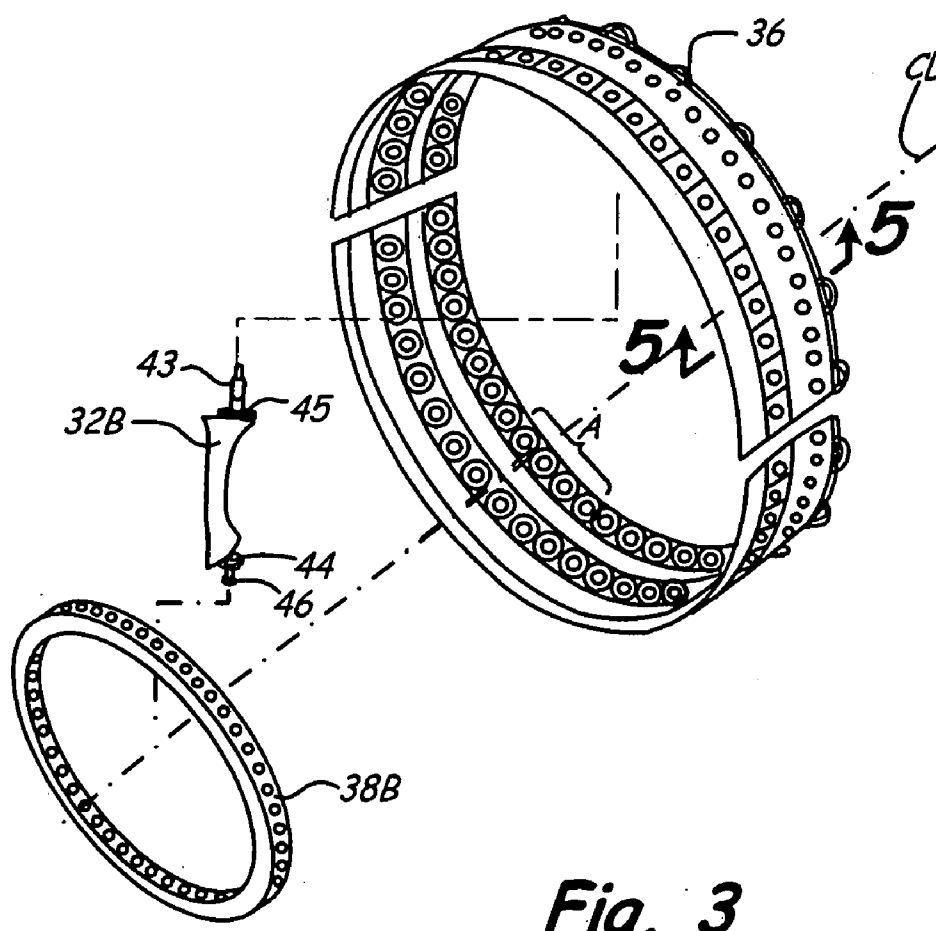
**Fig. 3**

[0008] FIG. 3 shows a perspective view of the HPC front case of FIG. 2.

**[0018]** FIG. 3 shows an exploded view of variable vane **32B** positioned between outer vane shroud **36** and inner vane shroud **38B**. Outer vane shroud **36** and inner vane shroud **38B** are positioned concentrically around engine centerline CL at the inner and outer diameters of vane **32B**, respectively. Vane shroud **36** comprises a conically shaped body that surrounds stages **S6** and **S7** of HPC **16**, including vanes **32A** and **32B** and blades **34A** and **34B**. Vane shroud **36** typically comprises a split-ring construction wherein it is divided into upper and lower halves.

**[0019]** Vane **32B** includes outer trunnion **43** and inner trunnion **44** that rotate within variable vane counterbored holes. Using sync ring **40B** and sync arms **42** as shown in FIG. 2, vane **32B** is rotatable about trunnions **43** and **44** within the counterbored holes in outer vane shroud **36** and inner vane shroud **38B**. Additionally, trunnions may include additional features for assisting in true rotation of the variable vanes. For example, vane **32B** includes outer diameter hub **45** and inner diameter hub **46** that rotate within the counterbores surround-

**[0020]** As engine **10** progresses into its lifecycle, the counterbores become damaged or worn from use and weather, thus impeding the free rotation of trunnions **43** and **44** within the counterbores, and hubs **45** and **46** against the counterbores. Impediments to the rotation of vanes **32A** and **32B** can lead to misalignment of the vane pitch along the flow path of engine **10** resulting in sub-optimal operation of HPC **16** and engine **10**. Typically, the counterbores begin to show wear after one engine overhaul cycle, with extensive damage appearing typically after 2-3 engine overhaul cycles. In lieu of replacing expensive engine components, such as outer vane shroud **36**, after they have worn beyond practical use, the present invention provides a system and method for repairing counterbored holes, principally for variable vanes. Particularly, the repair system and method includes a counterbored hole liner, which can be included in new engine components or can be retrofit into engine components as a fix to damage already sustained. Although hereinafter the invention is described with respect to repairing vane bottom counterbores at the outer diameter end of a high pressure compressor, the repairs can be made to both inner diameter and outer diameter vane shrouds. The repair is particularly well suited to HPC cases, but can also be used for LPC variable vane cases or in any other application using variable vanes.

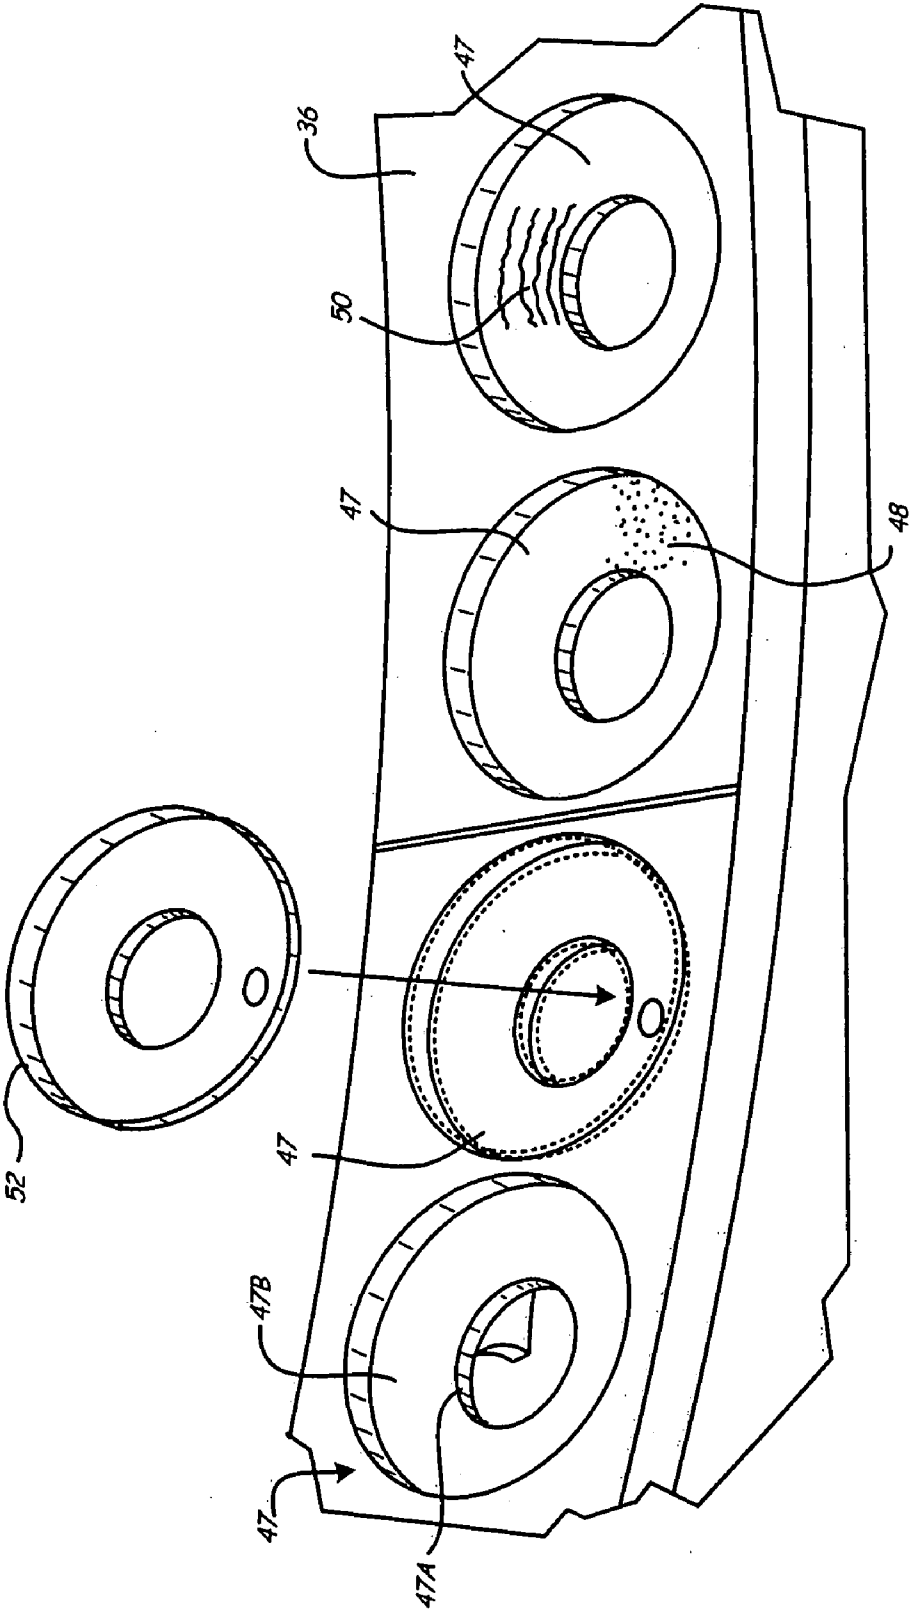
Fig. 4

[0009] FIG. 4 shows a perspective view of variable vane counterbores in the HPC front case of FIG. 3.

**[0021]** FIG. 4 shows breakout portion A of FIG. 3, showing a perspective view of vane bottom counterbored holes **47**, in outer vane shroud **36**. Outer vane shroud **36** includes counterbored holes **47** that each receives an outer diameter trunnion from a variable vane, such as trunnion **43** from vane **32B**. Counterbored holes **47** comprise hole **47A**, which is surrounded by counterbore **47B**. Counterbored holes **47** are machined to original design dimensions, free of any pitting, wear or corrosion. However, due to various sources, vane counterbored holes **47** become damaged such that rotation of hub **45** and trunnion **43** is hampered. For example, counterbored holes **47** develop corrosion **48** that arises from harsh operating conditions of engine **10**. Corrosion **48** includes pitting or other structural deficiencies of the base material comprising vane shroud **36**, which is typically a steel alloy such as an Austenitic steel or another iron-based alloy that builds up oxide layers leading to corrosion. Corrosion **48** arises from the extreme temperatures at which engine **10** operates and other external factors such as salt-rich operational environments. Counterbored holes **47** also develop scoring **50** that arises from routine rotation of trunnion **43** and hub **45** within counterbored holes **47**. Corrosion **48** and scoring **50** prevent free rotation of hub **45** on the surface of the counterbore into which they are inserted. As such counterbored holes **47** are provided with hole liner **52**. Counterbored holes **47** are over-bored such that any damage is removed from the base material of shroud **36**. Subsequently, liner **52**, having dimensions matching that of the removed over-bore, is inserted into counterbored holes **47** to restore shroud **36** to original specifications.

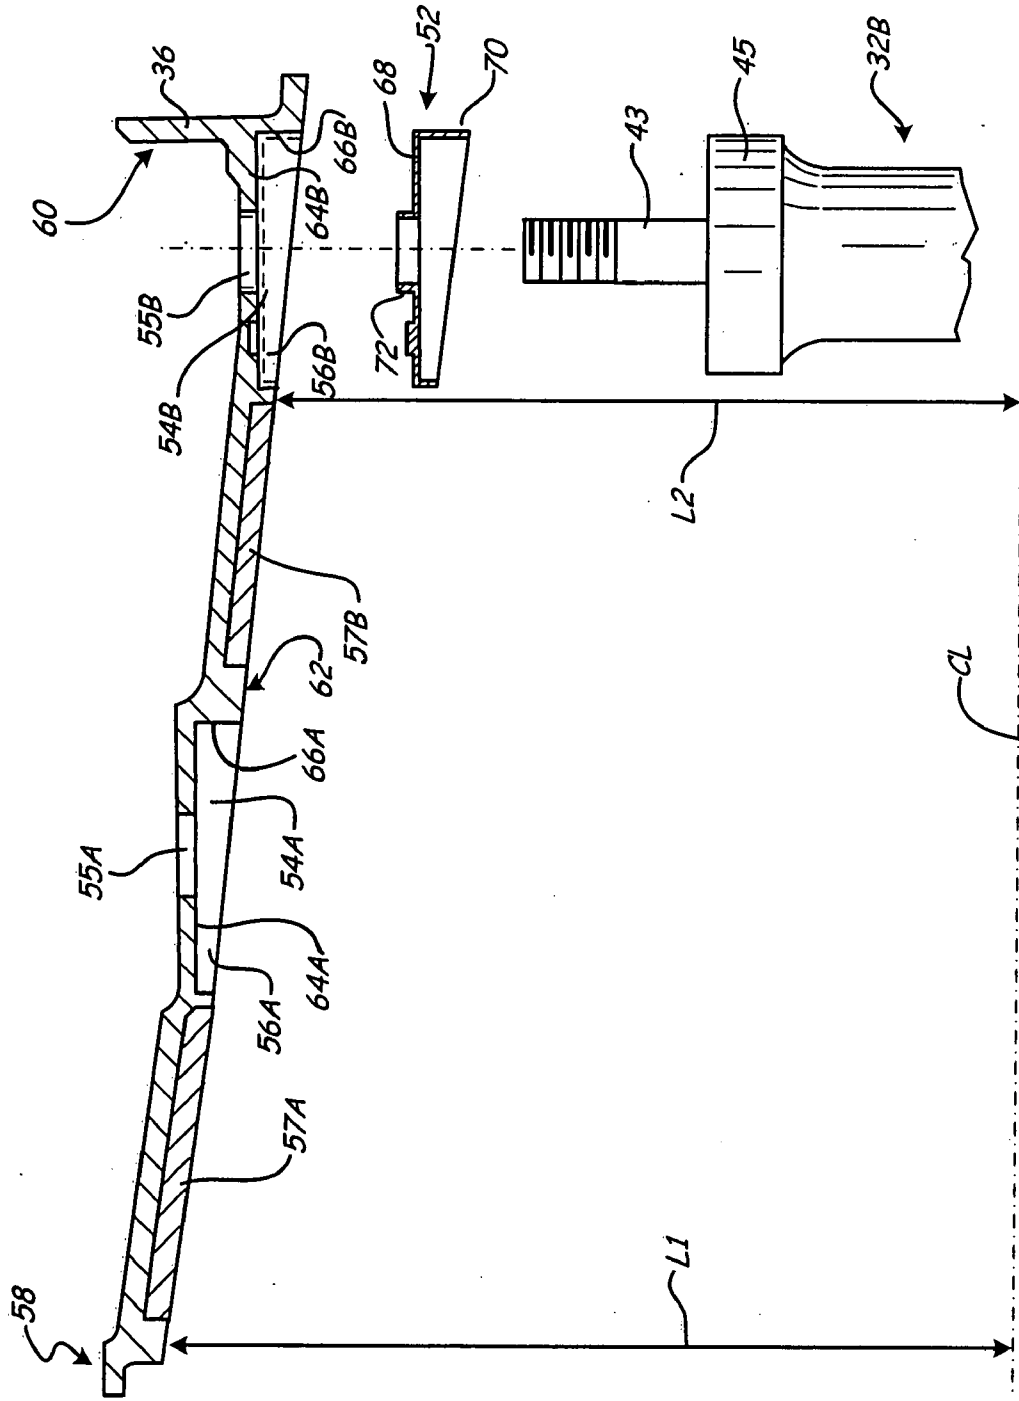
Fig. 5

[0010] FIG. 5 shows cross section 5-5 of FIG. 3 showing the insertion of a variable vane hole liner into an HPC front case counterbore.

**[0022]** FIG. 5 shows cross section 5-5 of FIG. 3 showing the insertion of counterbored hole liner **52** into outer diameter shroud **36** of HPC case **23C**. Outer diameter shroud **36** includes counterbored holes **54A** and **54B** for receiving trunnions of variable vanes. Counterbored holes **54A** and **54B** each comprise a trunnion hole **55A** and **55B**, respectively, extending through shroud **36** and a corresponding counter-

bore 56A and 56B, respectively, surrounding trunnion holes 55A and 55B, respectively. Outer diameter shroud 36 also includes trenches 57A and 57B against which the outer diameter ends of blades 34A and 34B engage. In various embodiments of shroud 36, trenches 57A and 57B are filled with a plasma-sprayed abradable material. As shown, counterbored hole 54B receives trunnion 43 and hub 45 of vane 32B. In order to facilitate repair of counterbored hole 54A or 54B, shroud 36 is provided with a variable vane hole liner. For example, liner 52, which is an exemplary embodiment of the hole liners, is used in conjunction with counterbored hole 54B.

[0023] Vane shroud 36 is generally a conically shaped cylinder such that it is disposed around engine centerline CL with a sloping orientation. Forward end 58 of shroud 36 is disposed length  $L_1$  away from centerline CL, whereas aft end 60 is disposed length  $L_2$  away from centerline CL. Length  $L_1$  is greater than length  $L_2$  such that radially innermost surface 62 of shroud 36 slopes toward centerline CL as shroud 36 extends from forward end 58 to aft end 60. However, since vanes 32A and 32B need to abut shroud 36 on a surface conducive to rotation, counterbores 56A and 56B include flat surfaces 64A and 64B, respectively. Thus, counterbores 56A and 56B are machined perpendicularly to centerline CL into surface 62. As such, counterbores 56A and 56B include walls 66A and 66B that are cylindrically shaped and extend from the generally flat surfaces 64A and 64B to the conically shaped surface 62 such that walls 66A and 66B follow the contour of surface 62.

[0024] Shroud 36 is typically produced as a single-piece unitary component. Thus, shroud 36 is finished to meet final dimensional tolerances, including the final dimensions of counterbored holes 54A and 54B. Counterbored holes 54A and 54B are typically finished such that they receive trunnion 43 and hub 45 with fairly tight tolerances such that slop is eliminated from the system, depending on design needs. However, due to damage imparted by corrosion and wear discussed above, the dimensions and tolerances of counterbored holes 54A and 54B become altered such that smooth rotation of trunnion 43 and hub 45 is affected. As such, shroud 36 is repaired with hole liner 52.

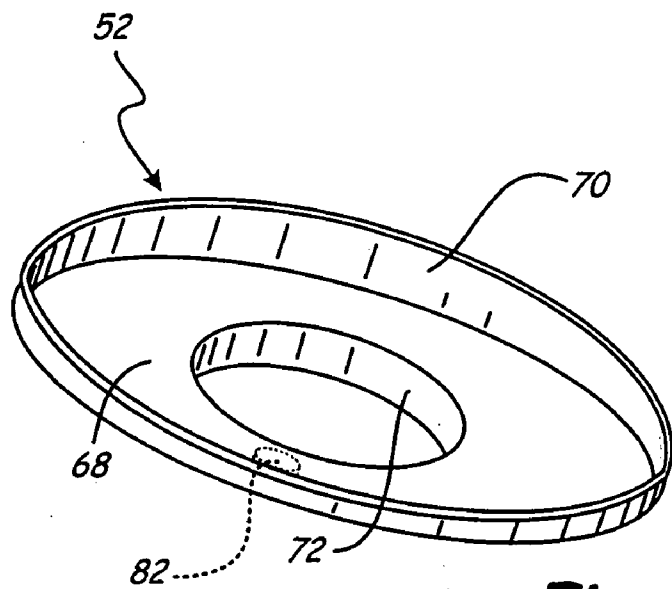
**Fig. 6A**

[0011] FIG. 6A shows a top perspective view of a variable vane hole liner.

[0025] FIG. 6A shows a top perspective view of liner 52, and FIG. 6B shows a bottom perspective view of liner 52. Liner 52 is constructed such that counterbored hole 54B can be milled out, or over-bored, to remove the corrosion or damage to counterbored hole 54B. Liner 52 includes flat floor 68, wall 70 and neck 72. As can be seen, wall 70 has a sloping shape that varies around its edge perimeter to match the contour of surface 62.

[0026] Liner 52 may be comprised of any material suitable for withstanding the thermal and mechanical stresses associated with shroud 36 during operation of engine 10. In various embodiments, liner 52 is made from a metallic alloy or from an engineered plastic. Any suitable alloy can be used, however, alloys matching that of shroud 36 are particularly suitable. For example, Austenitic stainless steels, such as 300 series stainless; or nickel materials, such as the Inconel family, would also be suitable materials. Polyetheretherketone (PEEK) materials, such as Sustatec® PEEK as is commercially available from Sustaplant, L.P., Edgewood, N.Y.; or PTFE-based materials, such as Rulon® 945 as is commercially available from St. Gobain Performance Plastics, Valley Forge, Pa. are examples of suitable engineered plastics. Rulon® 957, also available from St. Gobain, is another suit-

able material. For any material selected desirable properties include heat resistance, low friction and strength. Additionally, corrosion resistant material may be selected to reduce recurrence of corrosion damage. Low-friction materials may be selected such that the variable vanes are better able to rotate. Specifically, the material for liner 52 may be selected to have a lower coefficient of friction than that of the material comprising shroud 36. It is preferable that materials be able to sustain temperatures upwards of 600° F., preferably up to about 700° F., which are temperatures commonly reached around HPC 16. It is also desirable to match the thermal expansion rate of the material of liner 52 with that of the material comprising shroud 36. The qualities for shroud 36 can be selected to match design needs depending on performance parameters of engine 10.

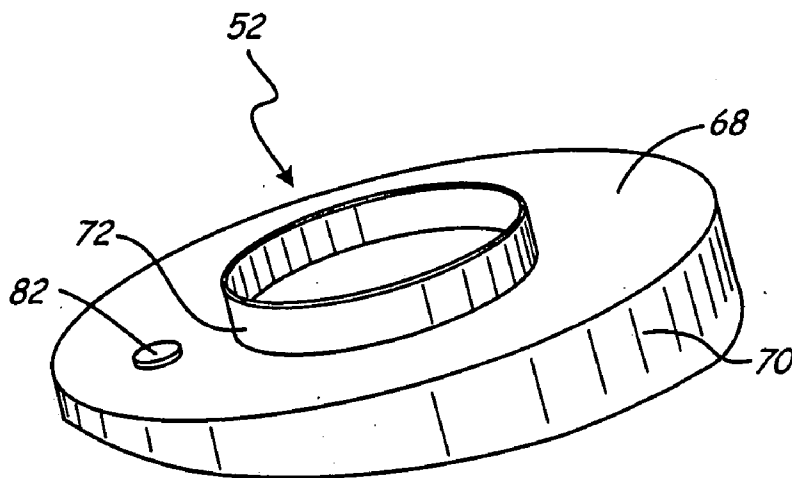
**Fig. 6B**

[0012] FIG. 6B shows a bottom perspective view of a variable vane hole liner.

[0030] In order to facilitate and expedite the assembly of liner 52 with counterbored hole 54B, floor 76 has additional material removed to form a void or locating recess 80. Liner 52 is thus fabricated with corresponding button 82 that comprises the negative shape of recess 80 and is positioned on floor 68 on a corresponding location. Locating recess 80 is positioned on floor 76 such that liner 52 can be properly inserted into counterbored hole 54B in only one way. This is particularly advantageous since wall 70 of liner 52 is of varying height to match the varying height of wall 78. Liner 52 would be difficult to rotate within counterbored hole 54B when fully seated due to its thin construction. Thus, in order to prevent misalignment of liner 52, which would interfere with the free rotation of vane 32B in counterbored hole 54B, button 82 prevents liner 52 from becoming fully seated within counterbored hole 54B unless wall 70 is aligned with the slope of wall 78. Also, button 82 prevents any rotation of liner 52 during any processes used to secure liner 52 to shroud 36.

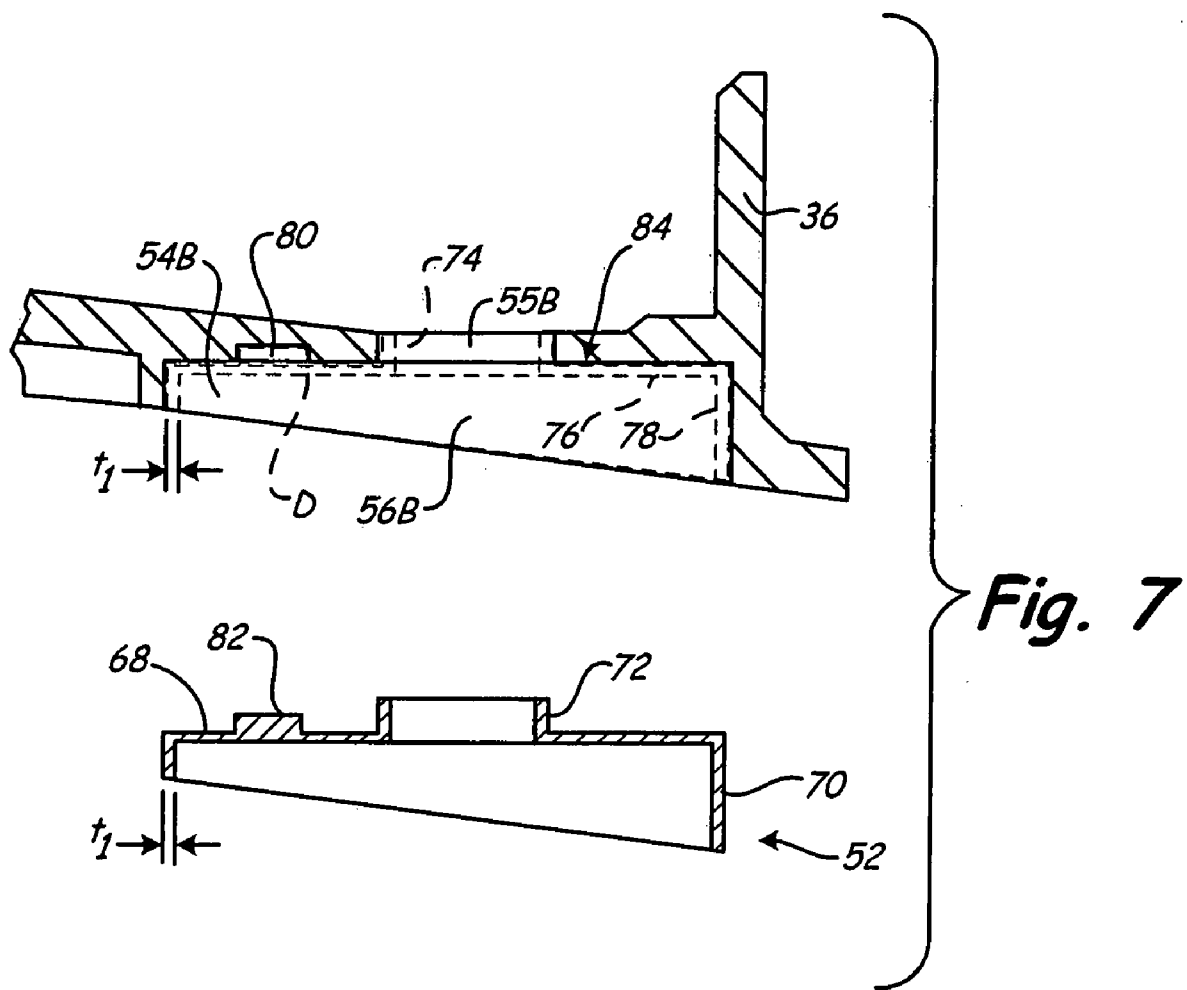
[0013] FIG. 7 shows a close-up view of a variable vane hole liner and a variable vane counterbore.

[0027] FIG. 7 shows a close-up view of liner 52 for insertion into counterbored hole 54B of outer diameter vane shroud 36. Counterbored hole 54B is machined into shroud 36 such that it is made to specification as is required by design parameters. Counterbored hole 54B extends into shroud 36 such that it is shown in dotted line D in FIG. 7. Counterbored hole 54B includes neck 74, base 76 and wall 78. As described above, counterbored hole 54B undergoes corrosion and wear such that shroud 36 becomes damaged. The damage associated with the corrosion or wear extends into the base material of shroud 36 a particular depth. As such, counterbored hole 54B is machined out, or over-bored, a particular depth to remove the damaged base material such as shown in solid lines in FIG. 7. However, it is not enough to simply remove the damaged material, as any material removal of shroud 36 permits slop in the rotation of vane 32B, which affects the efficiency of IPC 16. A uniform amount of material is removed from counterbored hole 54B such that it can be readily replaced to restore shroud 36 to its original design dimensions. Liner 52 is inserted into the over-bored counterbored hole 54B to restore shroud 36 and counterbored hole 54B to their original dimensions. Thus, liner 52 is made to dimensions that match the amount of material removed from counterbored hole 54B in removing the damaged base material.

[0028] Wear and corrosion may occur anywhere along counterbored hole 54B. For example, wall 78 undergoes wear and corrosion such that it becomes damaged to some depth less than or equal to depth  $t_1$ . Thus, material is uniformly removed from the entirety of wall 78 to depth  $t_1$  to ensure all damaged material is removed. Wall 70 of liner 52 is correspondingly manufactured to have a thickness corresponding to depth  $t_1$ . Likewise, material is removed from around neck 74 and floor 76 to a depth necessary to remove any damaged base material at those locations. Correspondingly, liner 52 is fabricated such that neck 72 and floor 68 have thicknesses matching the amount of material removed from neck 74 and floor 76, which may or may not equal depth  $t_1$ .

[0029] Alternatively, material may be uniformly removed from neck 74, floor 76 and wall 78 to a depth necessary to remove the deepest damage on counterbore 54B, regardless of the location of the damage. In any event, the least amount of material as is practically possible is removed from shroud 36 such that shroud 36 is not thinned-out too much and its structural integrity is not compromised, as the thickness of shroud 36 is generally on the order of about 0.04 inches (~0.1016 cm). As such, the invention is particularly well suited to shallow damage incurred to counterbored hole 54B.

Thus, when liner 52 is inserted into over-bored counterbored hole 54B, shroud 36 and counterbore 54B are restored to their original design dimensions.

[0031] Liner 52 may be secured to shroud 36 in any suitable manner. For example, depending on the material of liner 52, liner 52 may be welded, brazed or glued to shroud 36. In one embodiment, liner 52 is furnace brazed using a foil bonding material. In another embodiment, liner 52 is resistance welded to shroud 36 at surface 84. In other embodiments spot welding or electron beam welding would be suitable, however subsequent machining steps would be needed to remove slag or any other byproducts. For welding methods, shroud 36 and liner 52 can be heat treated to reduce any stress risers produced during the welding process. Regardless of the method selected for securing liner 52 to shroud 36, it is preferable that no subsequent machining steps are required. For engineered plastic liners, high temperature adhesives or glues would be suitable methods for securing liner 52 to shroud 36.
