US011472491B1

(54) **VEHICLE FRAME AND CARGO BAY LINER**

(71) Applicant: **PennPlastics, LLC**, Mishawaka, IN (US)

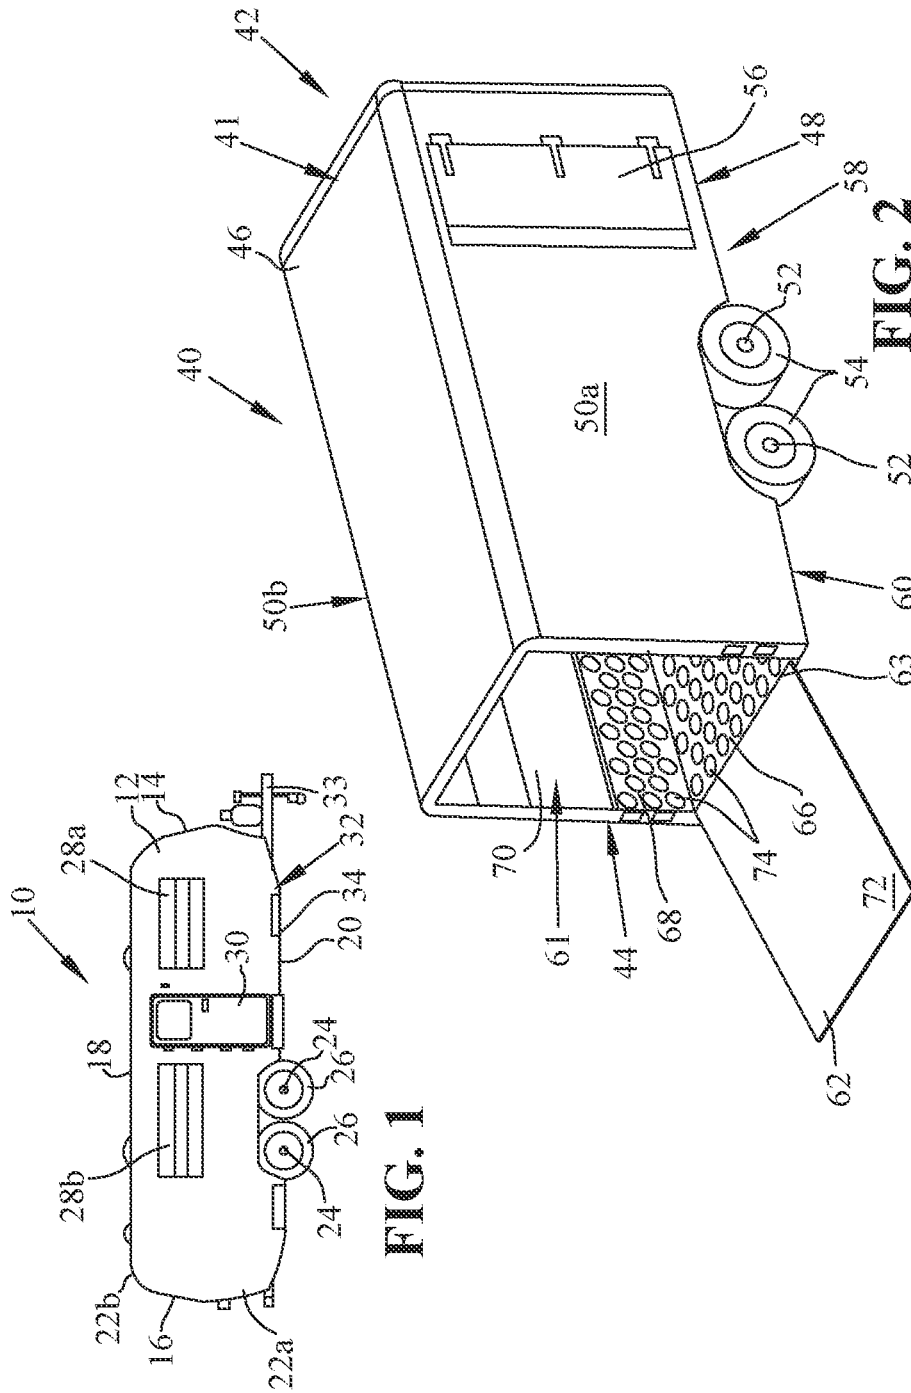
FIG. 1 is a side view of a recreational vehicle and frame liner in accordance with the subject invention;

Referring now to FIG. 1, a recreational vehicle is shown generally indicated as 10. In the embodiment shown, recreational vehicle 10 is a type commonly called a travel trailer. Travel trailer 10 is generally defined by a housing 12 including a front end 14, a rear end 16, a top 18, a bottom 20, and a pair of generally parallel sides 22a, 22b. Recreational 10 further includes a pair of axles 24 having wheels 26 mounted thereon. Recreational vehicle 10 also includes

windows **28a**, **28b** and a door **30**. Housing **14** is mounted upon and supported by a frame assembly, generally indicated as **32**, extending into a hitch **33**. These are all known and common in the recreational vehicle industry. A liner **34** in accordance with the subject invention is mounted and attached at the bottom of frame assembly **32** to protect the undercarriage of recreational vehicle **10** as described above in the background section.

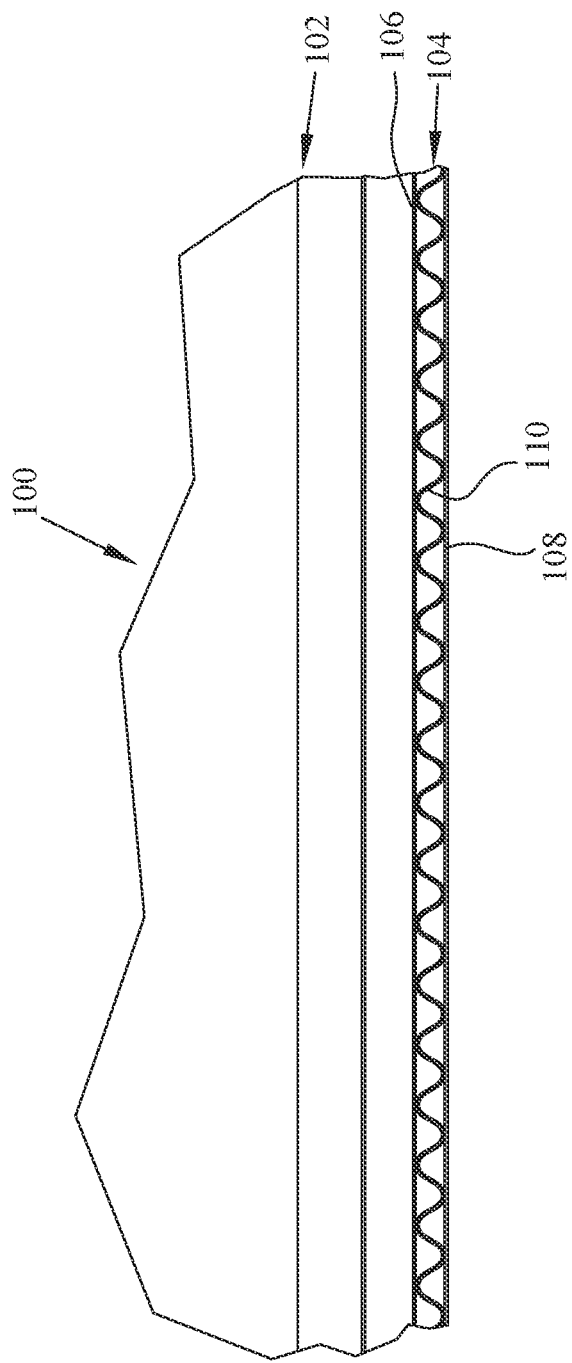
FIG. 3
(PRIOR ART)

FIG. 3 is a side view of a prior art recreational vehicle frame liner;

Referring now to FIGS. 3 and 4, these depict prior art vehicle undercarriage frame liners in common use in the industry. A portion of a recreational vehicle is generally indicated as **100**. Recreational vehicle **100** includes a frame assembly generally indicated as **102** and a corrugated liner generally indicated as **104**. Corrugated liner **104** includes a top sheet **106**, a bottom sheet **108**, and a corrugated or sinusoidal ply **110** extending therebetween. Top sheets **106** and **108** are adhered or attached to corrugated ply **110**. Typically, the corrugated material is polyethylene.

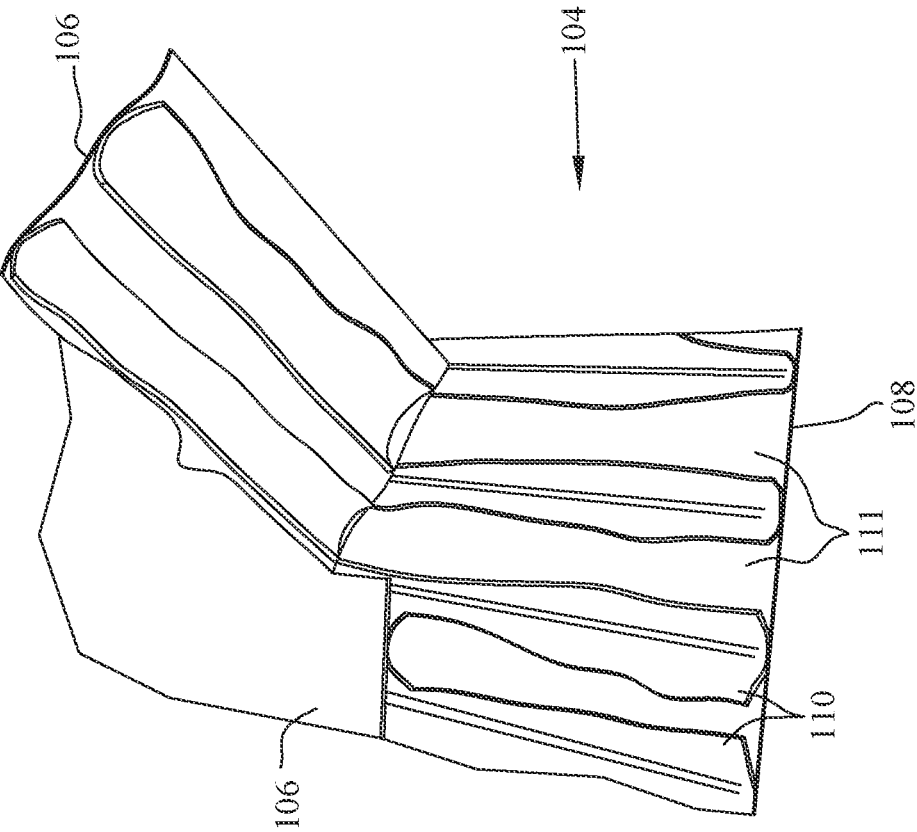
FIG. 3A
(PRIOR ART)

FIG. 3A is an enlarged perspective view of the frame liner in FIG. 3 showing the top layer partially peeled back and channels therein.

Referring to FIG. 3A, a portion of the corrugated liner **104** is shown removed from recreational vehicle **100**. In FIG. 3A, a portion of the top sheet **106** has been pulled back revealing channels **111** that extend between top sheet **106** and bottom sheet **108** and along/within the sinusoidal ply **110**. As should be appreciated, a problem, with the prior art liner is that any water or moisture entering the open ends of the corrugated liner **104** easily crosses through channels **111** so that channels **111** can become filled with water. The water can leak or freezing of the water may cause ripping, tearing or pulling apart of corrugated liner **104**, thereby destroying its structural integrity.

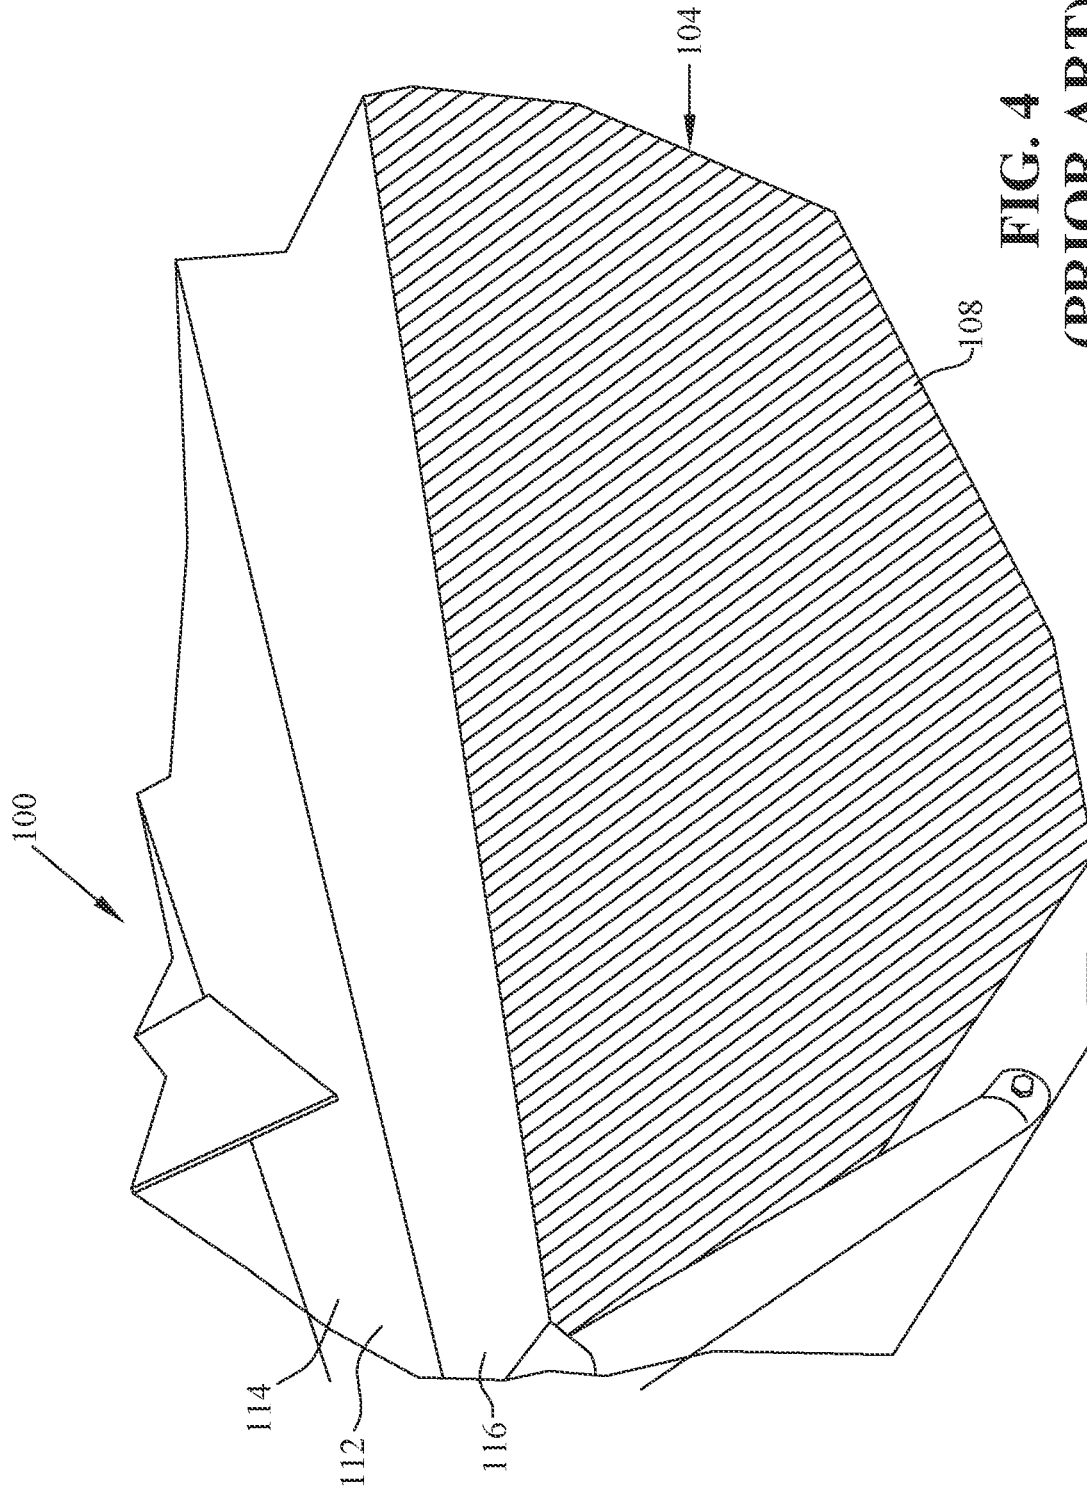
FIG. 4 is a bottom prospective view of a prior art recreational vehicle and frame liner;

Referring to FIG. 4, only the bottom sheet **108** of corrugated liner **104** is visible. Furthermore, the corrugations are not visible as recreational vehicle **100** includes a frame

member **112**, such as in I-beam or C-channel including a vertical web **112** and horizontal flange **116**. Side edges of corrugated liner **104** are located on top of flange **112**.

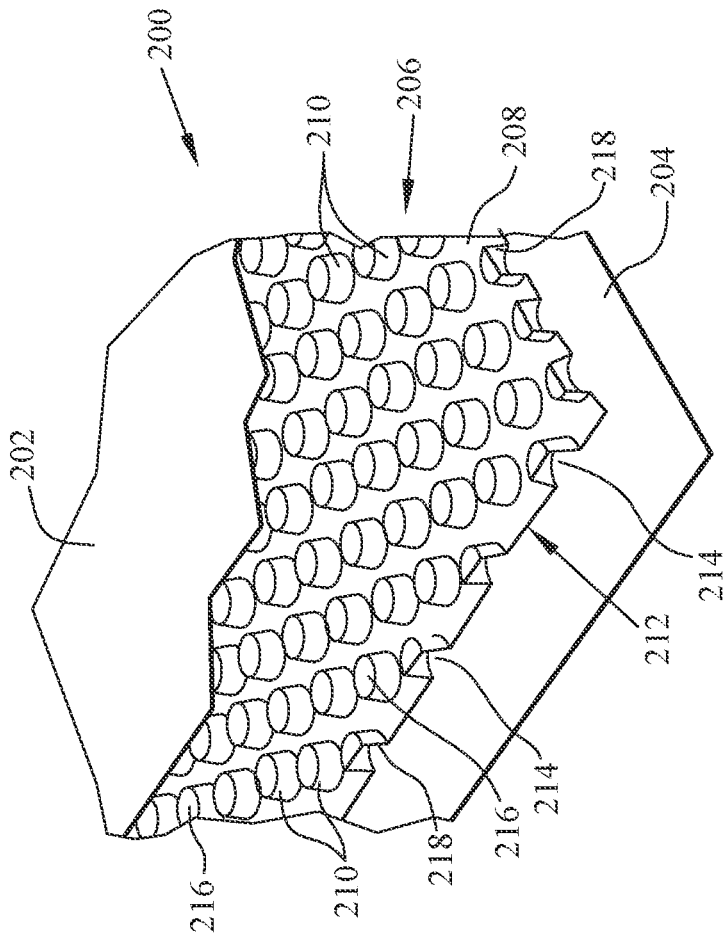
FIG. 5 is an exploded view of a sandwich material from which one embodiment of the liner for the subject invention is taken from;

Referring now to FIG. 5, an embodiment of a 3-ply panel from which the subject liner can be taken is generally indicated as **200**. 3-ply panel **200** includes a top sheet **202**, a bottom sheet **204**, and a core generally indicated as **206**. In a preferred embodiment, 3-ply panel **200** and core **206** is manufactured from polypropylene and is 100% recyclable. Core **206** may also be referred to as plastic honeycomb or plastic bubble board. 3-ply panel **200** may be provided in thicknesses of 10 mm, 5 mm or 3 mm. Applicant has found that the core **206** in a 3 mm thick 3-ply panel **200** is particularly suitable for use as a liner in accordance with the subject invention as will be discussed in further detail below. As can be seen in FIG. 5, core **206** has one face **208** having projections **210** extending upward therefrom. The opposite face **212** includes openings **214** extending downward into projections **212**. Accordingly, projections **210** have a generally cylindrical configuration being hollow in the center thereof and including an end face **216** and side walls **218**. Applicant has determined that one suitable 3-ply panel **200** from which core **206** may be extracted and used is IntePro® 3 mm Titan board from the IntePlast Group.

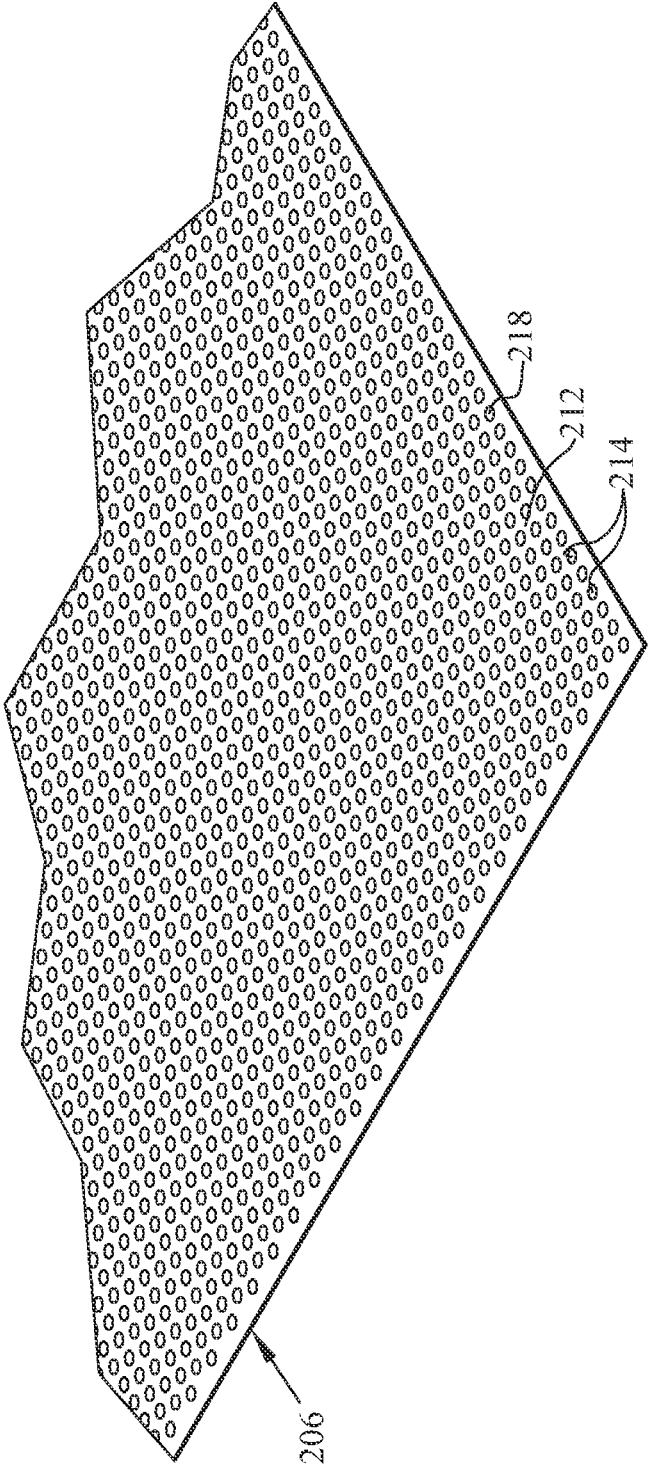
FIG. 6 is a perspective view of one embodiment of a vehicle frame liner and cargo bay liner of the subject invention, with top and bottom sheets removed, showing a face of the liner having openings therein;

Referring now to FIGS. 6-11, further details, of vehicle frame and cargo area liner/core **206** are disclosed. As can be seen, the projections and/or openings **210**, **214**, respectively are aligned in a lengthwise direction of core **206** but going crosswise across core **206**, projections **210** and openings **214** are staggered.

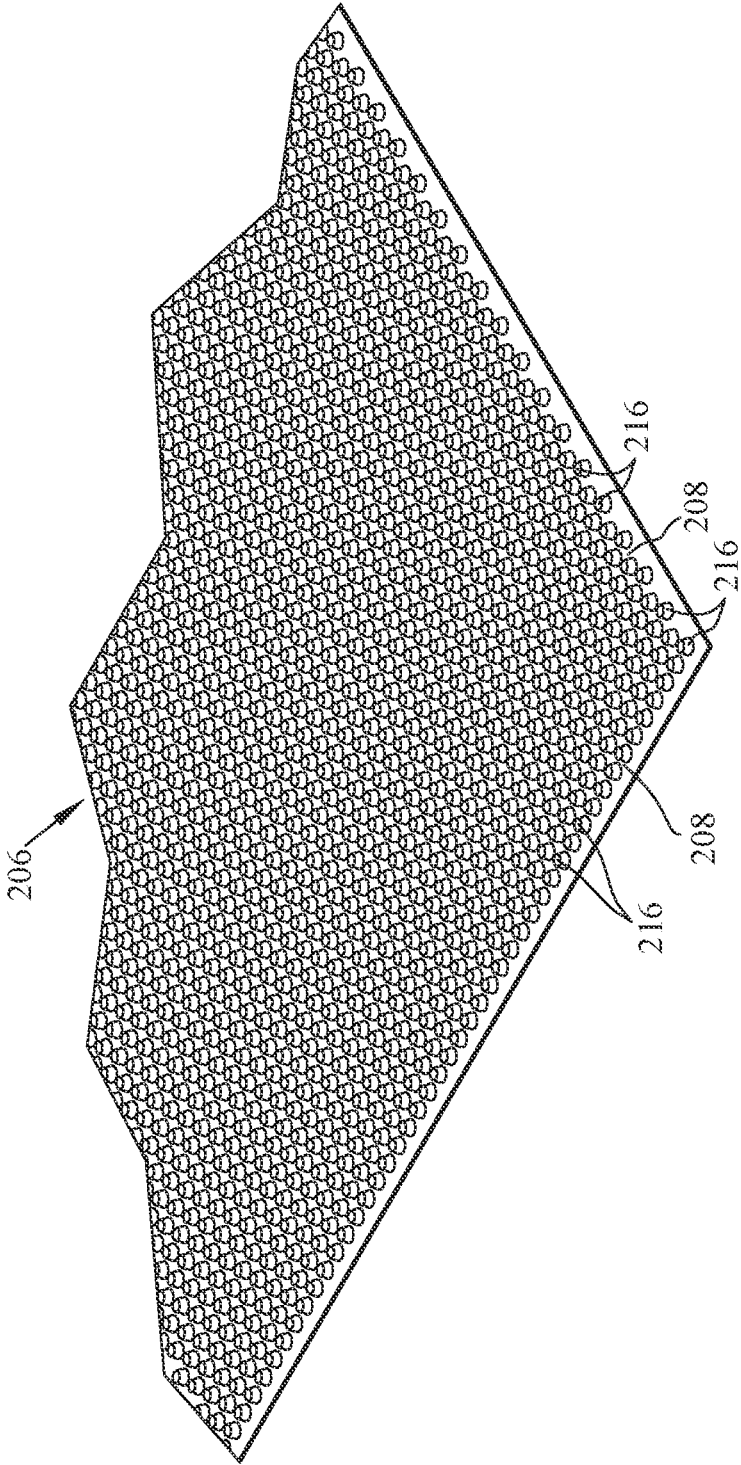
FIG. 7 is the vehicle frame and cargo bay liner of FIG. 6 showing an opposite face of the liner having projections extending therefrom;

Referring to FIG. 7, it can be appreciated that end faces **216** may have a variety of configurations including domed, flat, and/or convex.

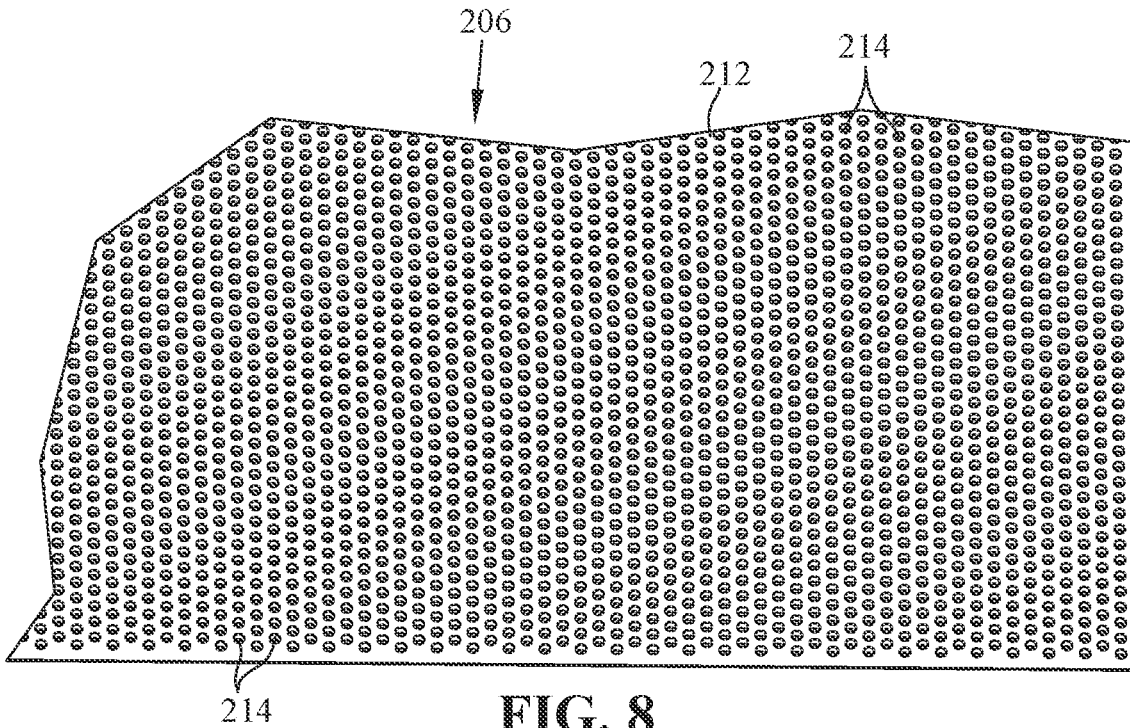
FIG. 8 is a plan view of the liner of FIG. 6 showing the face having openings;

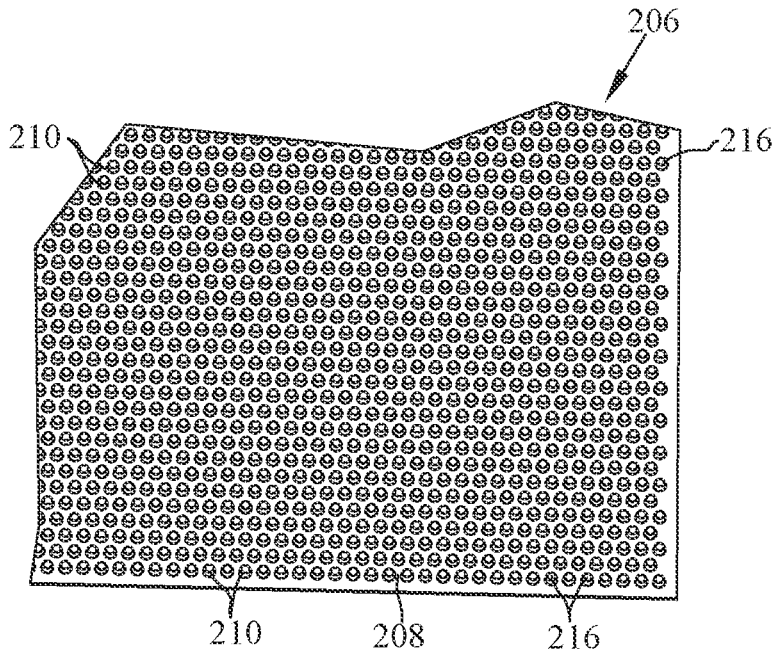
FIG. 9 is a plan view of the liner of FIG. 6 showing the face having projections extending therefrom;

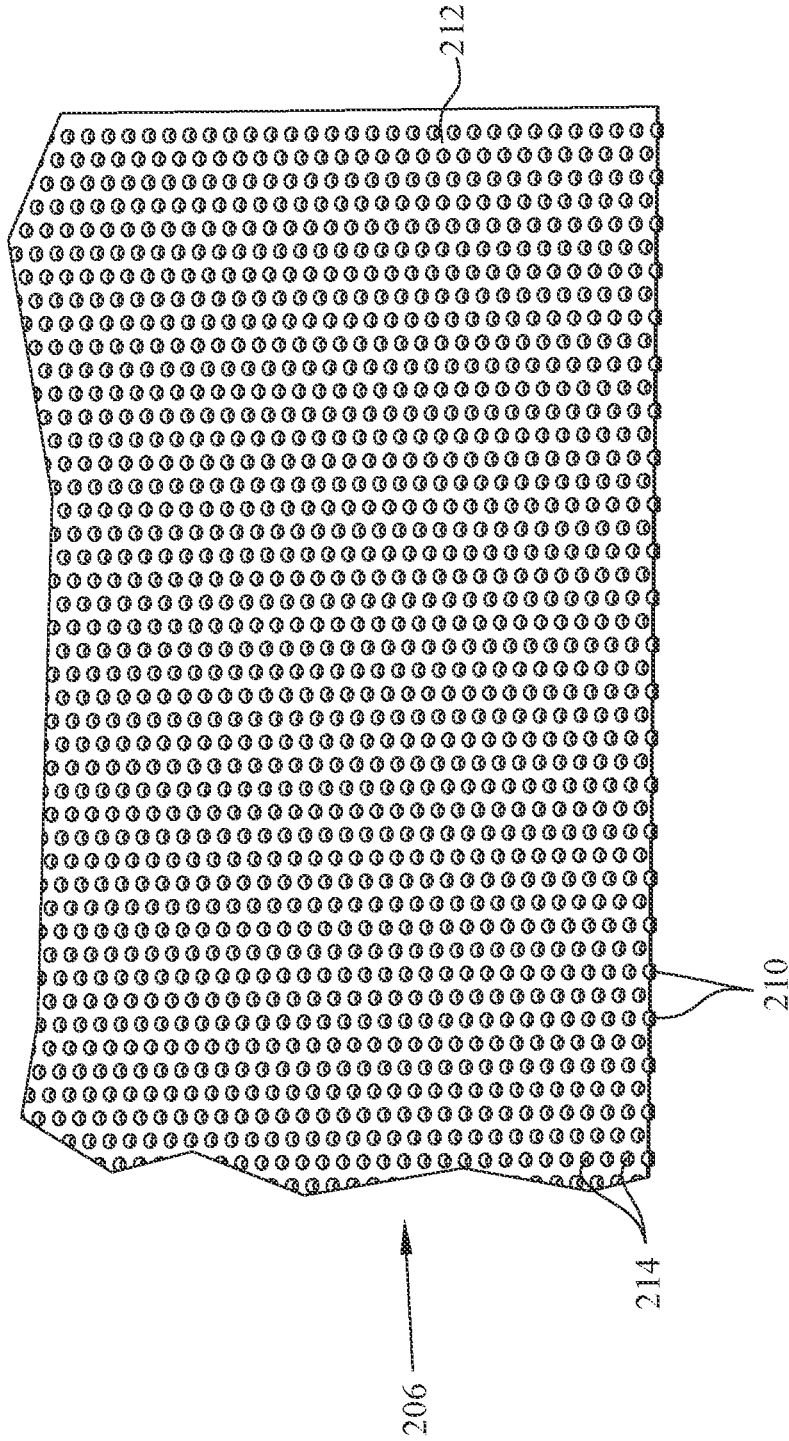
FIG. 10 is another perspective view of the vehicle and cargo bay liner of FIG. 6 with the face having openings facing upward;

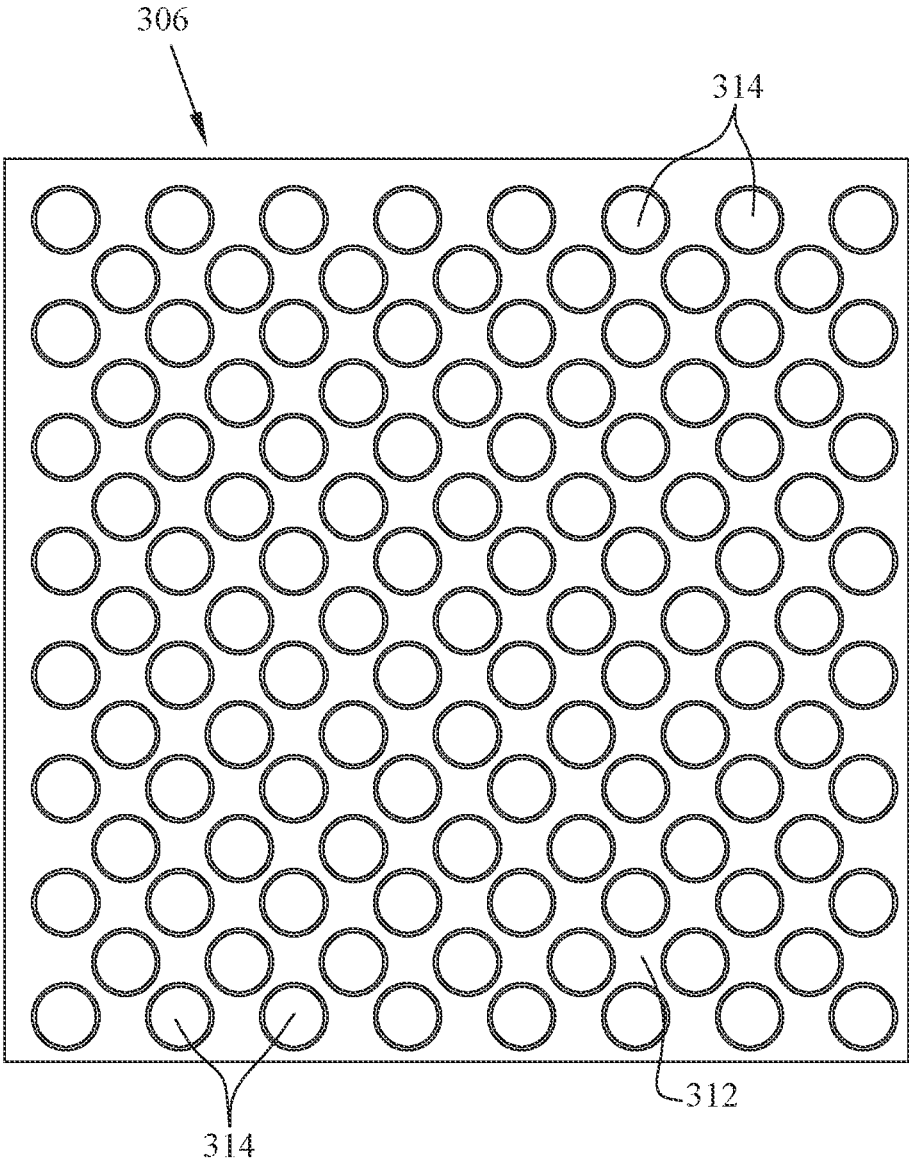
FIG. 12 is a plan view of an alternate embodiment vehicle frame and cargo bay liner showing a face having openings therein;

Now referring to FIGS. 12 and 13, an alternate vehicle frame and cargo area liner is shown generally indicated as **306**. As can be seen in FIG. 13, liner **306** includes a face **308** having projections **210** thereon. As shown in FIG. 12, liner **306** has an opposite face **312** having openings **214** therein. Projections **310** include end faces **316** and sidewalls **318** as best seen in FIG. 13. Line **306** can be manufactured from single or multi-layer materials sandwiched together (twin or triple layer).

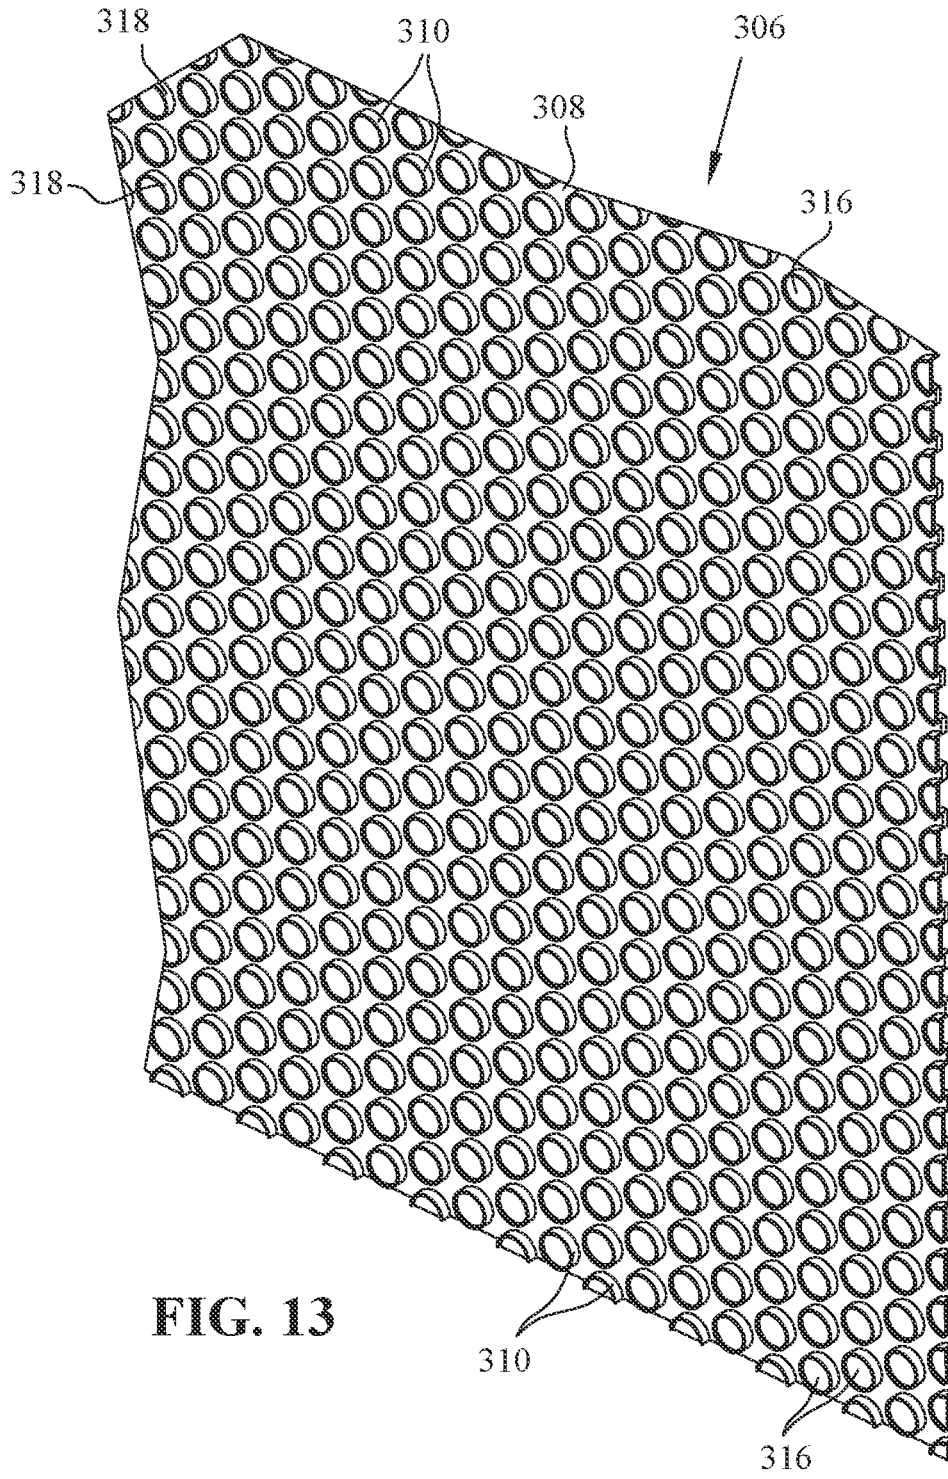
FIG. 13 is a plan perspective view of the alternate embodiment vehicle frame and cargo bay liner of FIG. 12 showing a face having projections extending therefrom;

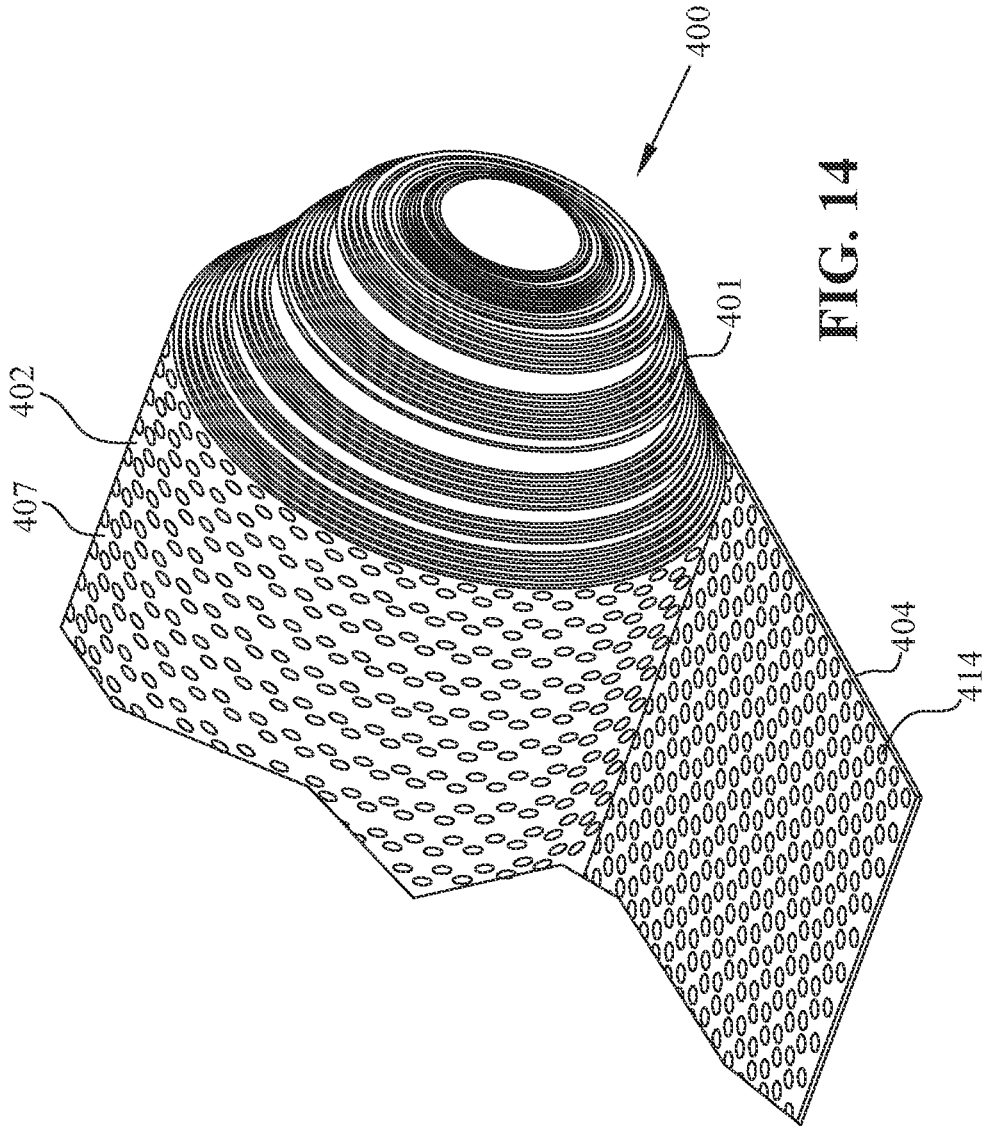
FIG. 14 is a perspective view of another alternate embodiment vehicle frame and cargo bay liner shown rolled in a coil and having aluminum foil on one side thereof;

Now referring to FIGS. 14-24, another alternate vehicle frame and cargo area liner is shown generally indicated as 400. Liner 400 can be provided in a coiled form 401 as shown in FIGS. 14 and 15, making it extremely suitable for use as a liner for vehicle frames and cargo bays. The desired length of liner can be rolled out and cut to size for assembly to the vehicle. Vehicle frame and cargo bay liner 400 is of a 3-ply configuration and includes a top ply, sheet, or layer 402 and a bottom ply, sheet, or layer 404. A core 406 (see FIGS. 19 and 22-24) separates top sheet 402 from bottom sheet 404. Additionally, vehicle frame and cargo bay liner 400 also includes a sheet of aluminum foil or metalized film 407 on one side thereof. In the embodiment shown, aluminum foil/metalized film 407 is provided on top sheet 402; however, it should be appreciated that aluminum foil or metalized film could also be provided on the bottom sheet 404. Aluminum foil or metalized film 407 may be adhered to top sheet 402 using an adhesive or other suitable means. The metalized film can be a polymer film coated with a thin layer of metal, which can be aluminum or other suitable metal.

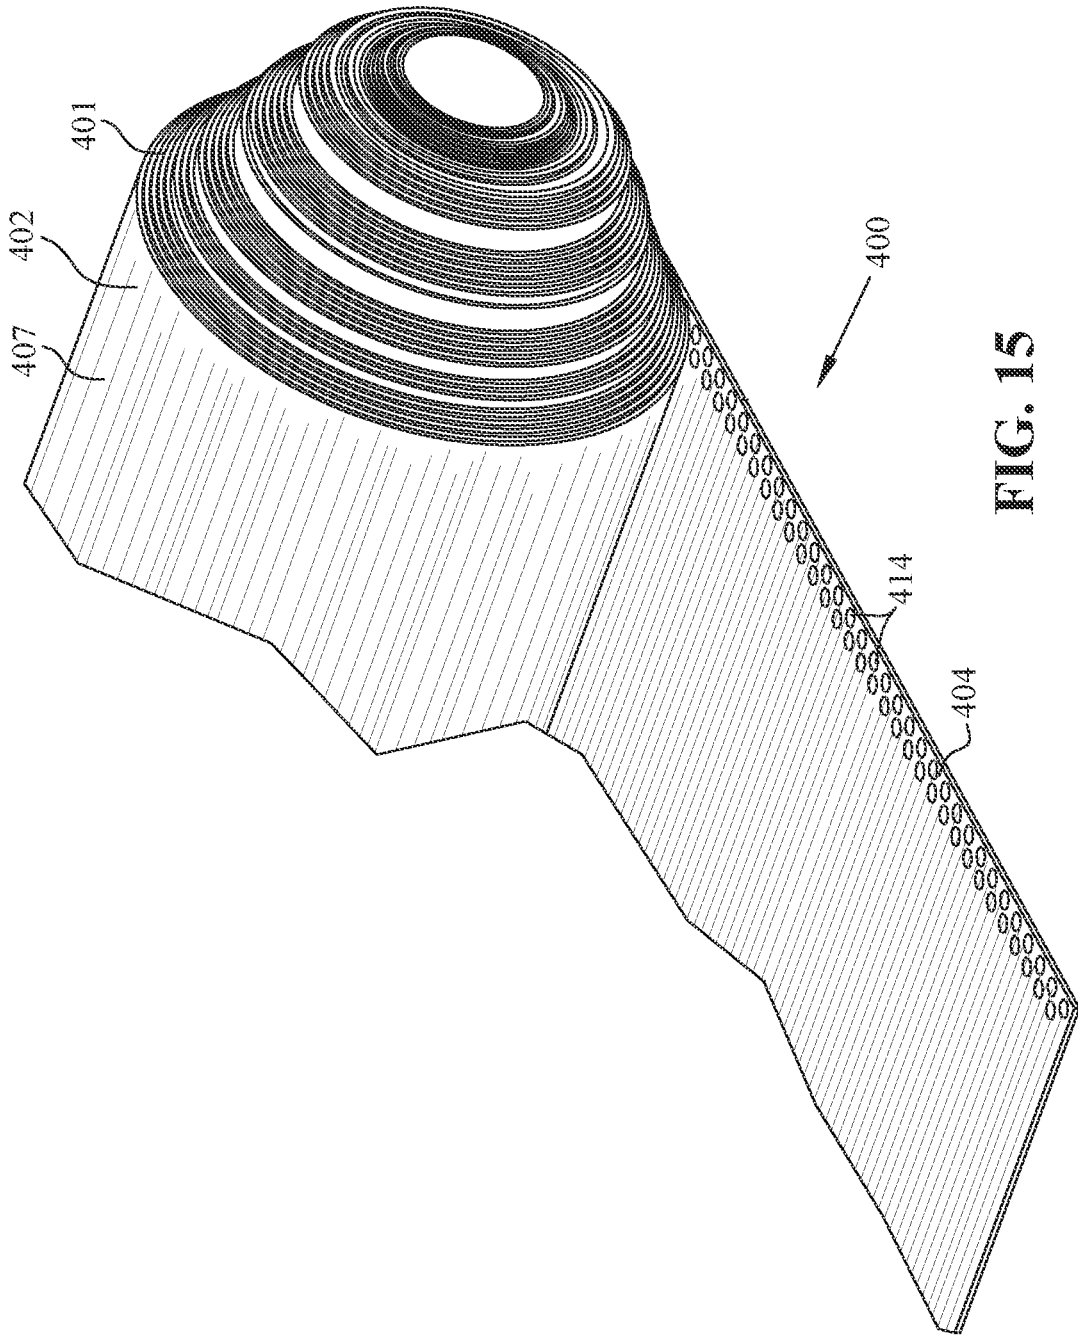
FIG. 15 is a perspective view of the vehicle frame and cargo bay liner of FIG. 14 partially rolled out showing the aluminum foil on a top side thereof;

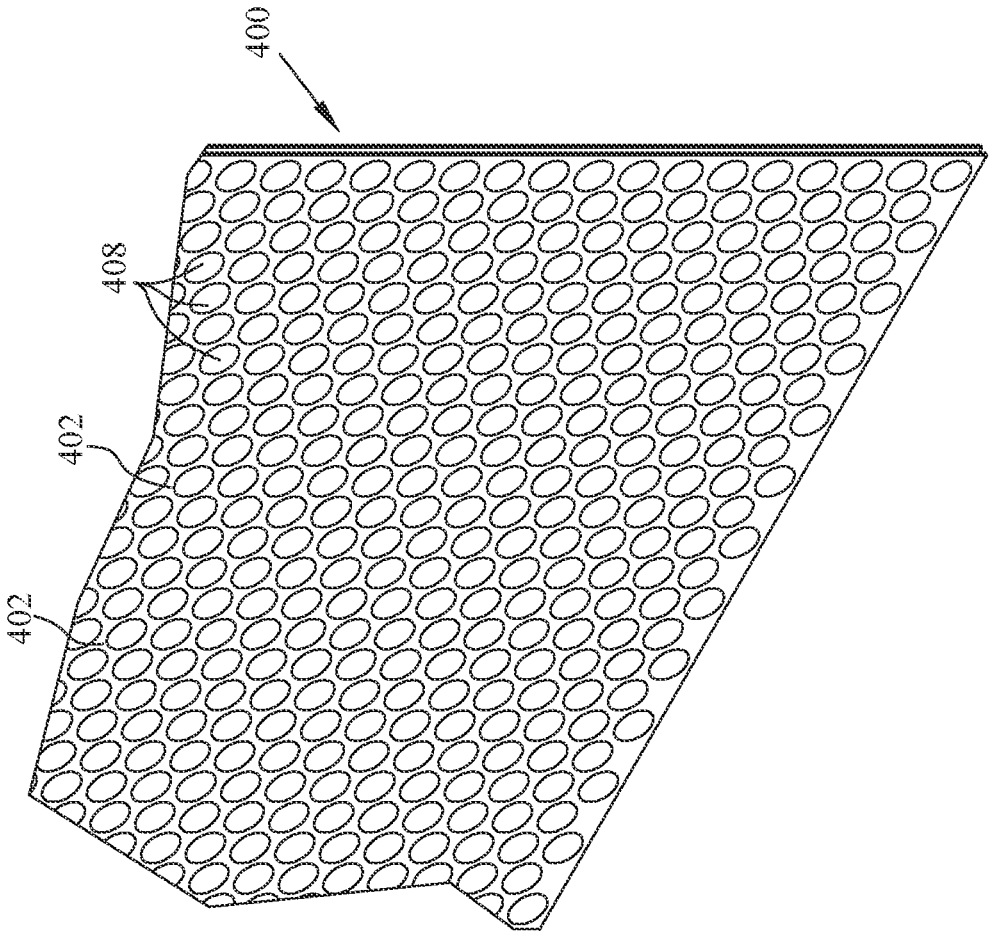
FIG. 16 is a plan view of the vehicle frame and cargo bay liner of FIG. 14 showing the top side with aluminum foil thereon;

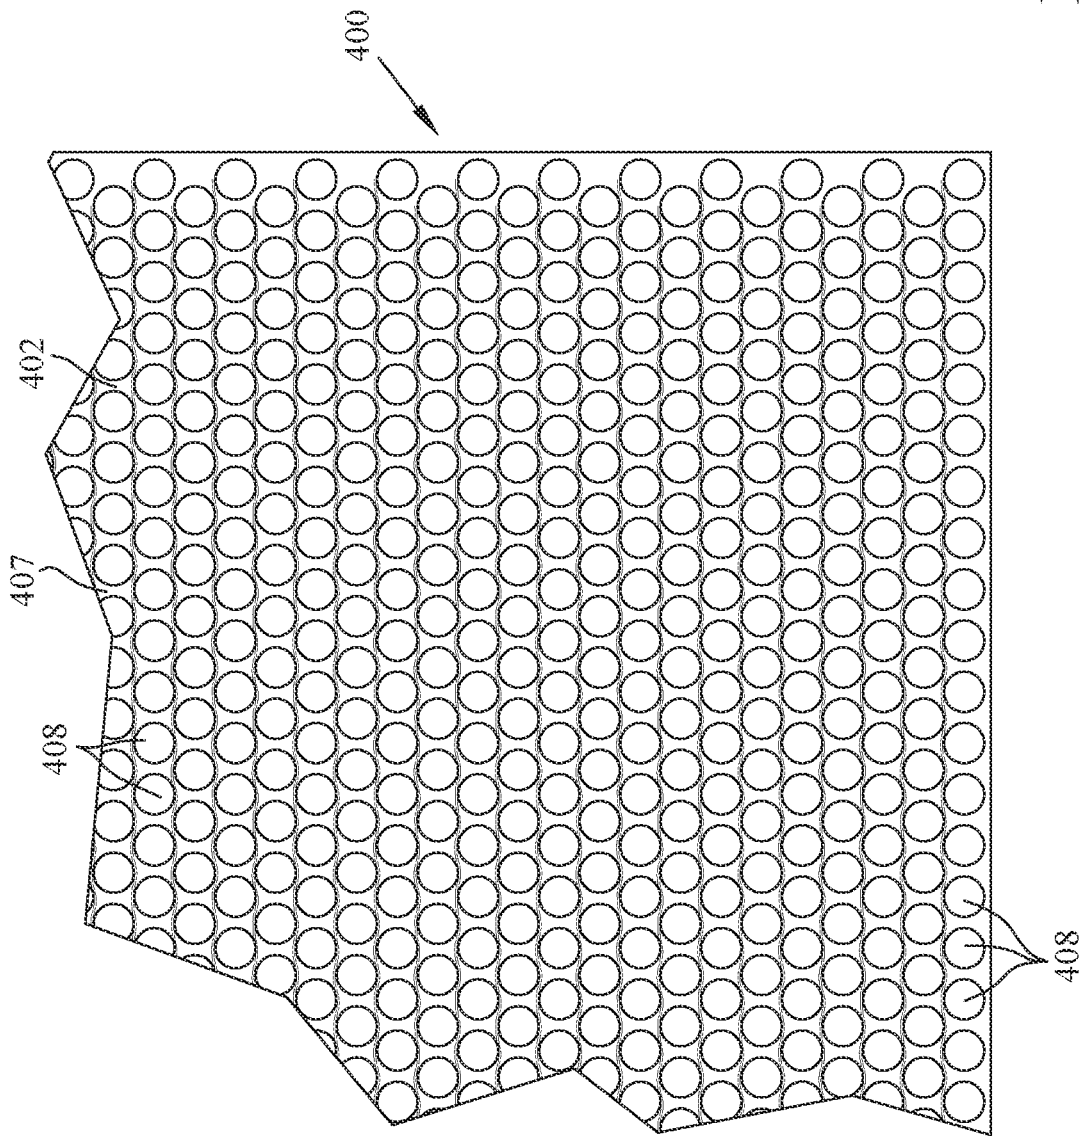
FIG. 17 is an enlarged plan view of the vehicle frame and cargo bay liner of FIG. 14 of the top side having aluminum foil thereon;

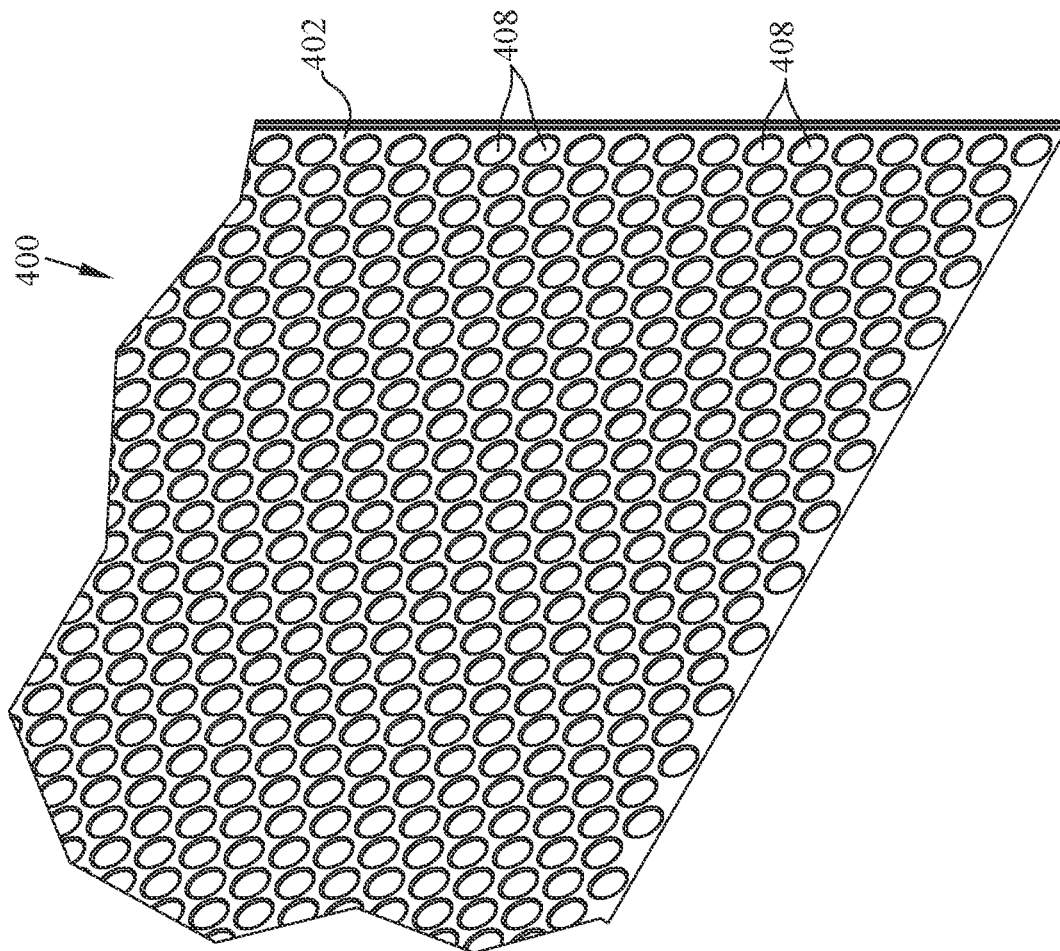
FIG. 18 is a top plan perspective view of the vehicle frame and cargo bay liner of FIG. 14 having the aluminum removed from the top side thereof;

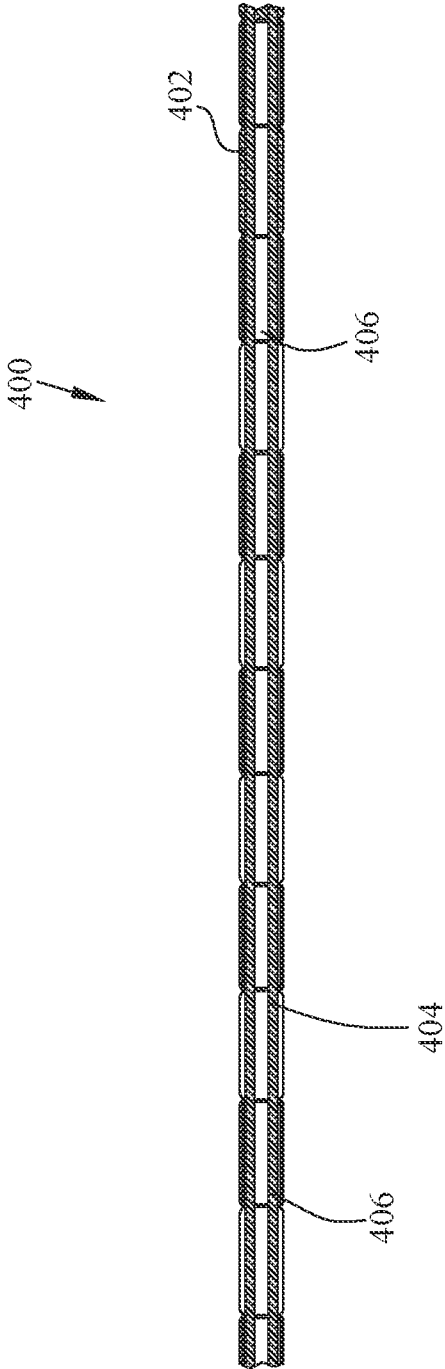
FIG. 19 is a side perspective view of the vehicle frame and cargo bay liner of FIG. 14 with the aluminum foil removed;

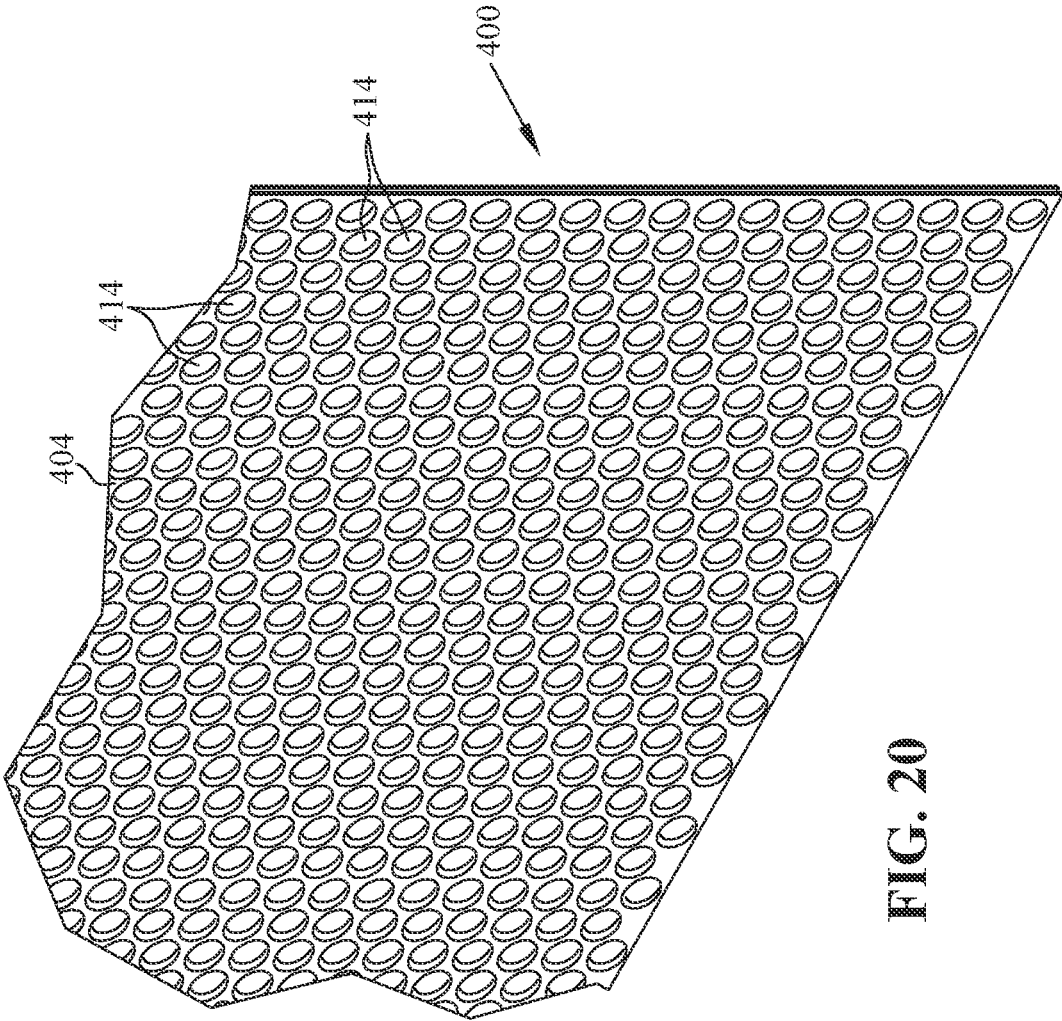
FIG. 20 is a plan perspective view of the bottom side of the vehicle frame and cargo bay liner of FIG. 14;
