US011472491B1

(54) **VEHICLE FRAME AND CARGO BAY LINER**

(71) Applicant: **PennPlastics, LLC**, Mishawaka, IN (US)

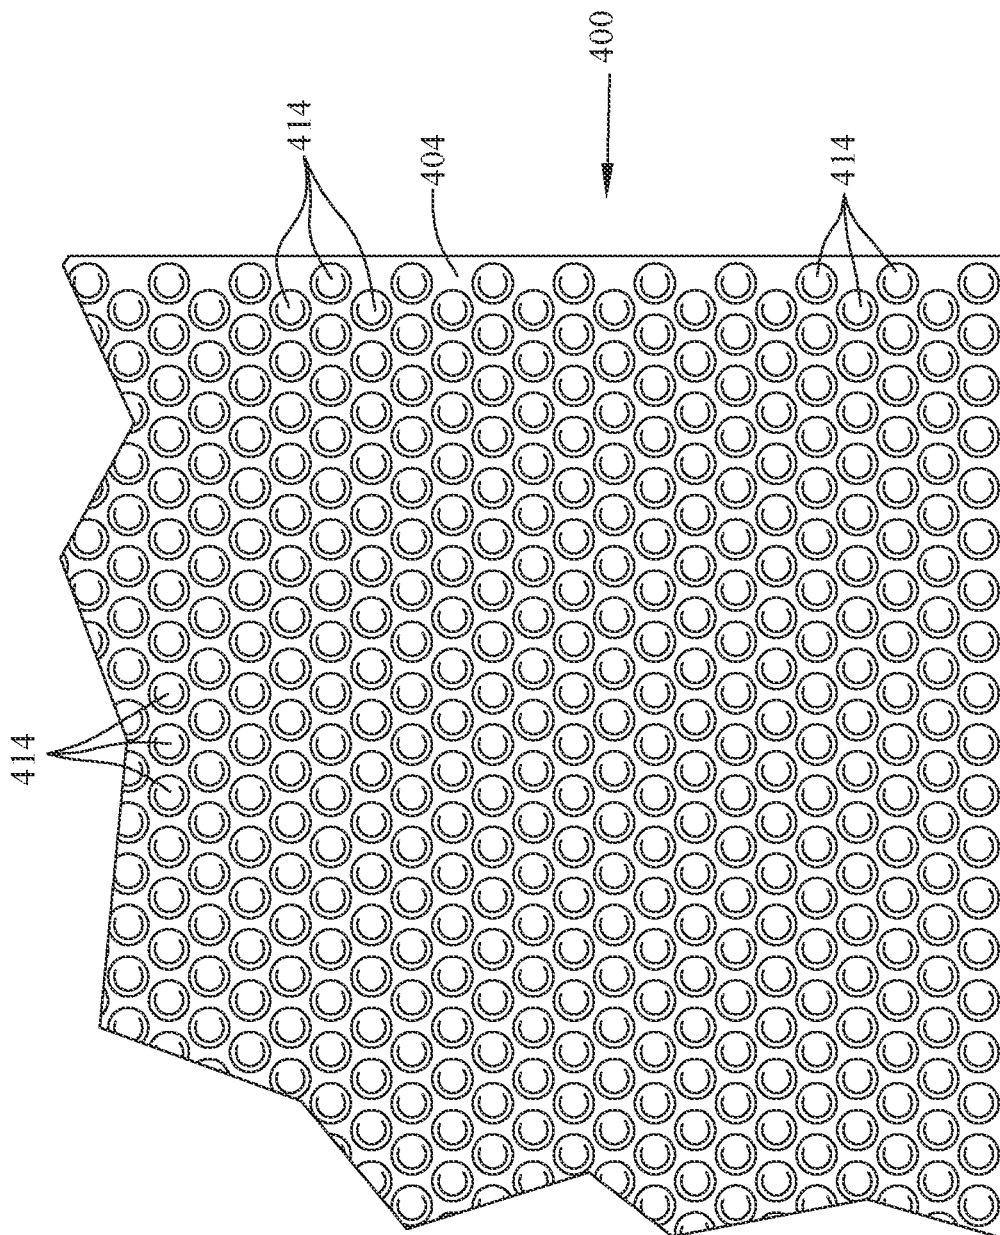
FIG. 21 is an enlarged bottom plan perspective view of the vehicle frame and cargo bay liner of FIG. 14;

Now referring to FIGS. 14-24, another alternate vehicle frame and cargo area liner is shown generally indicated as 400. Liner 400 can be provided in a coiled form 401 as shown in FIGS. 14 and 15, making it extremely suitable for use as a liner for vehicle frames and cargo bays. The desired length of liner can be rolled out and cut to size for assembly to the vehicle. Vehicle frame and cargo bay liner 400 is of a 3-ply configuration and includes a top ply, sheet, or layer 402 and a bottom ply, sheet, or layer 404. A core 406 (see FIGS. 19 and 22-24) separates top sheet 402 from bottom sheet 404. Additionally, vehicle frame and cargo bay liner 400 also includes a sheet of aluminum foil or metalized film 407 on one side thereof. In the embodiment shown, aluminum foil/metalized film 407 is provided on top sheet 402; however, it should be appreciated that aluminum foil or metalized film could also be provided on the bottom sheet 404. Aluminum foil or metalized film 407 may be adhered to top sheet 402 using an adhesive or other suitable means. The metalized film can be a polymer film coated with a thin layer of metal, which can be aluminum or other suitable metal.

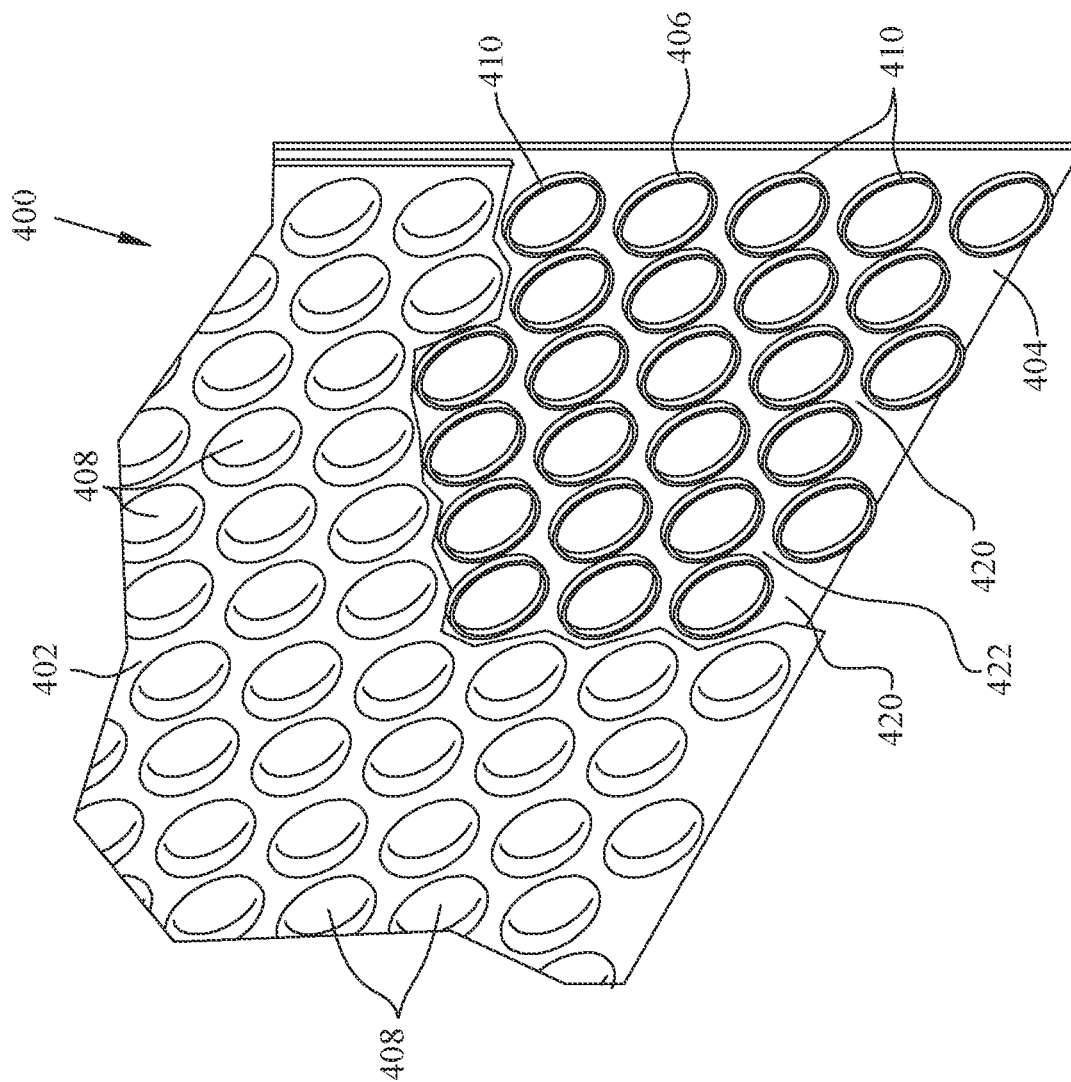
FIG. 22 is a perspective view of a portion of the vehicle frame and cargo bay liner of FIG. 14 showing part of the top layer removed;

As can be seen in FIGS. 22 and 23, cylindrical projections 410 form an obstruction to passage through core 406 such that any water entering the ends thereof is obstructed and impeded or hindered from propagating across liner 400 as compared to channels 111 in corrugated liner 104, which readily allow transport of liquids. Additionally, as where vehicle frame and cargo bay liner 400 is cut, it will intersect a plurality of cylindrical projections 410 in the liner. As each cylinder is closed off, any water entering into an end of the liner where a projection has been cut will be prevented from further propagating by encountering the wall of the projection. Only a small area or channel 422 between cylindrical projections would allow any water or moisture to enter into core 406 of liner 400, but that will not readily propagate to the offset projections internal to core 406 that will impede or hinder any advancement of the moisture.

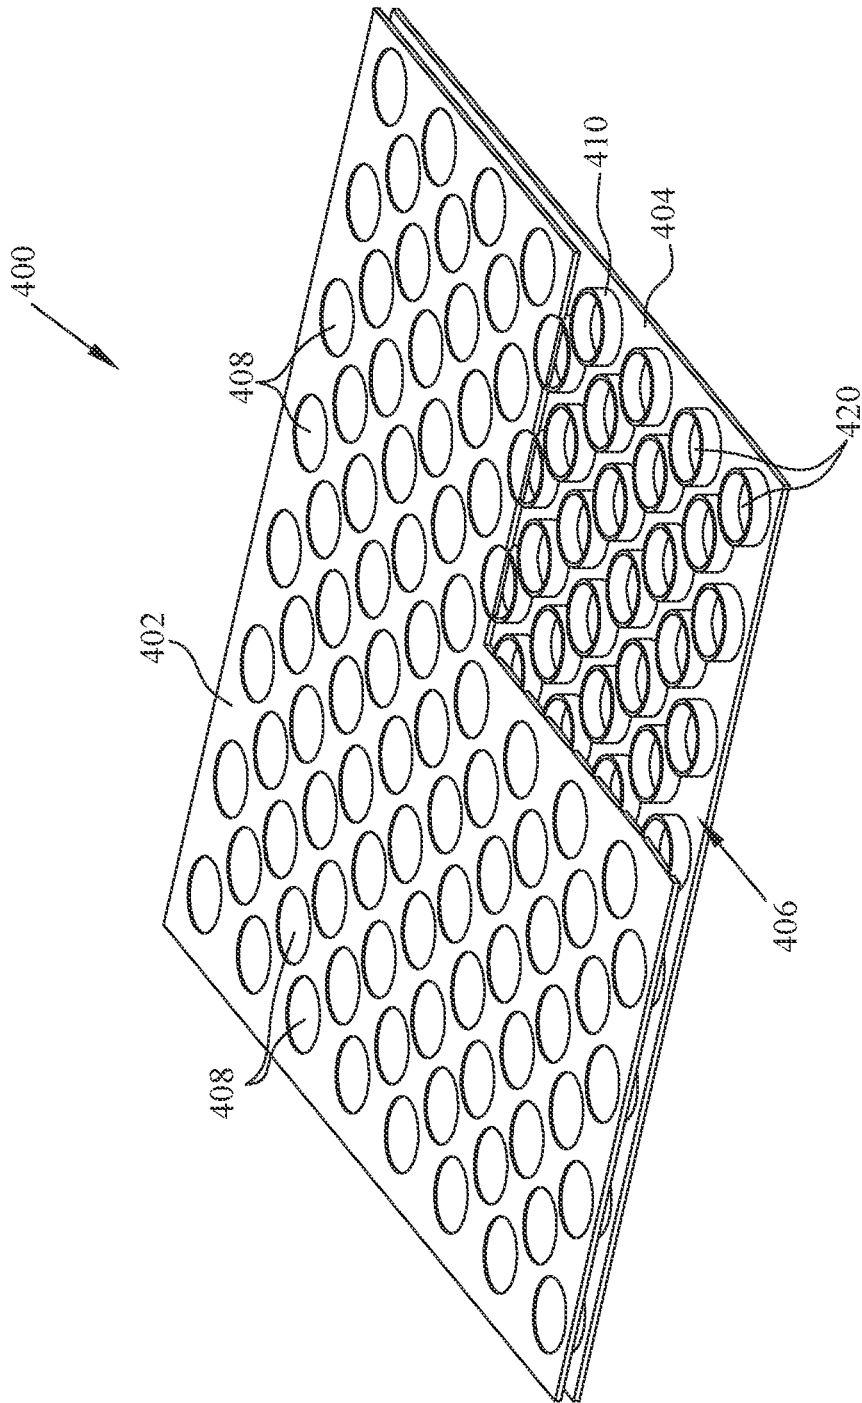
FIG. 23 is another perspective view of a portion of the vehicle frame and cargo bay liner of FIG. 14 with part of the top layer removed;

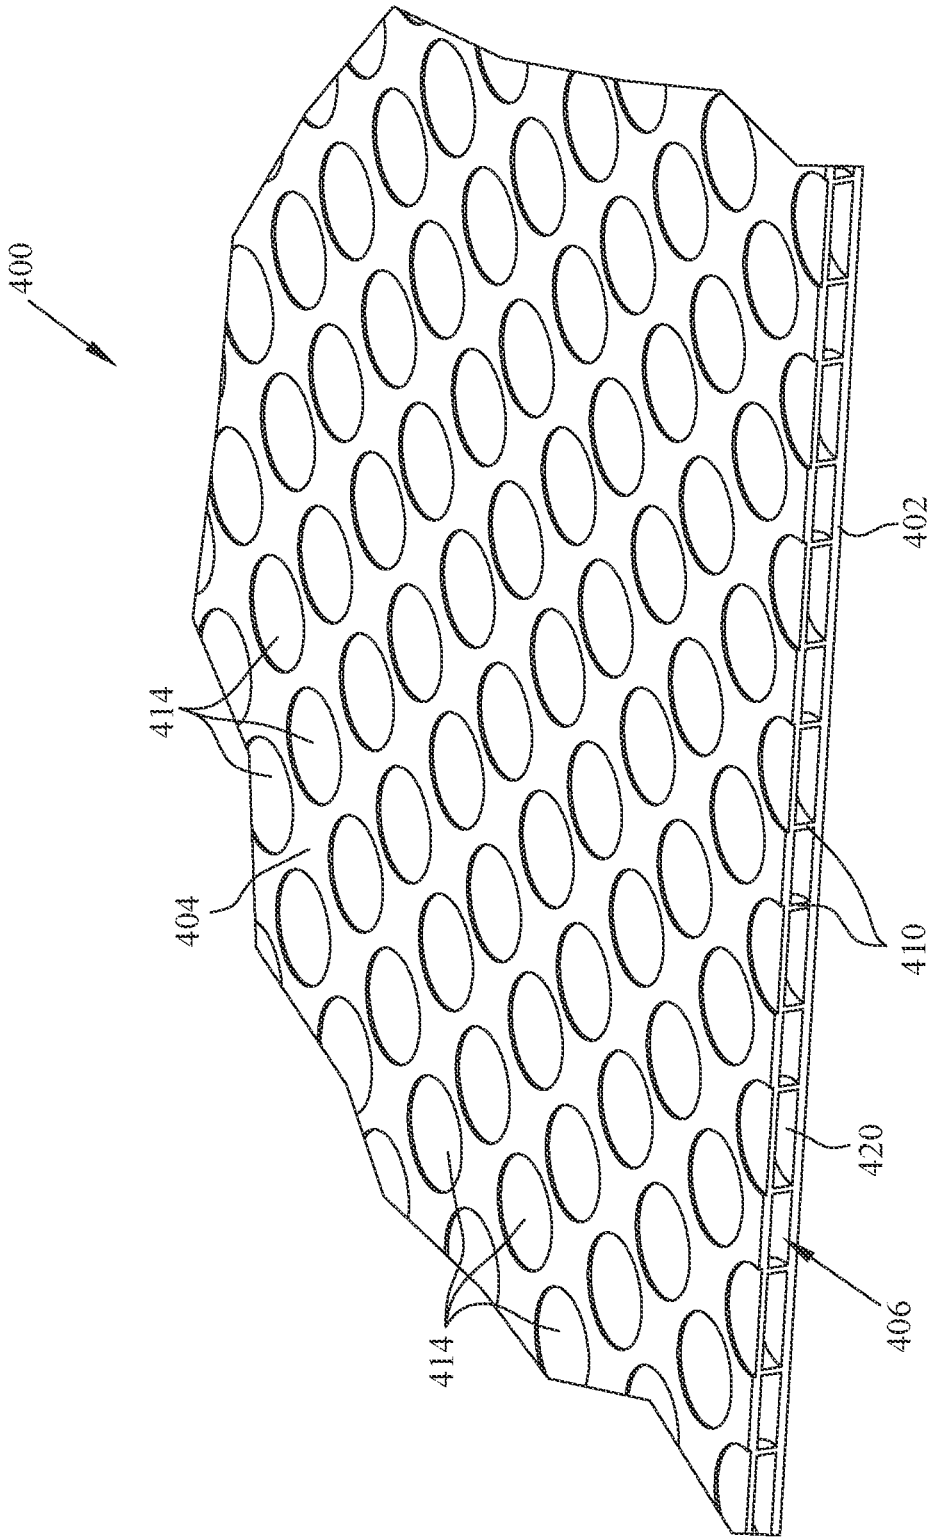
FIG. 24 is a perspective view of the bottom side of a portion of the vehicle frame and cargo bay liner of FIG. 14;

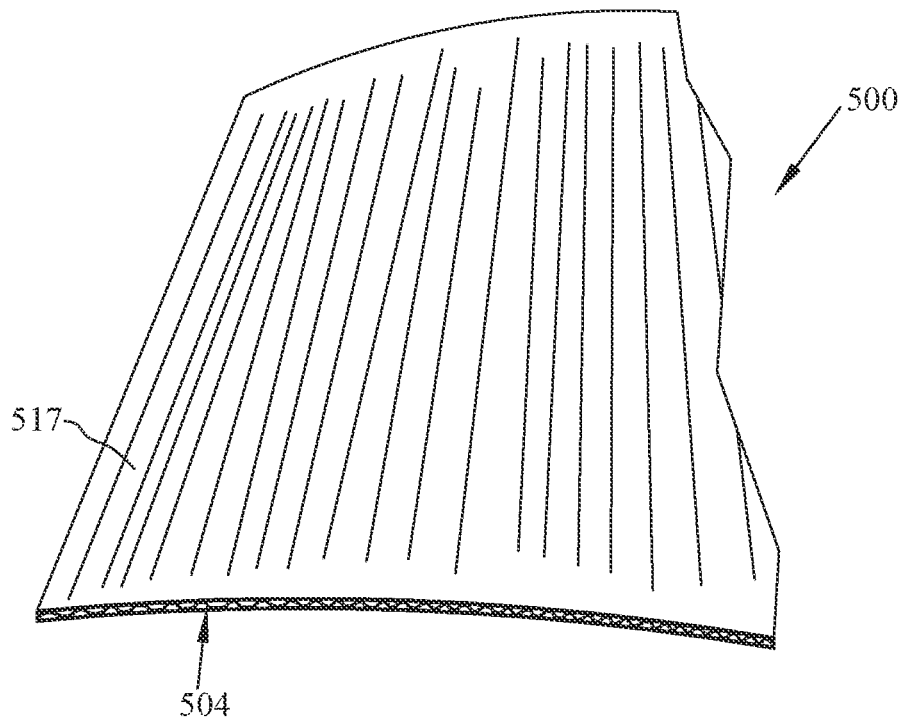
FIG. 25 is a perspective view of an additional alternate embodiment vehicle frame and cargo bay liner shown laid out and having an aluminum foil on one side thereof;

Now referring to FIGS. 25-27, other alternate embodiment vehicle frame and cargo area liner is shown generally indicated as 500. Liner 500 includes a corrugated liner, generally indicated as 504. Corrugated liner 504 includes a top sheet 506, a bottom sheet 508, and a corrugated or sinusoidal ply 510 extending therebetween, as best shown in FIGS. 26 and 27. Top sheet 506 and bottom sheet 508 each have a generally planar configuration, not including any rolling memory that may be embedded therein and are adhered or thermally attached to corrugated ply 510. It should be appreciated that the corrugated ply is defined to include either a sinusoidal configuration as shown in FIGS. 26 and 27 or alternately a plurality of member perpendicular to top sheet 506 and bottom sheet 508 such as is shown in the material utilized in FIGS. 7 and 8 of U.S. Pat. No. 10,000,930 B2 to Lowe et al., which is incorporated in its entirety herein by reference. In one embodiment, corrugated liner 504 is polyethylene. Of course, other materials, and in particular, polymers such as polypropylene may be used for corrugated liner 504. As best shown in FIG. 26, when the corrugated liner 504 is rolled, the outer sheet will become stretched and the inner sheet may fold as shown with top sheet 506, and bottom sheet 508 in FIG. 26, respectively.

Additionally, vehicle frame and cargo area liner 500 also includes an aluminum foil or sheet or metalized film 517 adhered to top sheet 506 of corrugated liner 504. Aluminum foil or sheet or metalized film 517 is preferably mounted so that it is between corrugated liner 504 and housing or living quarters 14 of the recreational vehicle 10, in order to provide additional protection and insulation to the living quarters. However, aluminum foil or sheet or metalized film 517 may also be mounted downwardly on the vehicle frame so that it is facing the road surface. It should be appreciated that aluminum foil or sheet or metalized film 517 may be adhered to bottom sheet 508 rather than top sheet 506. Vehicle frame and cargo area liner 500 may be mounted to a vehicle frame 32 utilizing means discussed above or other known means.

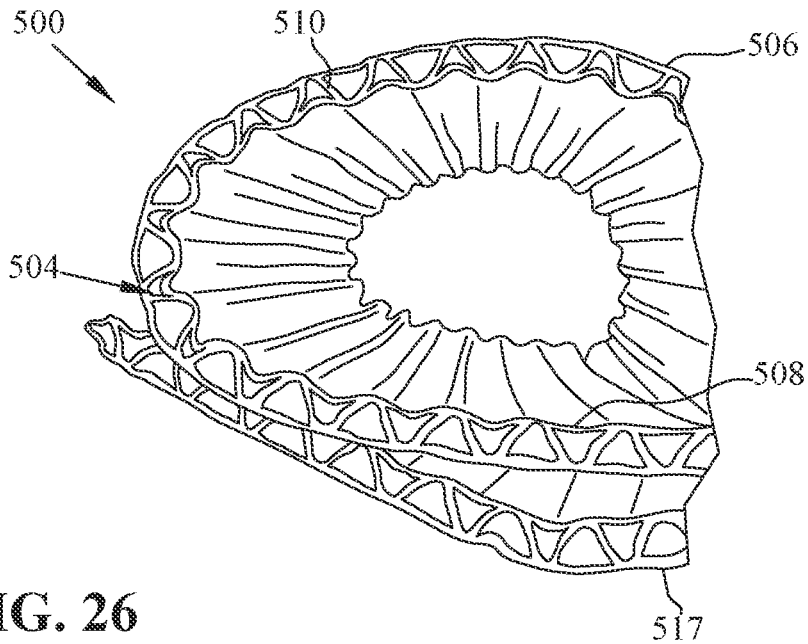
FIG. 26 is an end view of the vehicle frame and cargo bay liner of FIG. 25 shown rolled up wherein corrugations of the liner are readily visible;

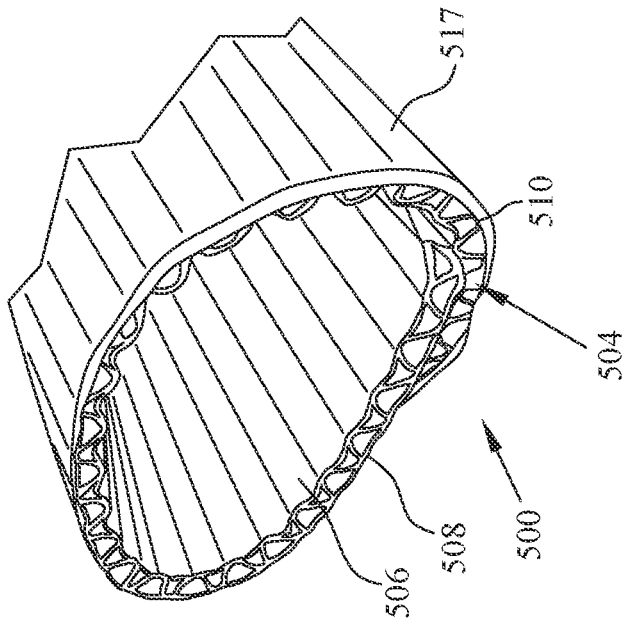
FIG. 27 is a perspective view of the vehicle frame and cargo bay liner of FIG. 25 rolled up with the aluminum foil on the outside thereof;

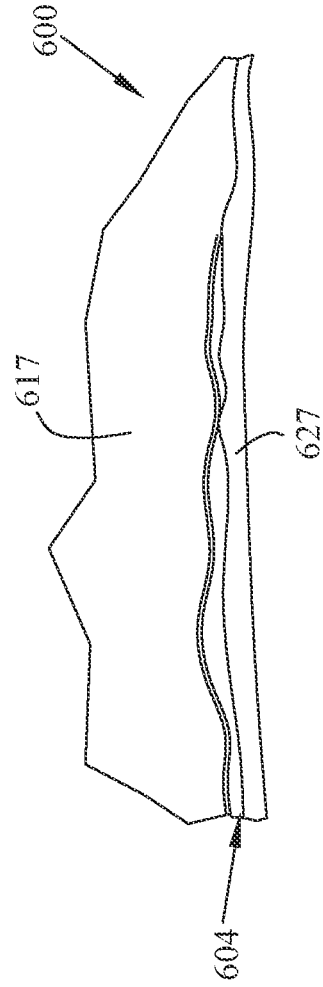
FIG. 28 is an end perspective view of another alternate embodiment vehicle frame and cargo bay liner shown laid out and having aluminum foil on both sides thereof;

Now referring to FIGS. 28-30, an additional embodiment of a 3-ply panel vehicle frame and cargo area liner is generally indicated as 600. As with vehicle frame and cargo area liners 500, vehicle frame and cargo area liner 600 includes a corrugated liner, generally indicated as 604. Corrugated liner 604 includes a top sheet 606, a bottom sheet 608, and a corrugated or sinusoidal ply 610 extending therebetween. Top sheet 606 and bottom sheet 608 are adhered or thermally attached to corrugated ply 610 and may be made from materials similar to corrugated liner 500, such as but not limited to polyurethane or polyethylene. Alternately, liner 600 may be an extruded manufactured design,

As with vehicle and frame and cargo area liner **500**, liner **600** also includes an aluminum foil or sheet **617** adhered to top ply or sheet **606**. Additionally, however, vehicle frame and cargo area liner **600** also includes a second aluminum foil or sheet **627** adhered to bottom sheet or ply **608** of corrugated liner **604**.

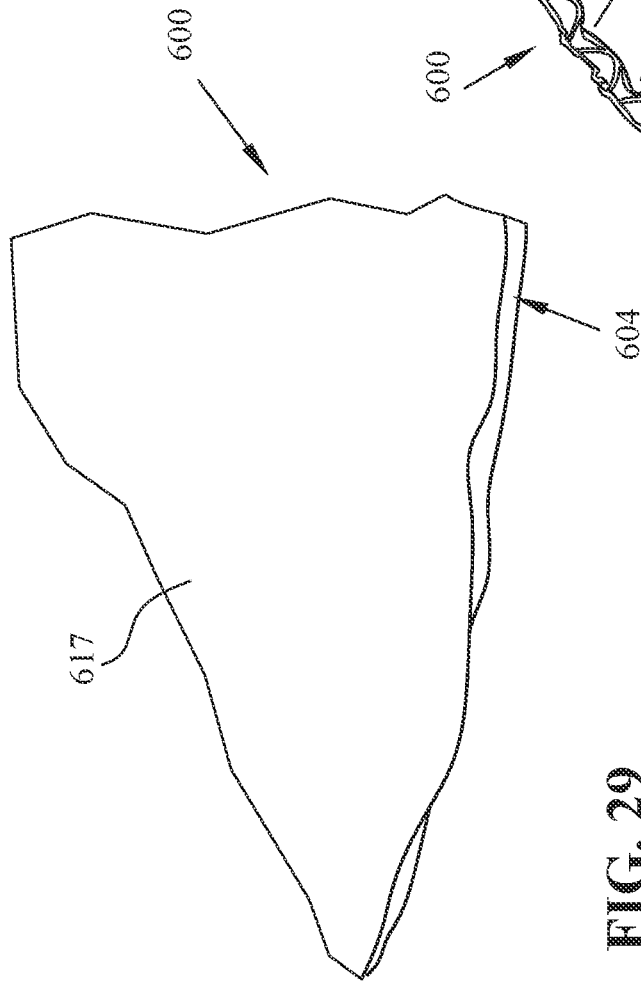
FIG. 29 is a perspective view of the vehicle frame and cargo bay liner of FIG. 28;

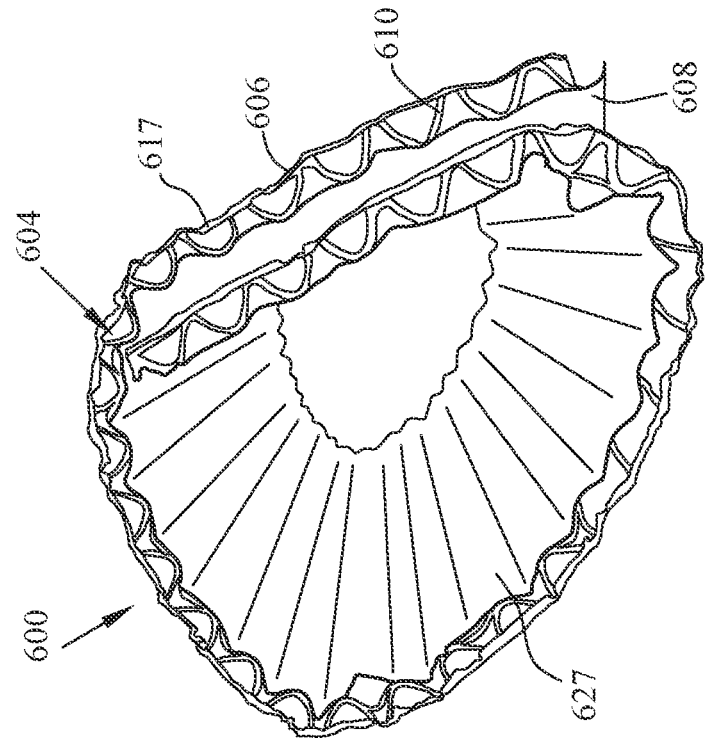
FIG. 30 is an end view of the vehicle frame and cargo bay liner of FIG. 28 rolled up and showing the aluminum foil on both sides thereof;

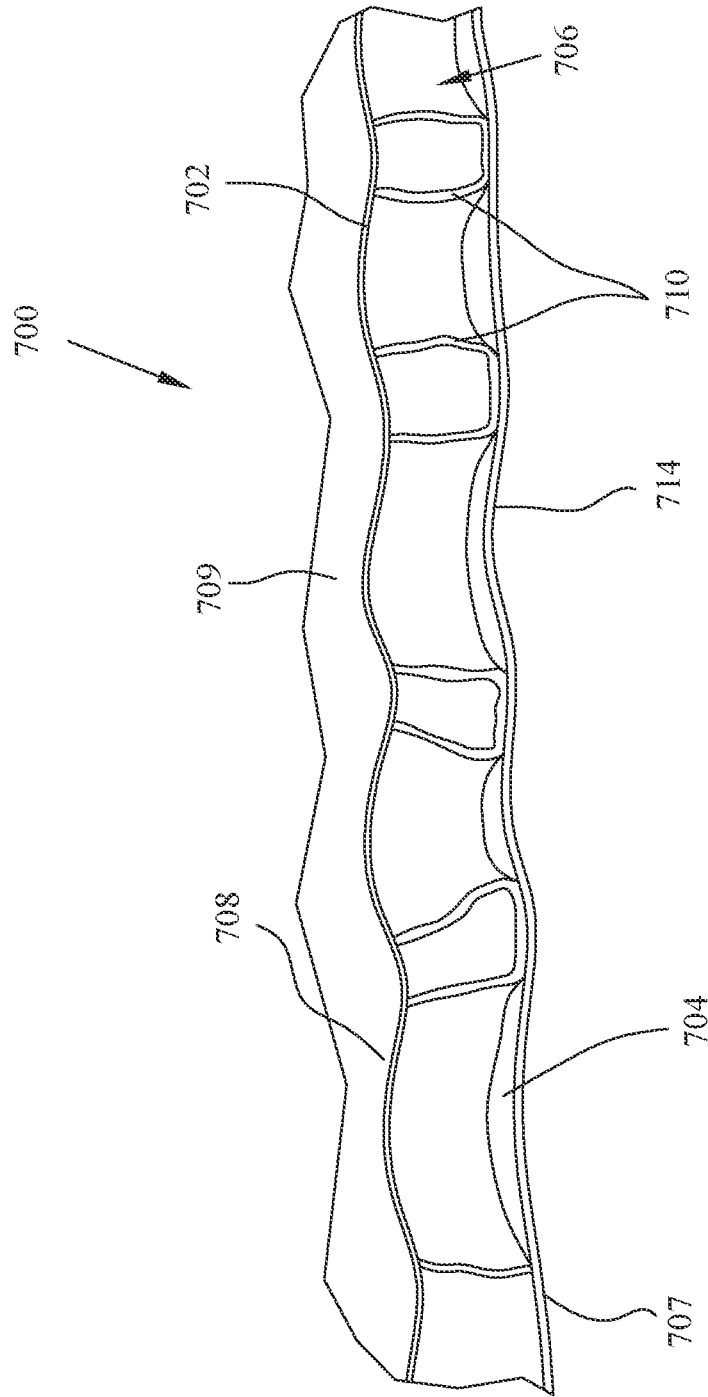
FIG. 31 is a side perspective view of yet another alternate embodiment vehicle frame and cargo bay liner having an aluminum foil on one side and a woven material on the opposite side

Now referring to FIGS. **31-34**, another alternate vehicle frame and cargo area liner is shown generally indicated as **700**. Liner **700** can be provided in a coiled form as liner **400**, making it extremely suitable for use as a liner for vehicle frames and cargo bays. The desired length of liner can be rolled out and cut to size for assembly to the vehicle. Vehicle frame and cargo bay liner **700** is of a 3-ply configuration and includes a top ply, sheet, or layer **702** and a bottom ply, sheet, or layer **704**. A core **706** (see FIG. **31**) separates top sheet **702** from bottom sheet **704**. Additionally, vehicle frame and cargo bay liner **700** also includes a sheet of aluminum foil or metalized film **707** on one side thereof. In the embodiment shown, aluminum foil/metalized film **707** is provided on bottom sheet **404**; however, it should be appreciated that aluminum foil/metalized film could also be provided on the top sheet **702** (see embodiment **700A** discussed below). Aluminum foil/film **707** may be adhered to bottom sheet **704** using an adhesive or other suitable means. Vehicle frame and cargo bay liner **700** also includes a woven or nonwoven layer of material **709** adhered to top layer **702**, opposite the side with aluminum foil **707** or metalized film. In one embodiment, material **709** is a woven sheet of polypropylene fabric.

In the embodiment of the 3 ply vehicle frame and cargo bay liner **700** of FIGS. **31-34**, the aluminum foil or metalized film **707** is shown adhered to the side of liner **700** with dimples **714** and woven material **709** is shown adhered to the side with convexities **708**; however, in FIGS. **35-37** an alternate embodiment vehicle frame and cargo bay liner, shown generally indicated as **700a**, has the woven or nonwoven sheet of material **709** adhered to the side of the liner having dimples **714** and the aluminum foil **707** adhered to the side of the liner having convexities **708**. Any and all of the aluminum foil, metalized film, woven material, and non-woven material can be laminated to the liner **700**. The lamination process can include an adhesive, heat, and/or pressure in the lamination process. Also, the vehicle frame and cargo bay liner may be manufactured with only a layer of woven or nonwoven sheet of fabric material and no aluminum foil or alternately with aluminum foil and no woven or nonwoven fabric. It should be appreciated that the lamination process securely attaches the foil, film and/or fabric firmly to the liner and helps keep the laminated layers in a strong sandwich configuration. This provides significant benefits for numerous things, such as for instance, preventing the foil layer from short circuiting with electric or electronic holes cut through the line as the foil will not slide or move on the liner. Alternately, it may be provided with either aluminum foil on both sides or with woven or nonwoven fabric on both sides.

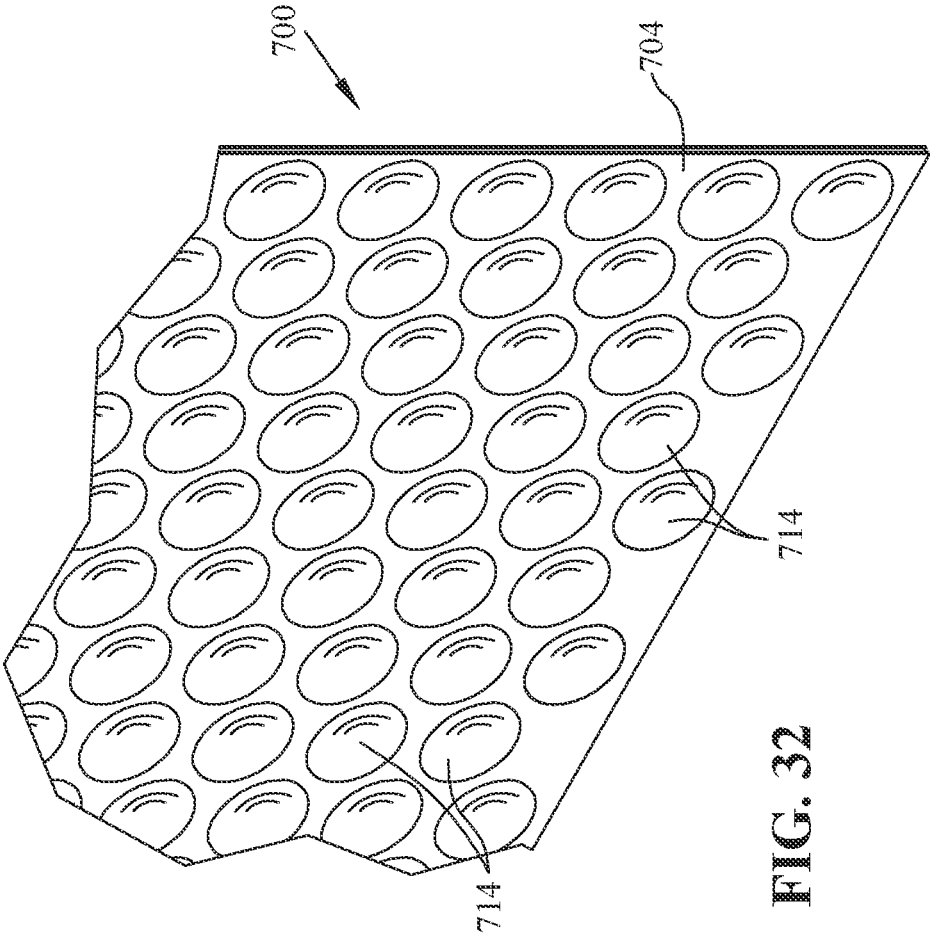
FIG. 32 is a plan view of the vehicle frame and cargo bay liner of FIG. 31 with the aluminum foil and woven material removed show a layer of the liner having dimples thereon.

In the embodiment shown, vehicle frame and cargo bay liner **700** also includes a plurality of circular convexities **708** on top sheet **702** and a corresponding plurality of circular dimples or depressions **714** in bottom sheet **704**. Vehicle frame and cargo bay liner **700** also includes a plurality of cylindrical projections **710** extending up from bottom sheet **704** and attached to top sheet **702** (see FIG. **31**). Projections **710** may be thermally bonded to top sheet **702** as well as to bottom sheet **704**. As can be seen in FIG. **31**, circular convexities **708** and circular depressions **714** coincide with

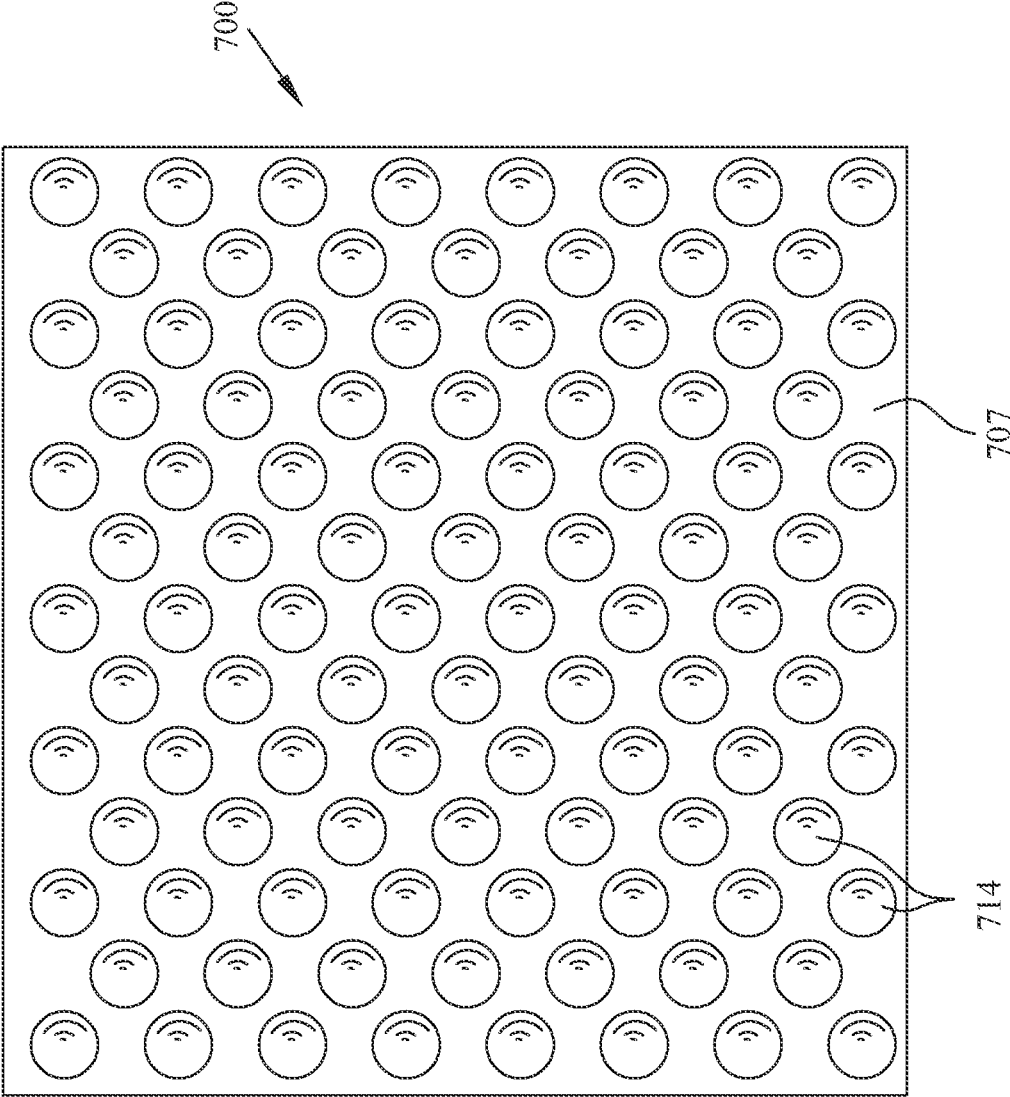
FIG. 33 is a perspective plan view of the vehicle frame and cargo bay liner of FIG. 31 showing the side with dimples and aluminum foil thereon;

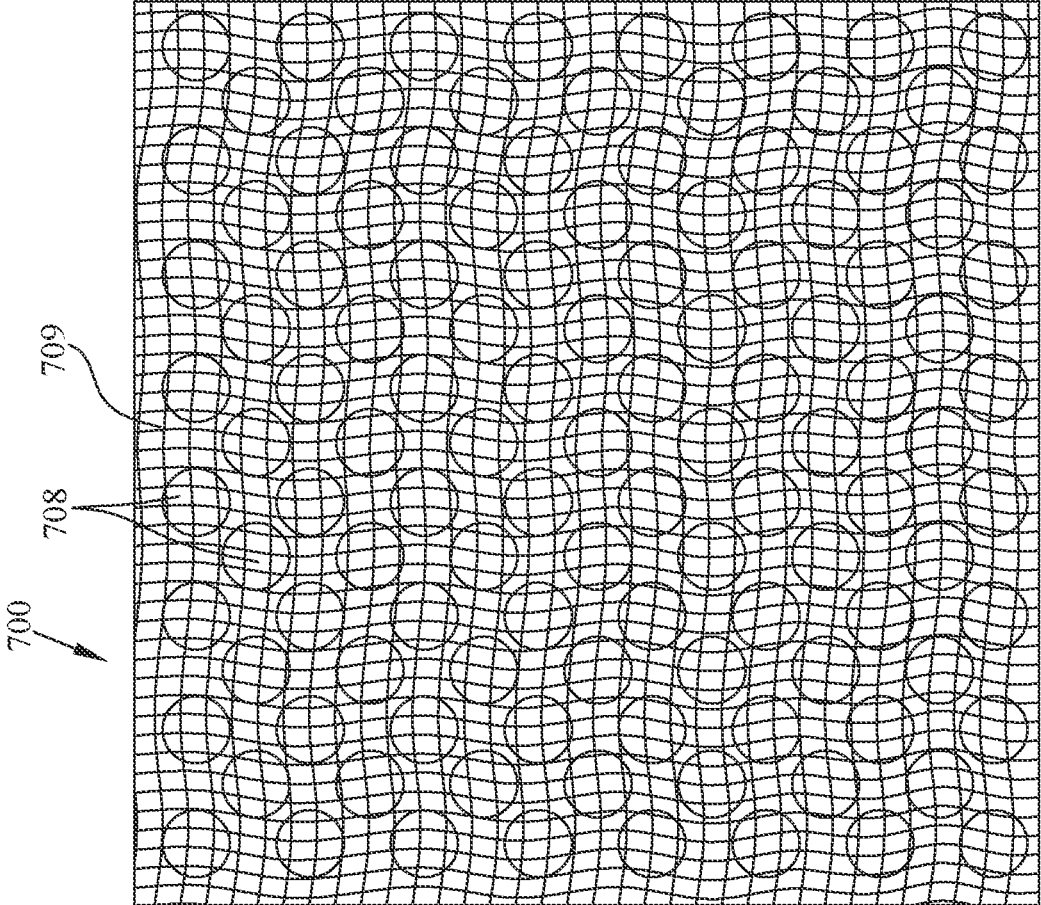
FIG. 34 is a perspective plan view of the vehicle frame and cargo bay liner of FIG. 31 showing a side with convexities and a woven material thereon;

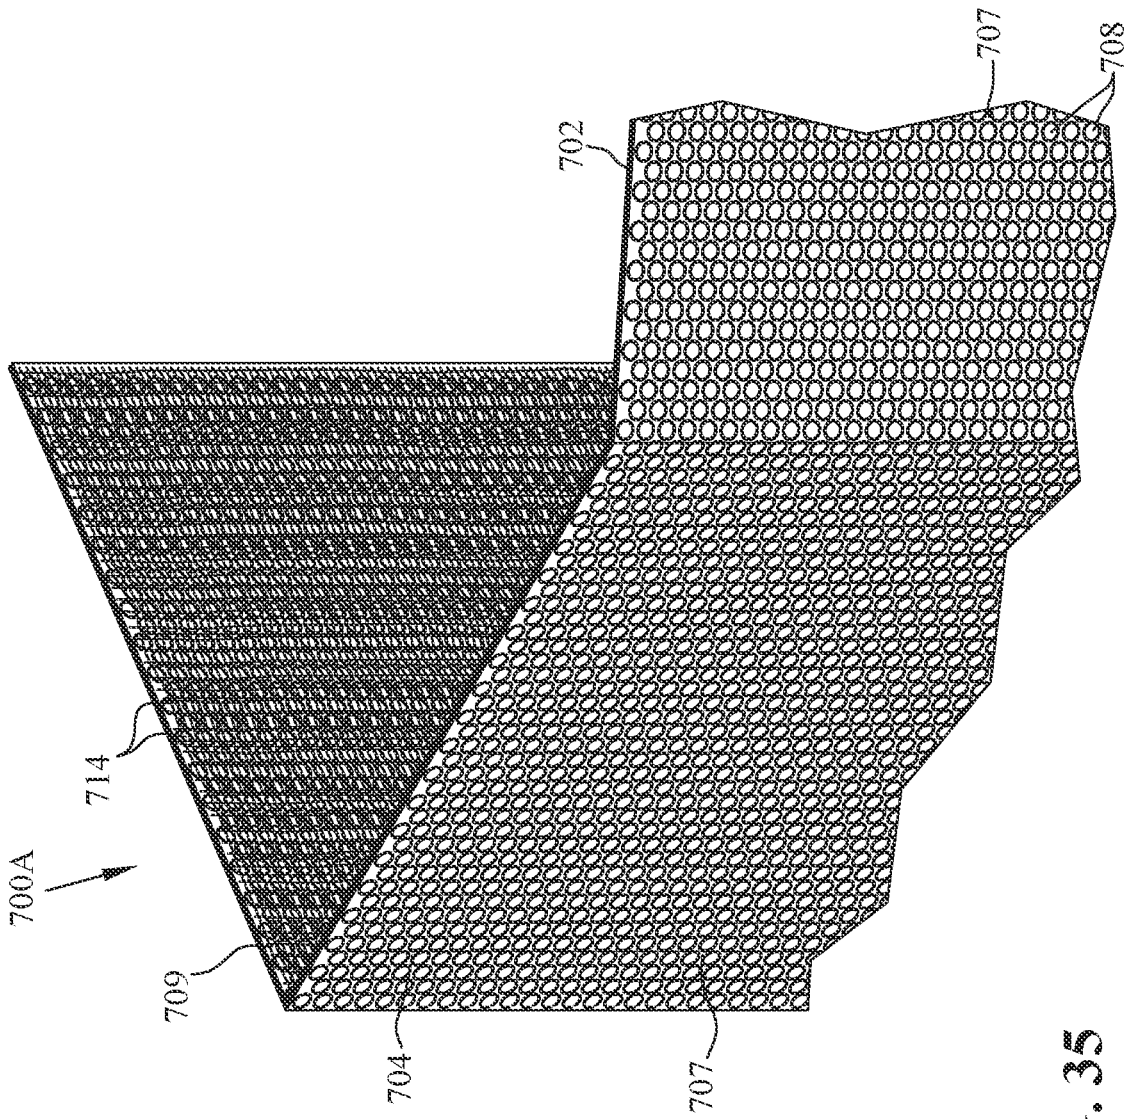
FIG. 35 is a perspective of a similar alternate embodiment view of a vehicle frame and cargo bay liner like FIG. 31, but with the aluminum foil on the side with convexities and a woven material on the opposite side with dimples;

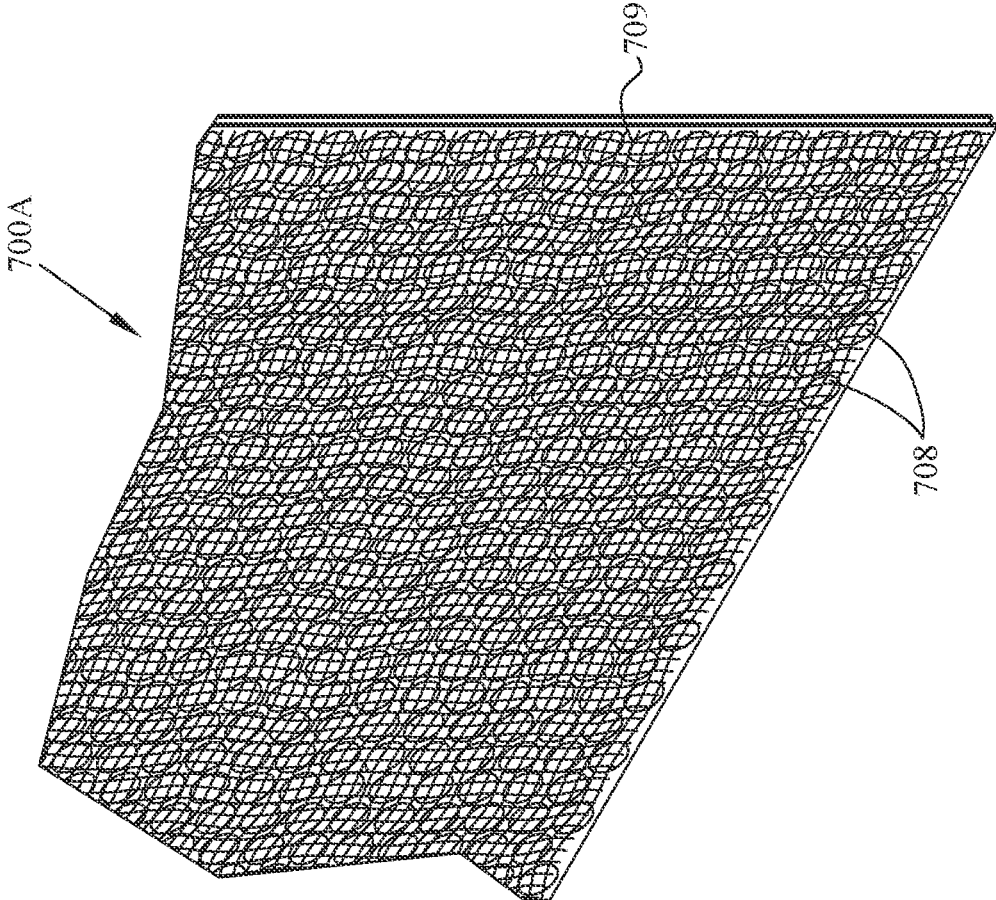
FIG. 36 is a plan perspective plan view of the vehicle frame and cargo bay liner of FIG. 35 showing the dimpled side having the woven material thereon;

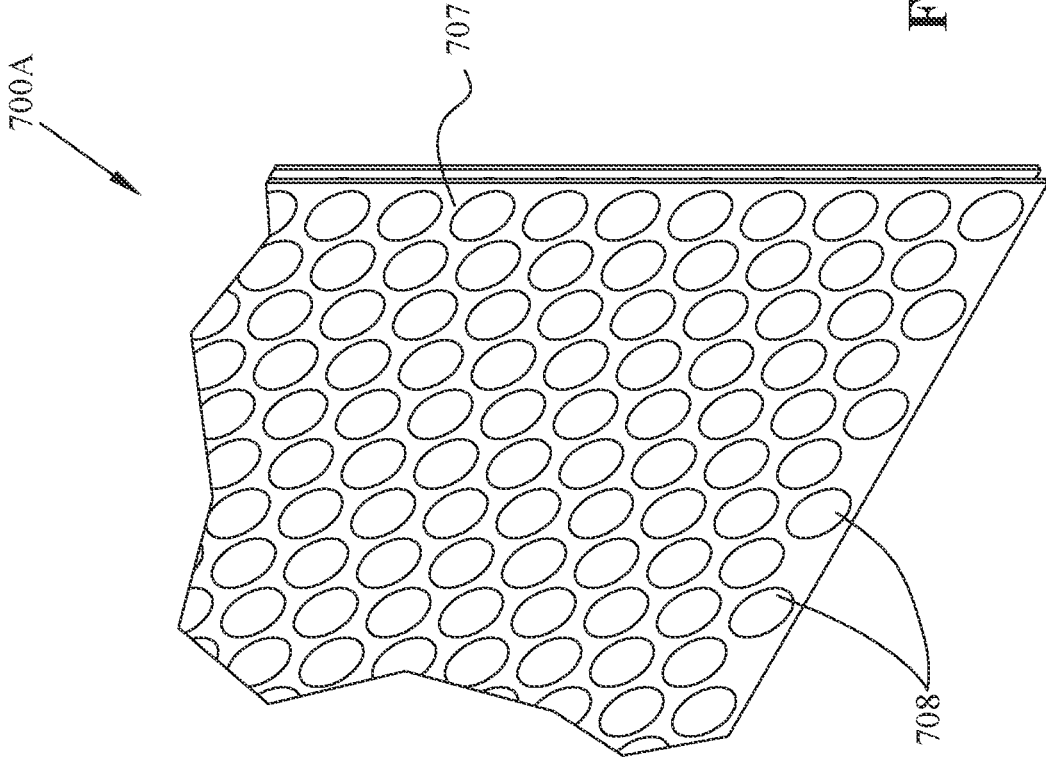
FIG. 37 is a plan perspective plan view of the vehicle frame and cargo bay liner of FIG. 35 showing the convex side having the aluminum foil thereon side;

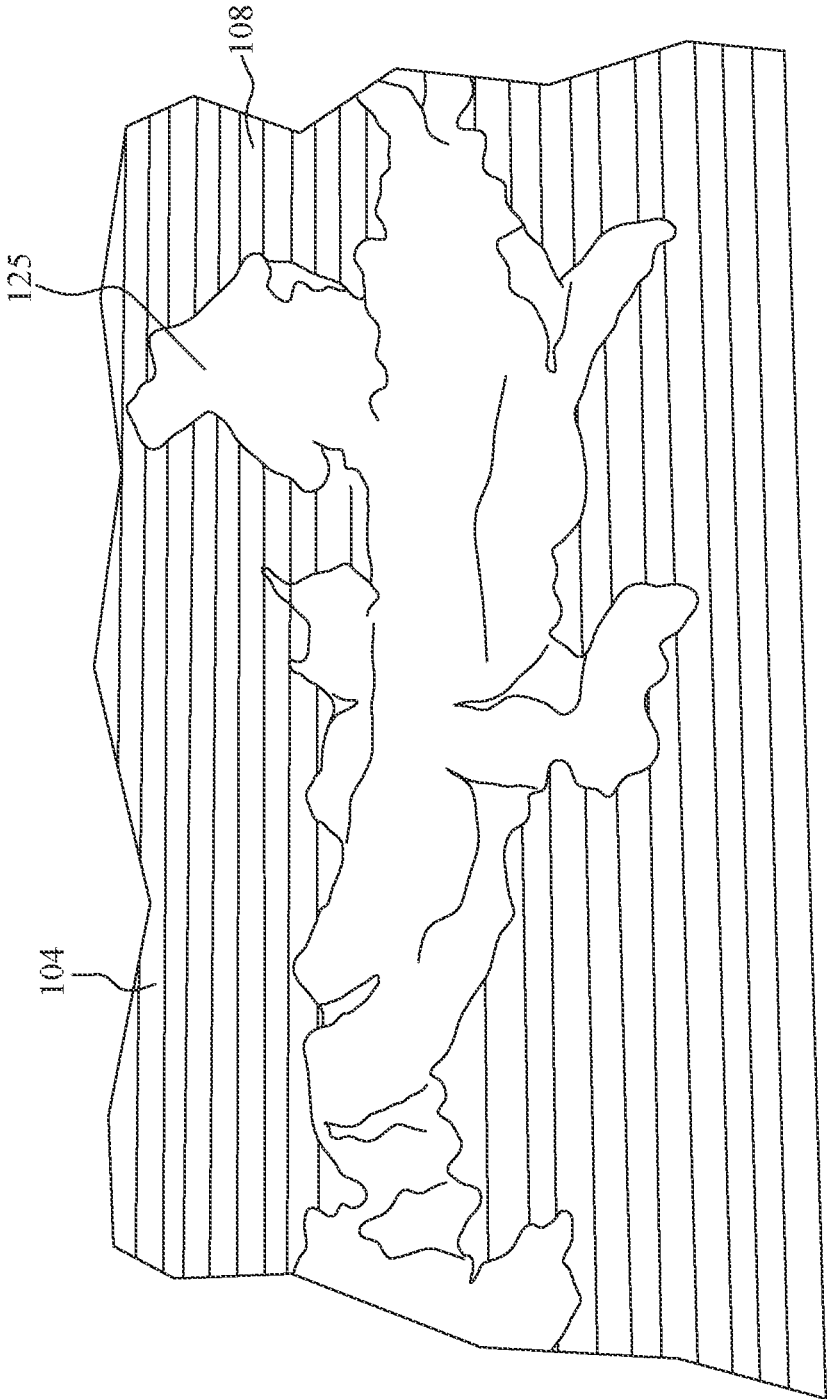
FIG. 38 is a plan perspective view showing a foam sealing material adhered to the bottom of a prior art liner;

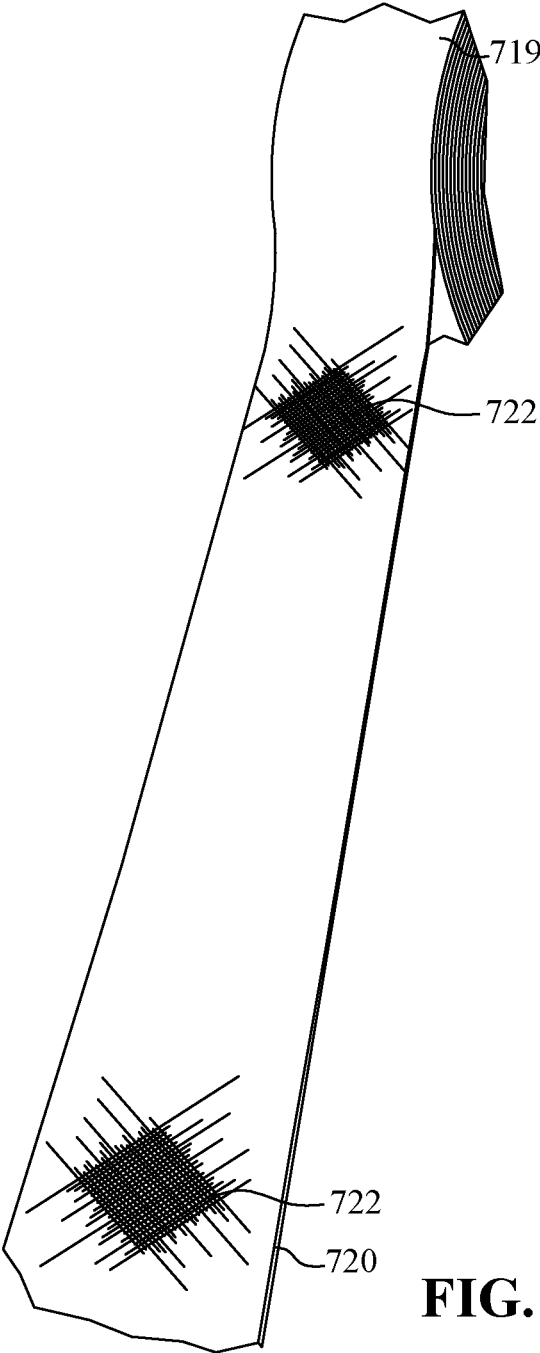
FIG. 39 is a perspective view of a role of repair tape for use in repairing the woven material;

Now referring now to FIGS. 39-42, a unique repair and reinforcing system is provided for any of the liners provide herein and may be used to repair rips, tears or holes in the liner itself, or in the aluminum foil or metalized film or to provided additional support, reinforcement or protection to the liner. However, it is particularly suitable for repairing rips, tears, holes etc. in the woven or nonwoven fabric that may be attached to and covering one or both outer faces of the liner. Such rips, tears etc. may be through only the woven or nonwoven fabric, but also may be through partially or entirely through the body of the liner. Also, it may be necessary to cut through the liner to install plumbing, electrical lines etc. in the recreational vehicle. The repair system can be used to repair around such installations.

In one embodiment, the repair system includes a role of woven or nonwoven fabric tape shown indicated as 719. In the embodiment shown, the fabric tape includes a woven fabric shown as 722. Also, in the embodiment shown, the tape can be supplied with a contact adhesive attached to one side thereof for attachment to the liner, foil, film or fabric that it is repairing or reinforcing. A protective layer of material 720 (see FIG. 39) to which the adhesive will readily release from may be used to facilitate providing the repair tape in a rolled form or otherwise facilitate removing thereof for easy repair or reinforcement of the recreational vehicle. As shown in FIGS. 42 and 43, repair tape 719 is attached to woven fabric layer 709, on the exterior thereof, creating an additional layer to the liner 700 as is best shown in FIG. 43. It should be appreciated that repair and reinforcing tape 719 could be placed or attached over itself to create additional reinforcing layers, and/or on the other side of the liner over the sheet of aluminum foil or metalized film 707. As many additional layers as is desired can be placed on either or both sides. It should also be appreciated that the repair tape could be an aluminum foil, or metalized film or other polymer or material, but the woven fabric tape has shown to be particularly suitable.

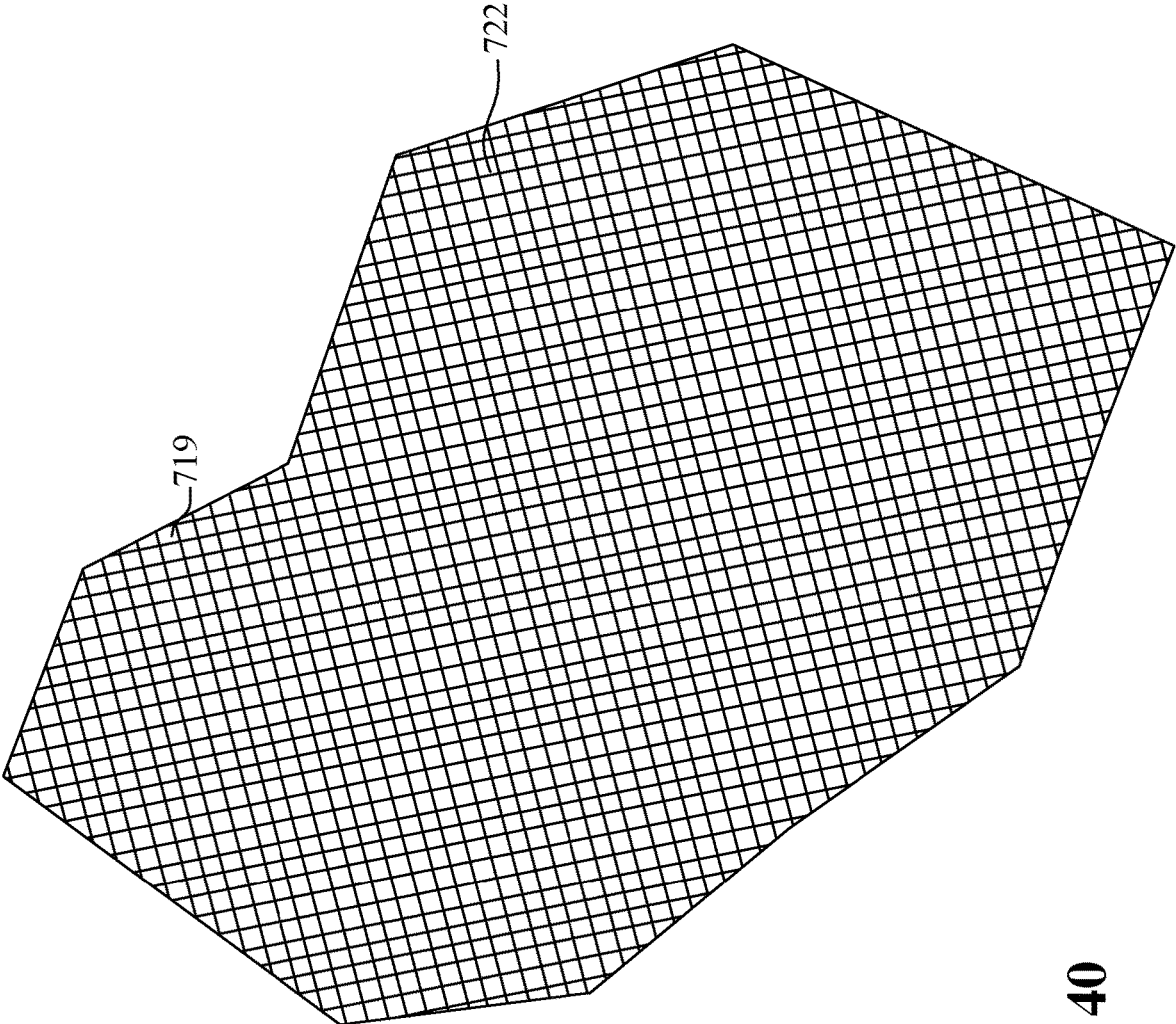
FIG. 40 is an enlarged plan view of the woven material repair tape;
