US011472491B1

(54) **VEHICLE FRAME AND CARGO BAY LINER**

(71) Applicant: **PennPlastics, LLC**, Mishawaka, IN (US)

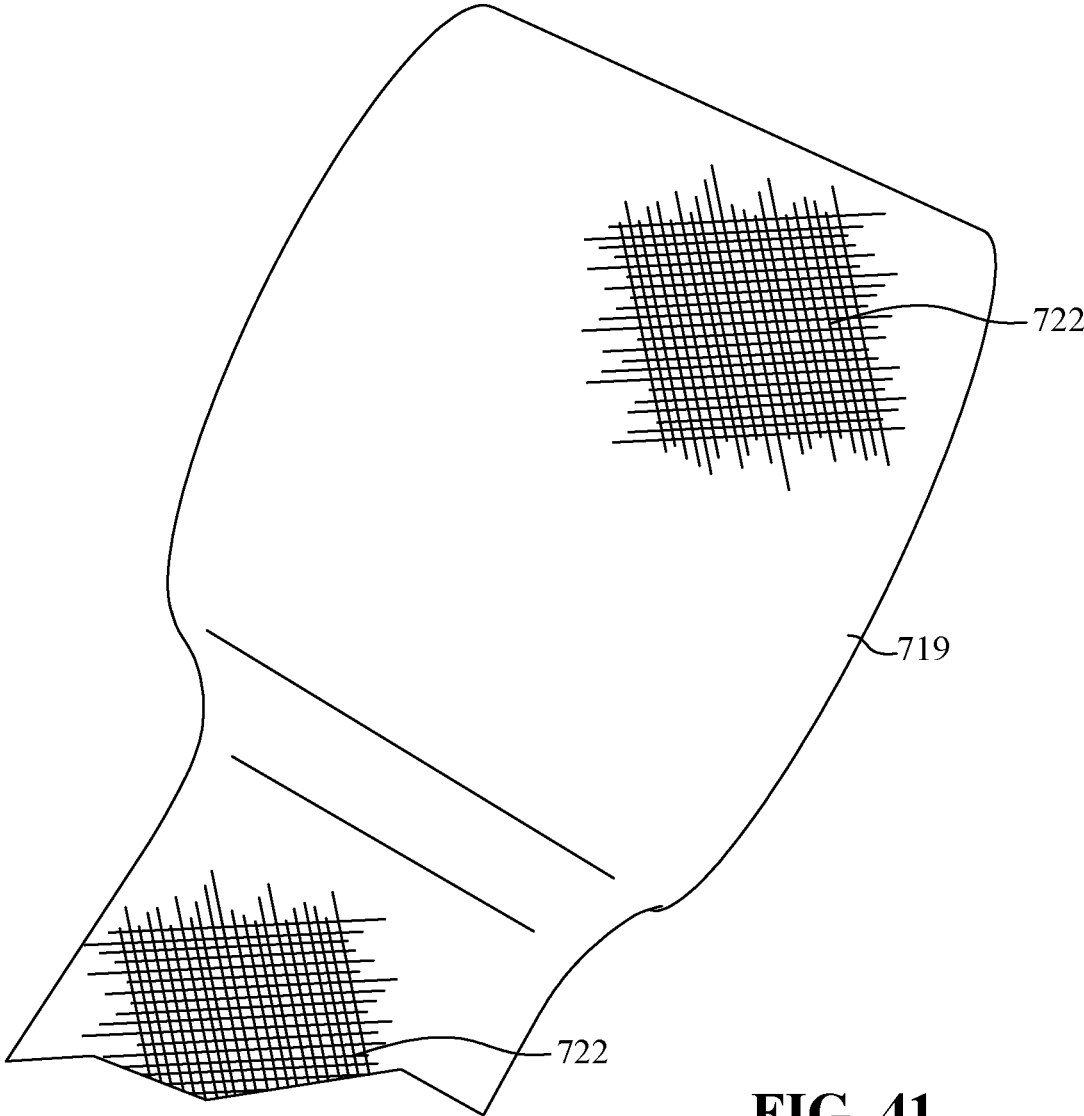
FIG. 41 is another plan view of the role of woven material repair tape;

In one embodiment, the repair system includes a role of woven or nonwoven fabric tape shown indicated as 719. In the embodiment shown, the fabric tape includes a woven fabric shown as 722. Also, in the embodiment shown, the tape can be supplied with a contact adhesive attached to one side thereof for attachment to the liner, foil, film or fabric that it is repairing or reinforcing. A protective layer of material 720 (see FIG. 39) to which the adhesive will readily release from may be used to facilitate providing the repair tape in a rolled form or otherwise facilitate removing thereof for easy repair or reinforcement of the recreational vehicle. As shown in FIGS. 42 and 43, repair tape 719 is attached to woven fabric layer 709, on the exterior thereof, creating an additional layer to the liner 700 as is best shown in FIG. 43. It should be appreciated that repair and reinforcing tape 719 could be placed or attached over itself to create additional reinforcing layers, and/or on the other side of the liner over the sheet of aluminum foil or metalized film 707. As many additional layers as is desired can be placed on either or both sides. It should also be appreciated that the repair tape could be an aluminum foil, or metalized film or other polymer or material, but the woven fabric tape has shown to be particularly suitable.

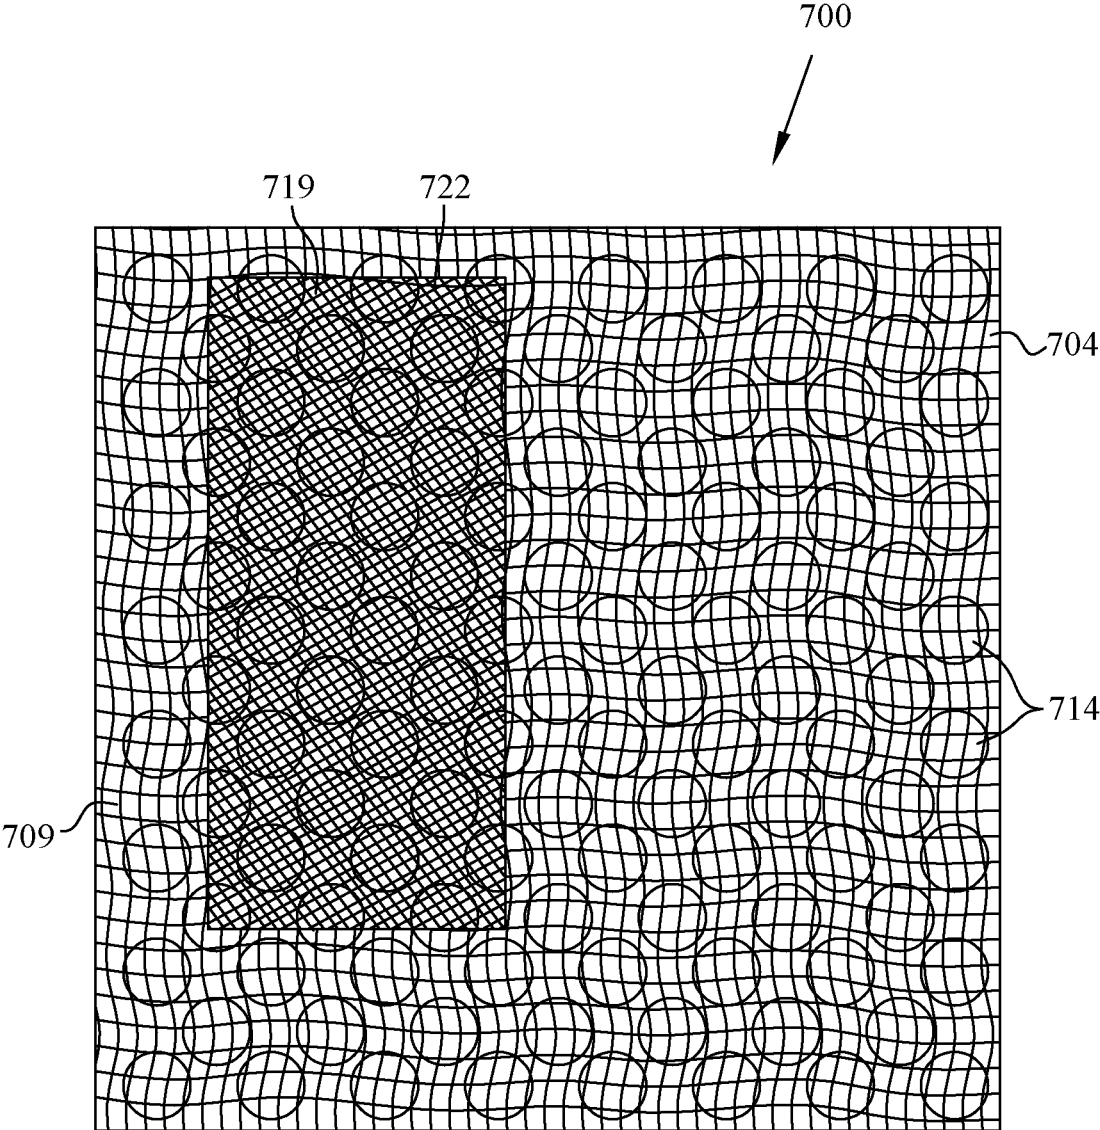
FIG. 42 is a plan view of a liner having a sheet of material with a woven fabric attached thereon and a piece of repair tape attached to the woven material; and

Now referring now to FIGS. 39-42, a unique repair and reinforcing system is provided for any of the liners provide herein and may be used to repair rips, tears or holes in the liner itself, or in the aluminum foil or metalized film or to provided additional support, reinforcement or protection to the liner. However, it is particularly suitable for repairing rips, tears, holes etc. in the woven or nonwoven fabric that may be attached to and covering one or both outer faces of the liner. Such rips, tears etc. may be through only the woven or nonwoven fabric, but also may be through partially or entirely through the body of the liner. Also, it may be necessary to cut through the liner to install plumbing, electrical lines etc. in the recreational vehicle. The repair system can be used to repair around such installations.

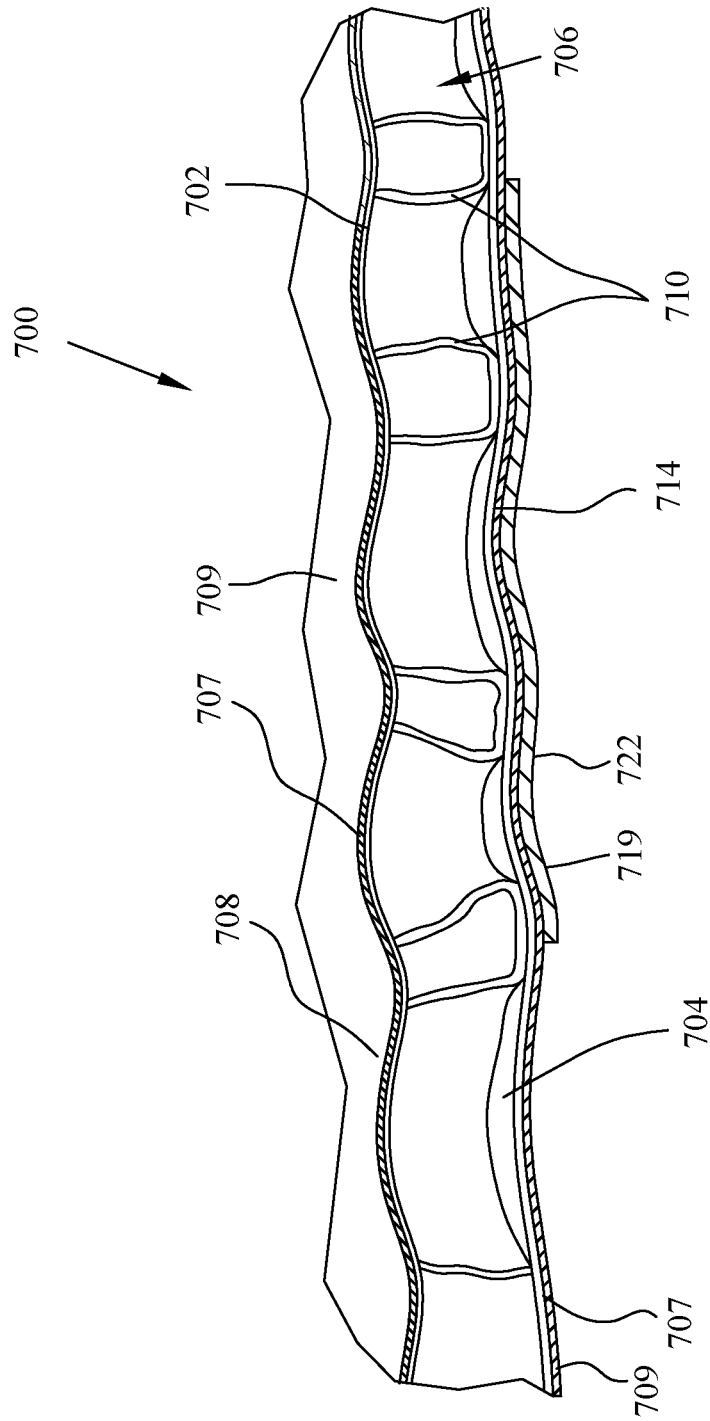
FIG. 43 is a cross sectional view of the liner of FIG. 42 taken through the piece of repair tape.
