# Fluviokarst in the top of the Maastrichtian chalk at Rørdal, Northern Jutland, Denmark

Stenestad, E. 2006–11–30: Fluviokarst in the top of the Maastrichtian chalk at Rørdal, Northern Jutland, Denmark. *Bulletin of the Geological Society of Denmark*, Vol. 53, pp. 93–110. © 2006 by Geological Society of Denmark. ISSN 0011–6297. ([www.2dgf.dk/publikationer/bulletin](http://www.2dgf.dk/publikationer/bulletin)).

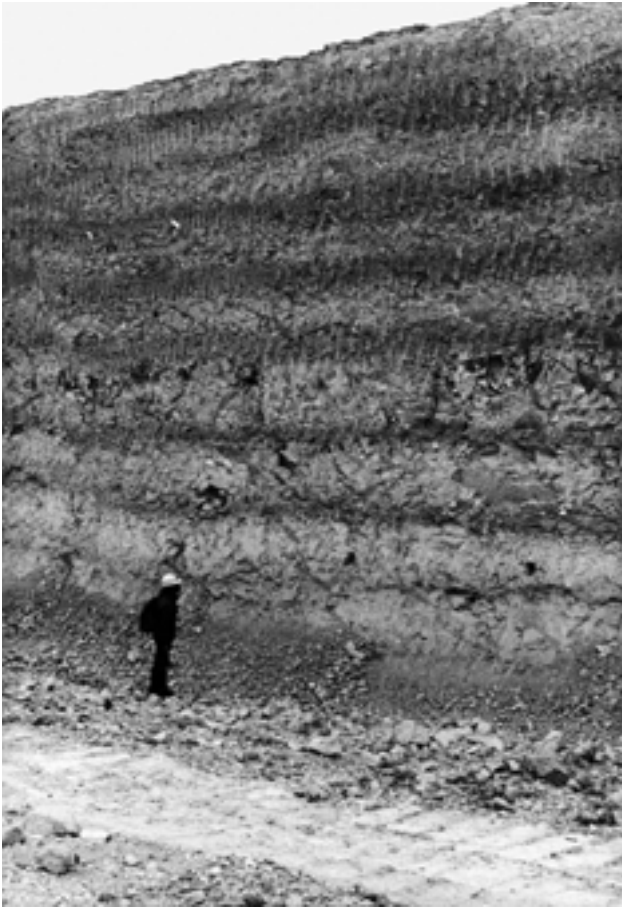
Fig. 1. Rhythmic sedimentation of upper Maastrichtian chalk at Rørdal.

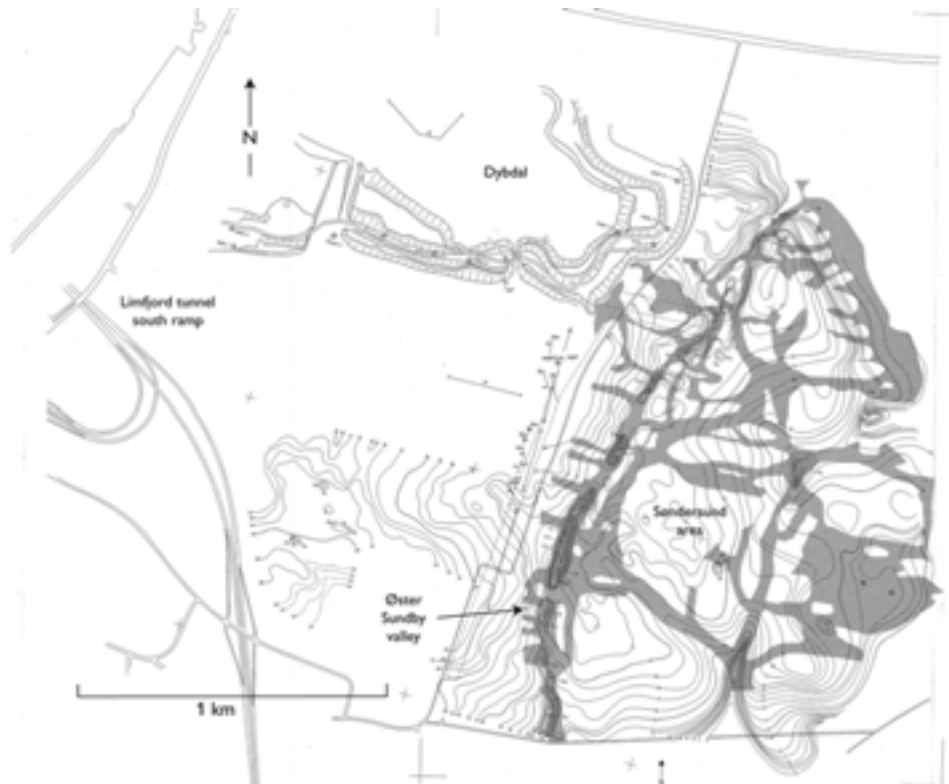
Fig. 3. Rørdal quarry, Dybdal and the Sønderlund area. The crop marks from figure 4 are shaded on the contour map of the pre-Pleistocene surface. The equidistance of contours is 1 m. The boreholes in Dybdal are shown without the DGU file numbers used in figure 17.

A number of shallow boreholes and excavations were made in order to map the surface of the chalk. The resulting contour map of the pre-Pleistocene surface demonstrates that the crop marks are clearly related to the relief of the top of the chalk (Fig. 3). The Øster Sundby valley follows the orientation of

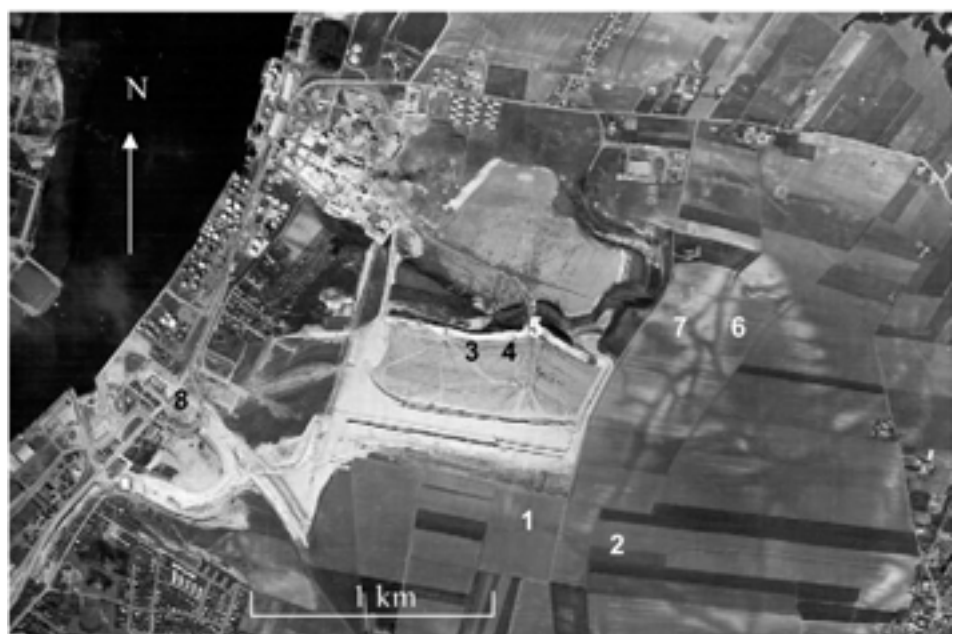
Fig. 4. Aerial photograph of the Rørdal area showing the same area as figure 2. Note crop marks. Localities nos. 1-8 are indicated. Based on an excerpt of Danish Geodetic Institute aerial photograph route 349 nr. 245. (Reproduced according to authorization A.63/75).

The description is based on observations in quarry profiles, excavations and cores from boreholes. A dense grid of drill holes was used to establish the relief of the pre-Pleistocene surface in the Sønder-sund area (Figs 2,3). Aerial photographs showing crop patterns helped to track the buried Øster Sundby valley (Fig. 4).

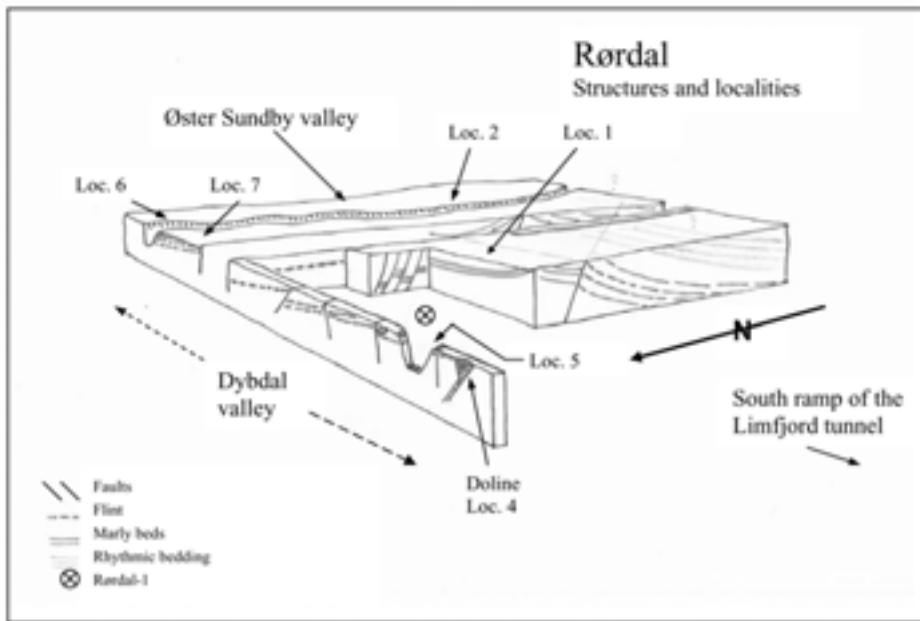
Fig. 5. Rørdal quarry. Structures and localities. The represented area is c. 1 × 1 km. (Cfr. Fig. 2).

The chalk that is exposed in the sections is white to greyish white with 90–95% carbonate and less than 0.5%  $\text{Fe}_2\text{O}_3$  and  $\text{MnO}$ , while the remaining impurities mainly comprise clay, and a few angular silt-size quartz grains. Flint nodules are generally scarce and are found only at a few levels (Fig. 5). The chalk is thoroughly bioturbated.

Marly beds and rhythmic bedding is found only in the southern part of the area (Fig. 5). This area is also characterised by many flint nodule beds. Minor faults were found in all parts of the chalk in the Rørdal quarry. Joints striking N–S, E–W, NE–SW and NW–SE are widespread in the chalk, and these directions coincide with the direction of the valleys eroded in the chalk (Fig. 6).

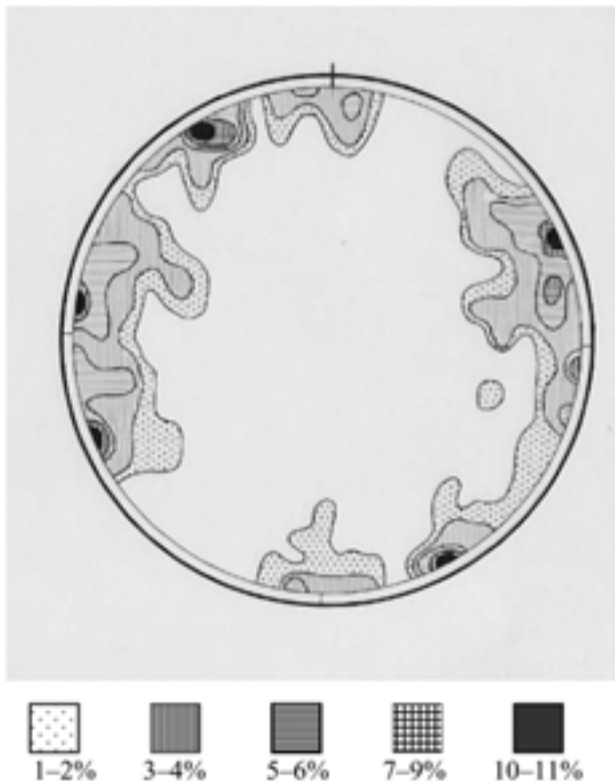
Fig. 6. Joints diagram based on 80 measurements. Lambert equal-area projection on lower hemisphere.

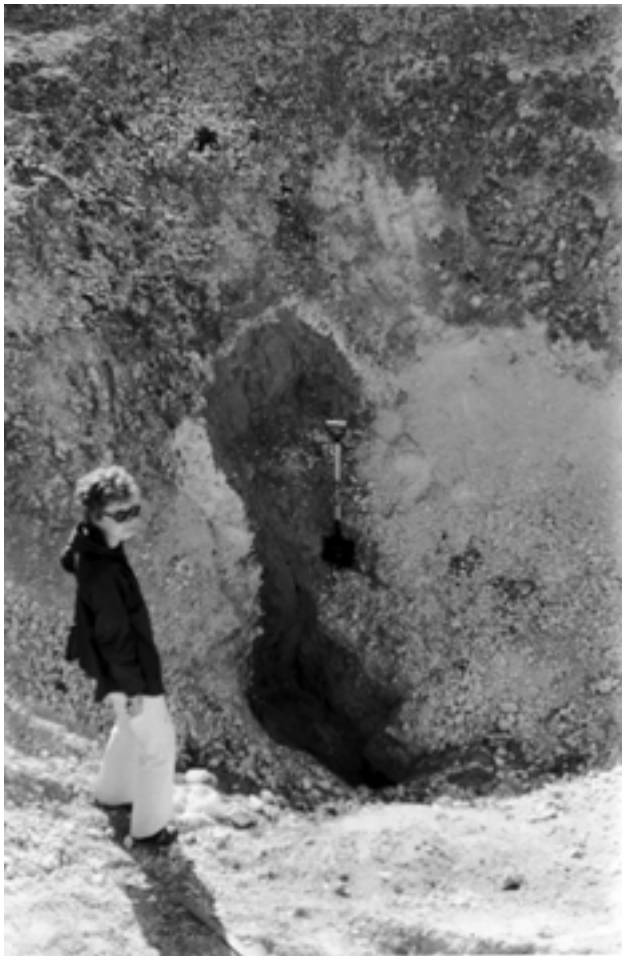
Fig. 7. Locality 1. The partly excavated doline viewed from top of the chalk. The dark section next to the spade represents layers (2) to (6) in fig. 8. The bottom layer (7) is not visible.

A major circular, funnel shaped hollow in the surface of the chalk was studied in the southern part of the quarry (locality 1, Figs 2, 4, 5). The overburden and most of the pebbly sand in the upper part of the hollow had been removed (Fig. 7). The top diameter of the excavation was c. 5 m and the depth c. 6 m (Fig. 8). The hollow is filled with greyish-brown or ochre-coloured sandy deposits, including fine to medium-grained coarse sand with pebbles and up to 15 cm large blocks of white chalk alternating with clayey and silty layers. Spots of soil rich in organic

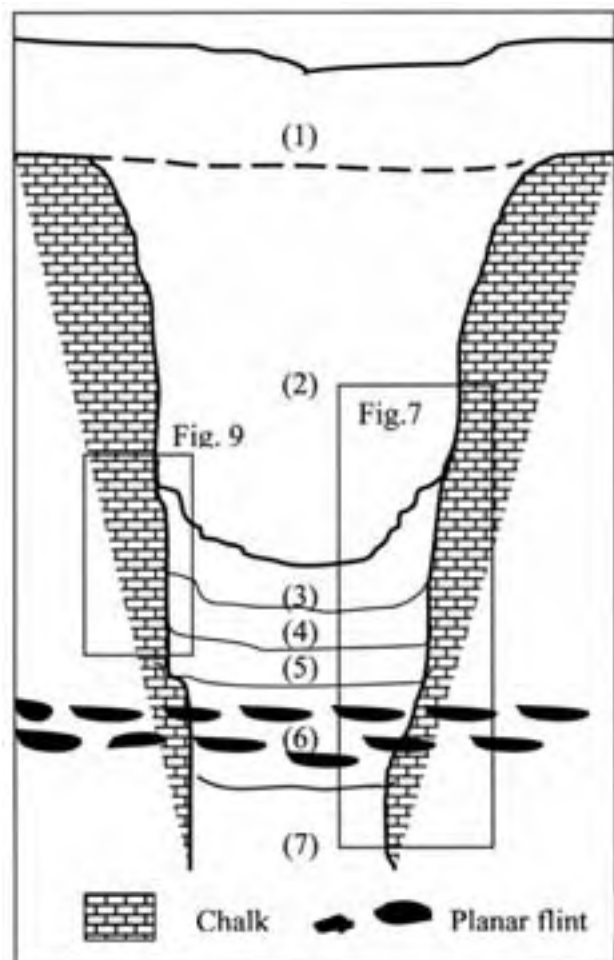
Fig. 8. Locality no.1. Doline. Diagram not to scale. Top diameter of the hollow is c. 5 m and the depth is c. 6 m. (1) Overburden; (2) Pebbly sand (partly removed), fine, greyish brown; (3) Sand, fine to medium-grained with pebbles, light greyish brown or ochre-coloured, with up to 15 cm large blocks of white chalk; (4) Sand, fine to medium-grained, greyish brown, with few pebbles, alternating with clayey and silty layers; (5) Sand, fine to medium-grained, greyish brown, with spots of soil rich in organic matter, with crumbling pebbles and ochre-covered flint nodules; (6) Sand as (5) with two undisturbed horizontal planar flint beds; (7) Chalk, white, soft, wet.

The funnel shaped hollow at locality 1 is interpreted as a doline on the basis of the form and size of the hollow, the sediments, the character of the walls, the contact sediment, and the nearby presence of a karst type drainage system.

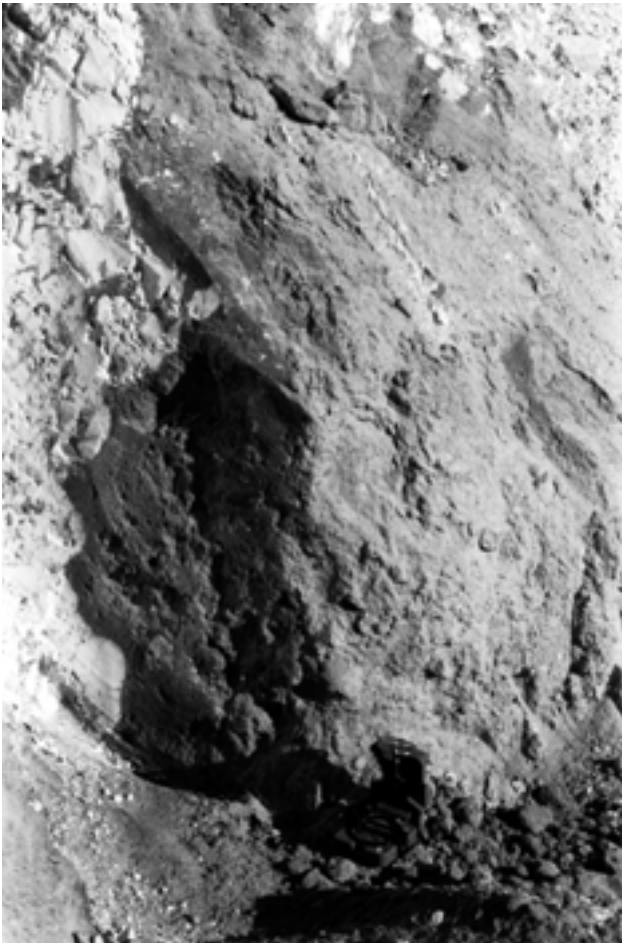
Fig. 9. Locality 1. Close up of contact to chalk *in situ*. (Cfr. Fig. 8)

The smooth and corroded walls of the hollow in the soft crumbling chalk also indicated dissolution of the chalk (Fig. 9). The contact sediment of clayey and silty sand may have been formed as layers of silt and clay on the surface of the chalk gradually

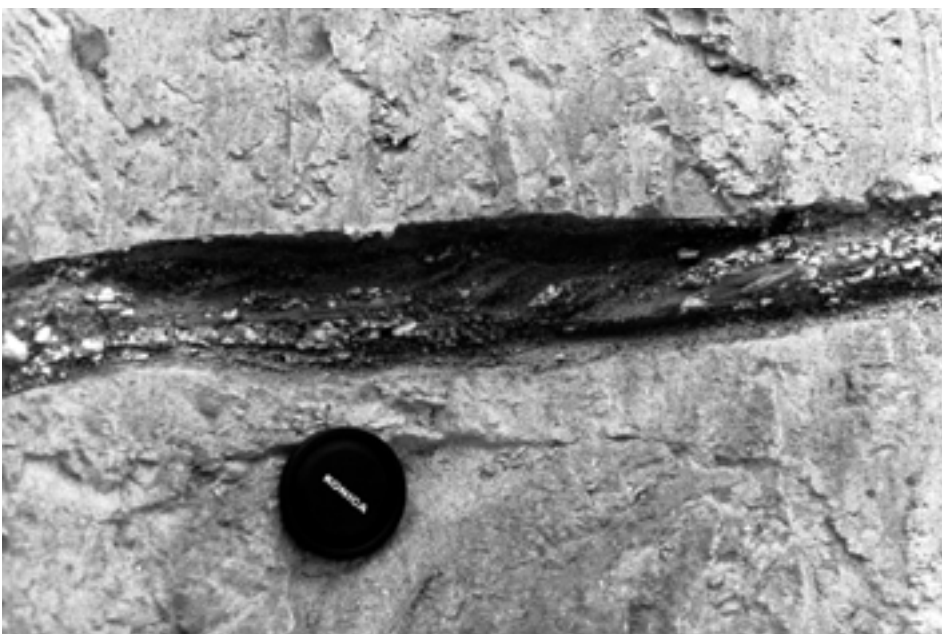
Fig. 10. Close-up of quarried wall near locality 1. Open channel in the chalk infilled with cross-stratified fluvial sediment.

Vertical and extensive horizontal subsurface channels in the chalk were exposed in the walls of the quarry quite near locality 1. The horizontal originally open subsurface channels are 5–10 cm deep and are infilled with cross-bedded sand and gravel by east-bound streams as is indicated by the east dipping foresets (Fig. 10). The subsurface channels are interpreted as fluviokarst channels developed by running water in combination with dissolution processes.

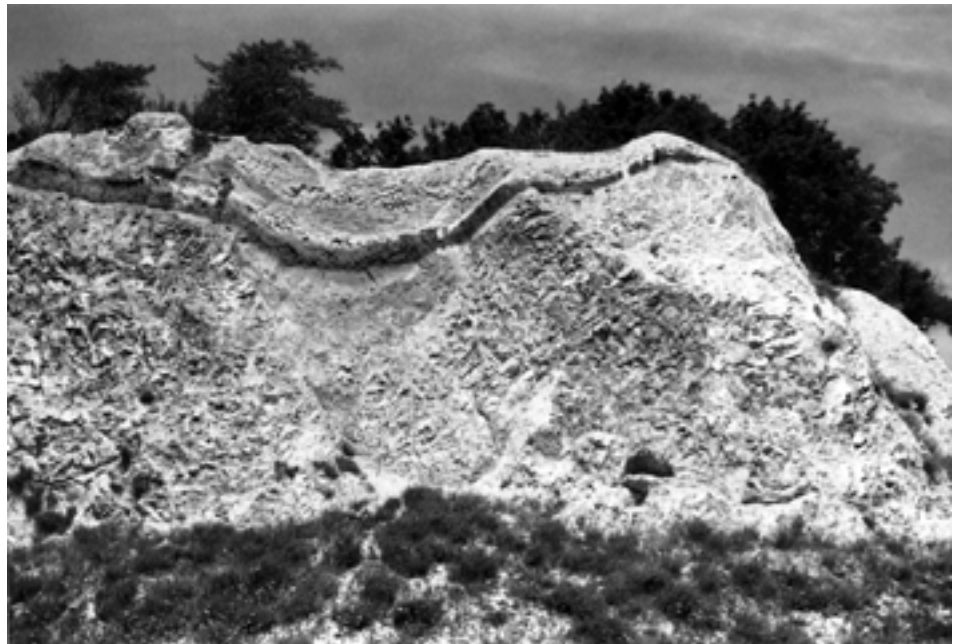
Fig. 11. Locality 4. General view of the doline next to Dybdal.

A funnel-shaped structure and an irregular horizontal channel with a sand-filled cavity was noted in the chalk in the quarry wall next to the Dybdal valley (locality 4, Figs 2, 4, 5). The funnel was c. 6–7 m in diameter and c. 4–5 m deep (Figs 11,12). Parallel faults ( $170^{\circ}/68^{\circ}\text{E}$ ) formed the shaft and one side of the funnel. Fine-grained partly stratified sand and cobbles with a diameter of 15–20 cm were deposited

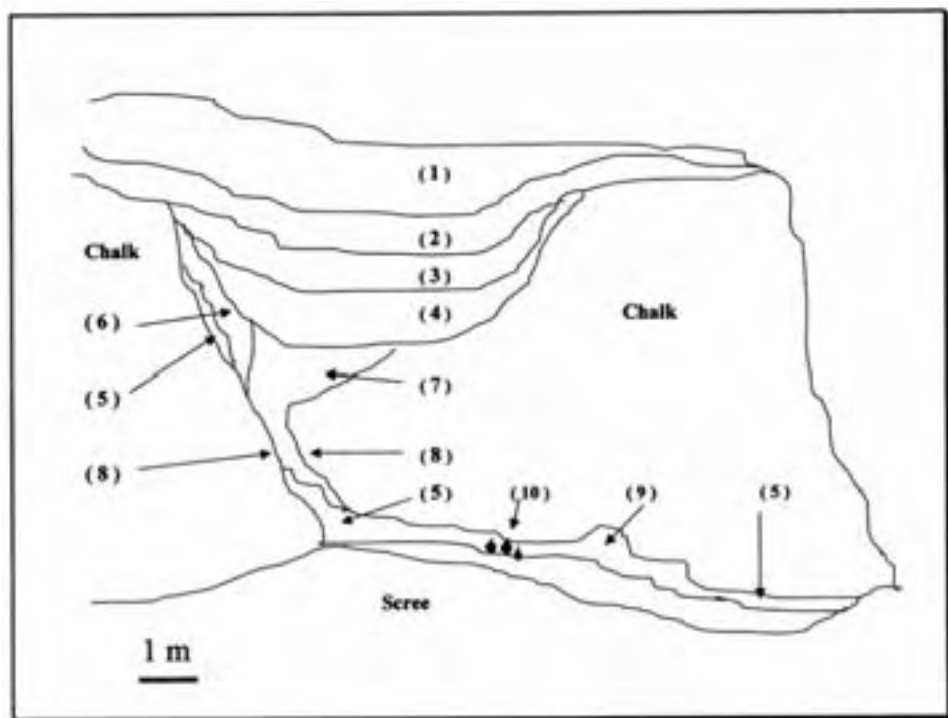
Fig. 12. Locality 4. Explanatory sketch to figure 11. (1) Landfill; (2) Soil; (3) Silty fine sand; (4) Stratified fine sand; (5) Sand, fine, partly stratified; (6) Block of solid chalk; (7) Fallen chalk fragments; (8) Faults; (9) Sand-filled cavity; (10) Cobbles with a diameter of 15–20 cm.

nel shaft and triggered the sliding down of a block of solid chalk (Fig. 12). A fining-upwards succession of bedded fine sand and silt eventually filled the channel.

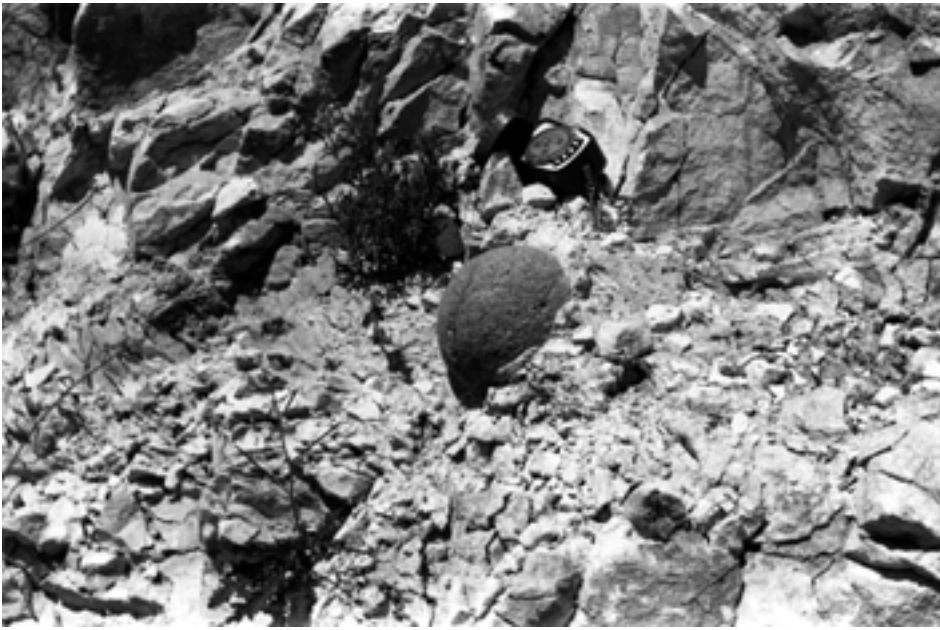
Fig. 13. Locality 4. Channel in the chalk filled with sand and cobbles. Cfr. fig. 12, item (10).

in the bottom of the funnel shaft and in the channel (Fig. 13). The funnel was filled with fallen chalk fragments covered by stratified fine-grained sand and silty fine sand.

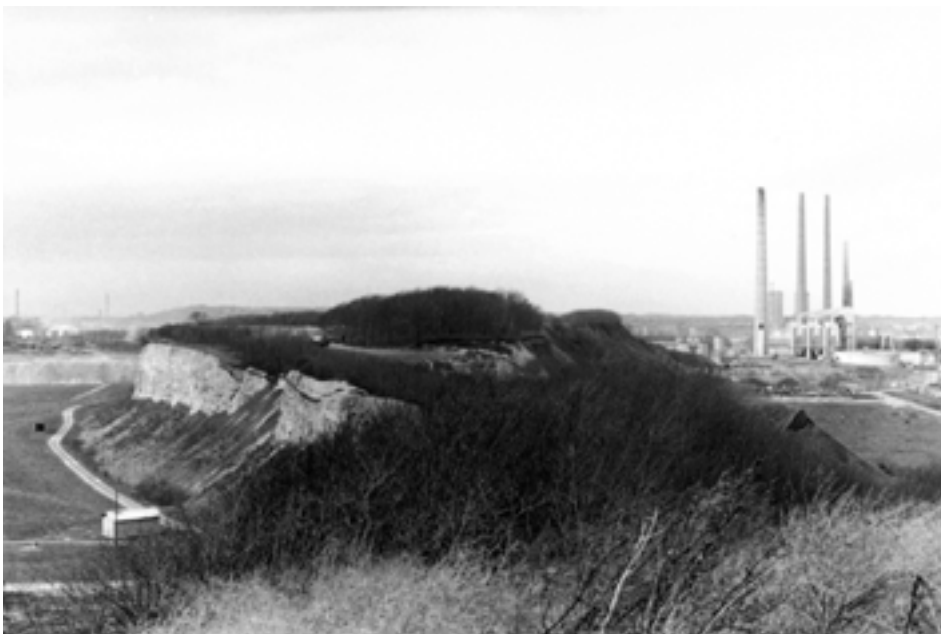
Fig. 14. Dybdal. Viewed from the East.

The c. 100 m wide Dybdal valley was left behind during quarrying as a 10–20 m high 'wall' between the quarried areas (Fig. 14). The profile (locality 5, Fig. 15) represents the south side of the valley. The side of the valley is here a steep or overhanging wall of chalk in contact with fine-grained sand that is very well sorted, finely laminated or cross-bedded. The same type of contact is seen at the nearby locality 3 (Fig. 2) between graded silt without chalk and an overhanging chalk wall (Fig. 16). The chalk wall at locality 5 is oriented NE–SW, almost perpendicular to the main direction of the valley at this point but it coincides with the direction of the joints. In the valley Late Glacial fine-grained sand and silt is interbedded with coarse-grained sand, pebbly sand and sand with cobbles up to 20–30 cm diameter. Some of the drilled sections have indications of cyclic sedimentation that may reflect climatically controlled changes in the Late Glacial flow of melt water (Fig. 17). The fining-upward cycles have coarse pebbly sand at the base overlain by progressively finer-grained, well-sorted sands. The content of chalk mud and silt is low at the base of each cycle and increases

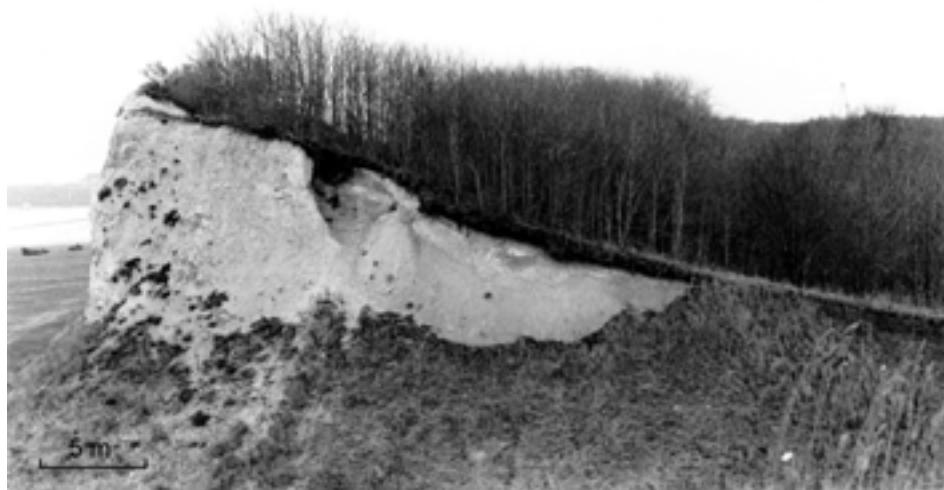
Fig. 15. Locality 5. Section of the south side of the Dybdal valley.

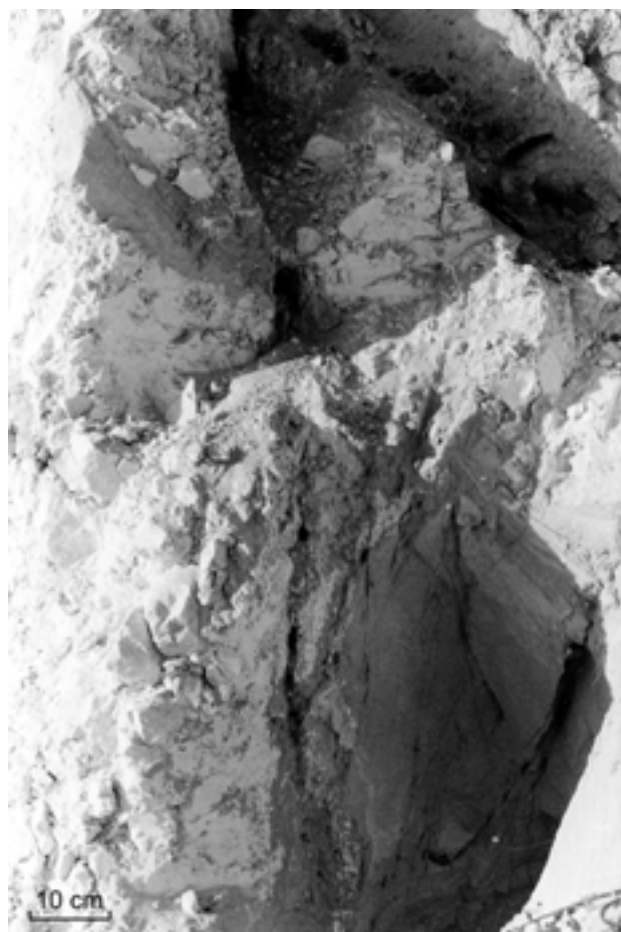
Fig. 16. Locality 3. Contact between the chalk wall and the valley-fill sediments of Dybdal.

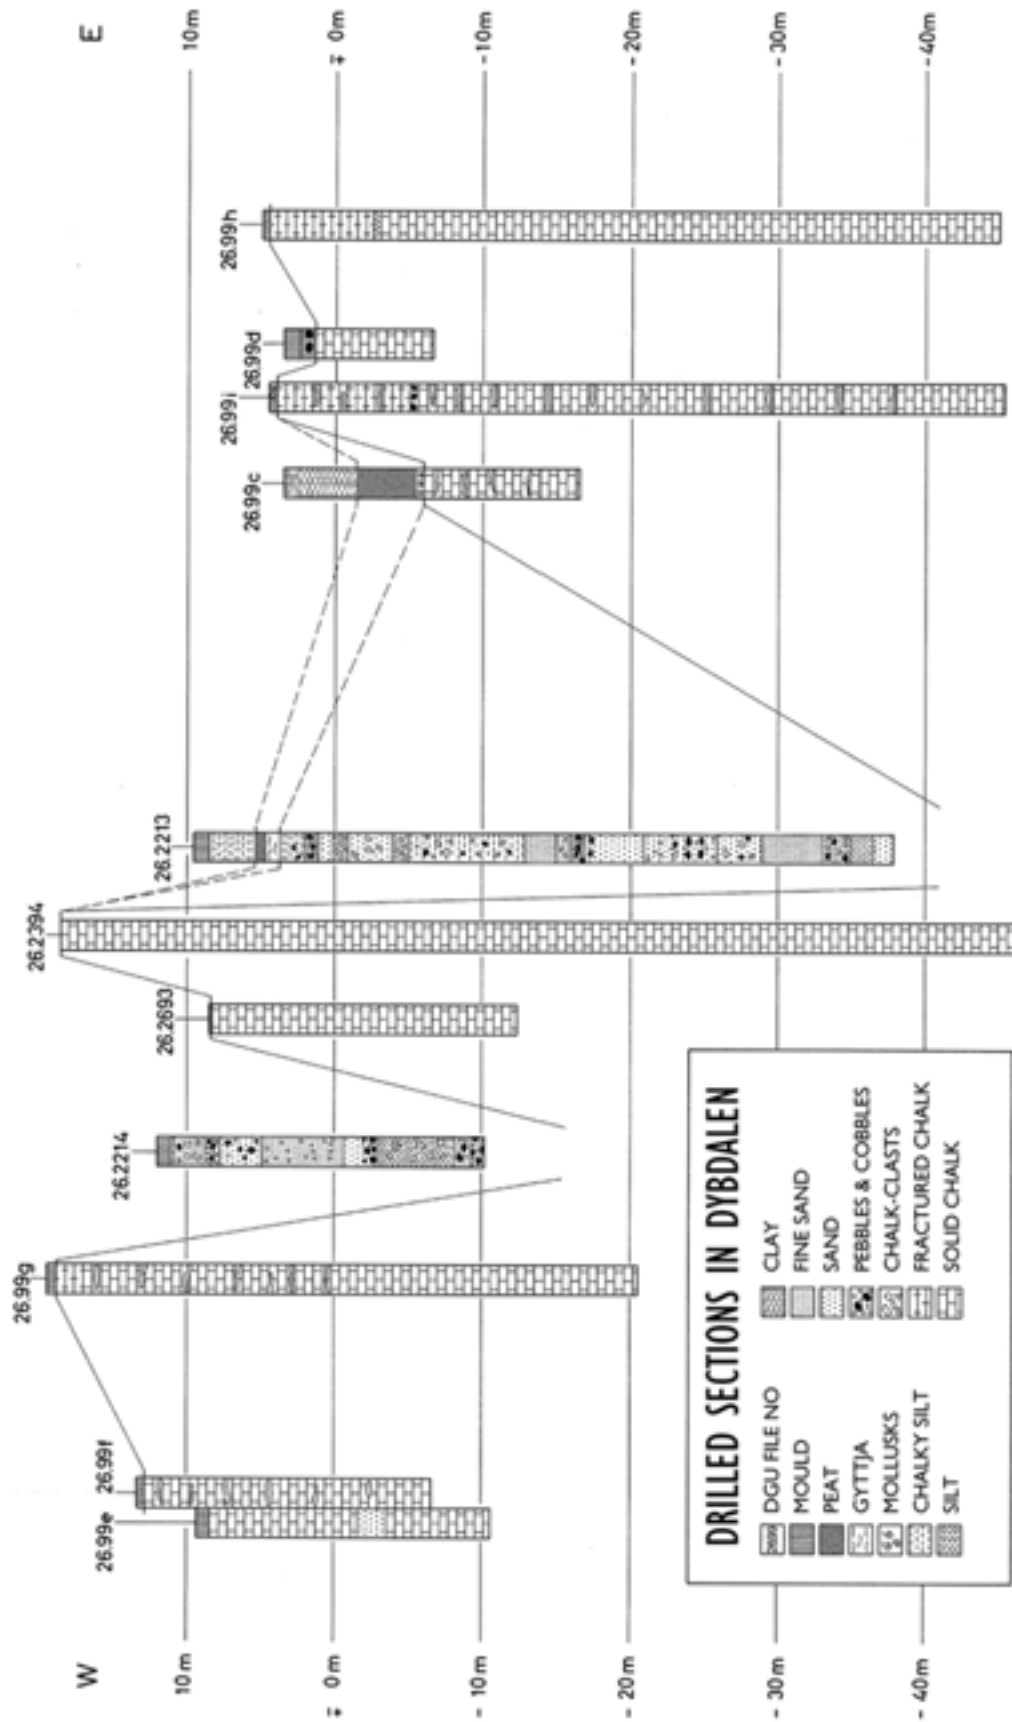
Fig. 17. Drilled sections in Dybdalen. The location of the boreholes is shown in fig. 3. The length of the composed cross-section is about 1½ km.

The valley is narrow and deep and the bottom topography is very uneven as indicated by the boreholes in the valley (Figs 3, 17). Geoelectric measurements in the valley failed because of interference from the narrow walls of chalk. However, one of the boreholes in the valley centre (Geological Survey of Denmark File no. 26.2213) did not reach the chalk at the final depth at level -38 m some 50 m below the surface of the chalk adjacent to the valley.

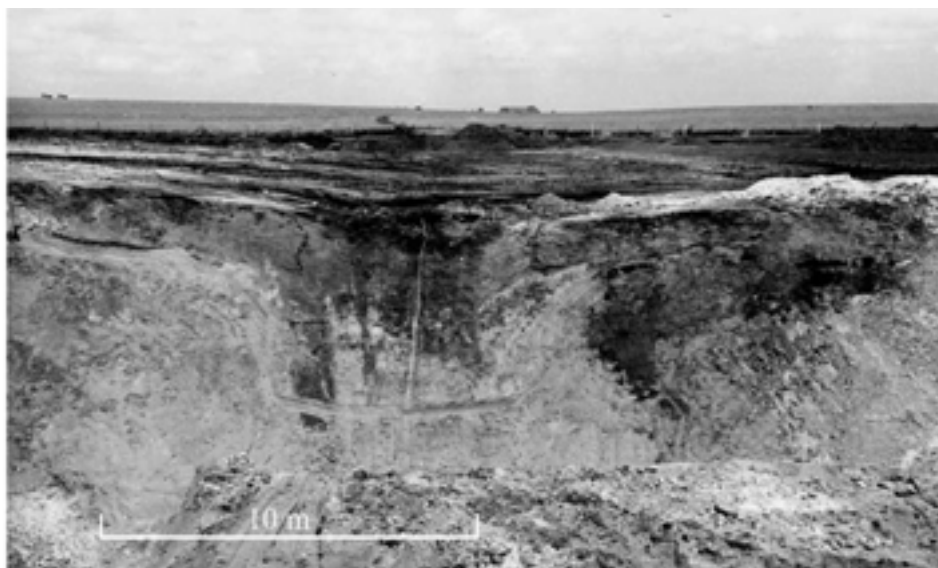
Fig. 18. Locality 2. The excavated cross-section of the uppermost part of the Øster Sundby valley viewed from the south. The buried valley is hardly visible in the terrain. The 10 m bar refers to the section in the centre of the picture. Barely visible spades right and left in the picture and a ranging pole in the centre for verification of the scale.

joints and faults in the chalk just like the Dybdal valley. A cross section (Fig. 18) was excavated in one of the deeper parts of the valley (Fig. 2, locality no. 2). This section did not reach the bottom of the valley and so a borehole was made at the profile (Fig. 2, borehole 1973/1). The composite profile is based on data from the excavation and the borehole (Fig. 19). The cross section of the excavated part of the valley is almost funnel-shaped. The section is c. 25 m wide at the top and c. 15 m wide at the bottom of the excavation at level +14 m. The upper 5 m of the western chalk wall of the valley is almost vertical. Below this level the wall dips towards the axis of the valley. The eastern chalk wall is overhanging to vertical. The chalk is somewhat disintegrated and clayey at the contact to the sandy valley fill, and this together with the steep and overhanging walls and the irregular funnel shaped cross-section seem to indicate that karstic processes have been active. The chalk-walls of the upper part of the valley are covered by 0.5–1 m silty and clayey sand sediment with abundant chalk clasts (Fig. 19, bed G). The sediment shows some similarity to boulder-clay (till) but it is slightly stratified and is supposed to have flowed into the valley as a debris flow.

The bedding and sedimentary structures across the profile indicate that the valley sediments subsided at a late stage of Quaternary sedimentation (Fig. 18). The bed named A in figure 19 was followed across the profile. It was evenly bedded in the middle of the valley. Near the sides of the valley, however, it was broken up into short subvertical flakes that could be followed c. 4 m upwards to a level, where the bed was again almost horizontal but was dissected by antithetic micro-faults. The subsidence of the central sediment package could be traced into the lower part of the sediment package above bed A, but it could not be established whether the subsidence was diminishing upwards which would indicate that the subsidence took place over a period of some length, possibly to the end of the sedimentation.

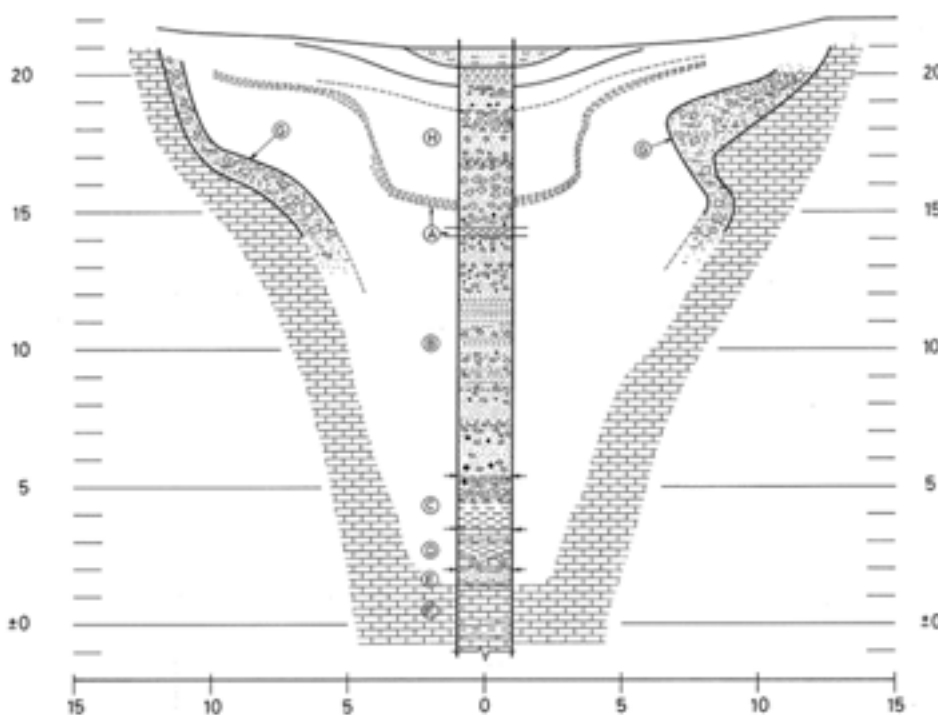
Fig. 19. Locality 2. Composite section based on the excavated cross-section (Fig. 18), and borehole 1973/1 (Figs 2, 4). Key as in Fig.17.

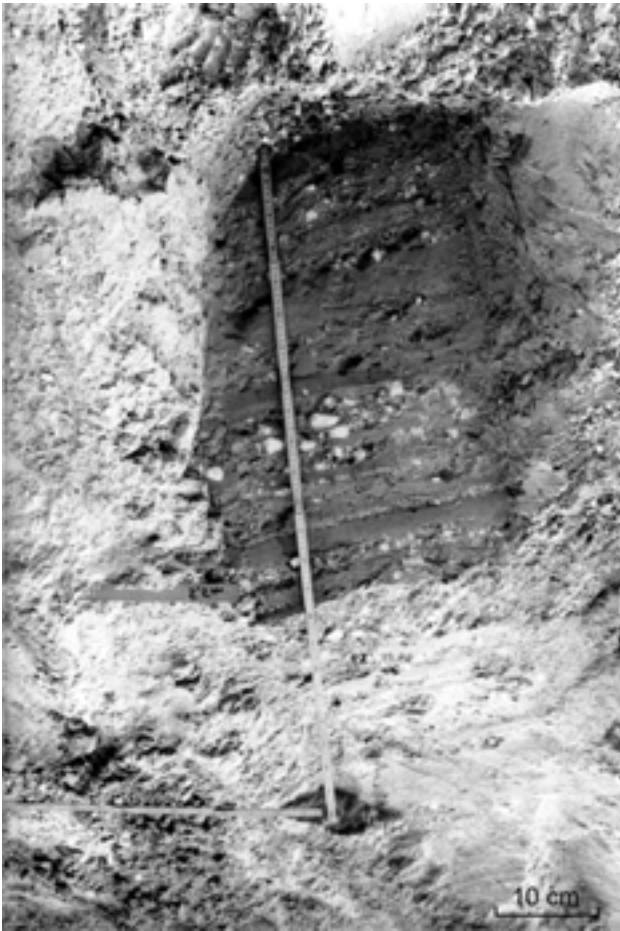
Fig. 20. Locality 2. Stratified contact sediments c. 5,5 – 6,3 m below the top of the excavated cross-section (Figs 18, 19).

the excavation consists of 10–20 cm thick graded beds separated by beds of chalk clasts (Figs 20, 21). Some grain-size distributions may be strongly affected by the content of chalk clasts, but the curves reveal a quite normal distribution if the chalk is removed, as was noted also for Dybdal. Because of the high porosity the chalk clasts are light for their size compared to less porous particles such as quartz sand.

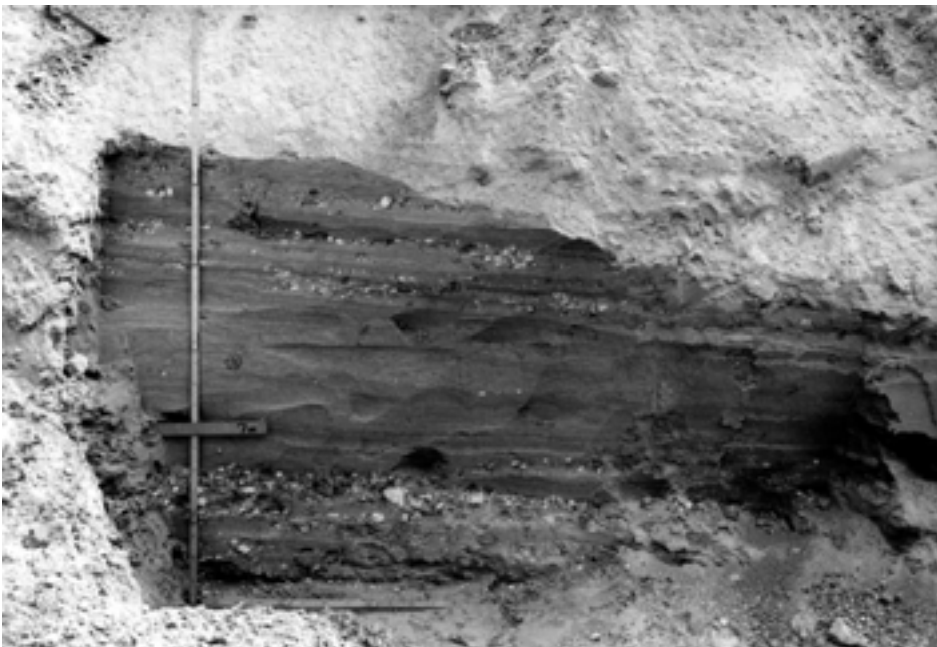
Fig. 21. Locality 2. Sediments from the axis of the Øster Sundby valley c. 6,3 – 7,4 m below the top of the excavated cross-section (Figs 18, 19).

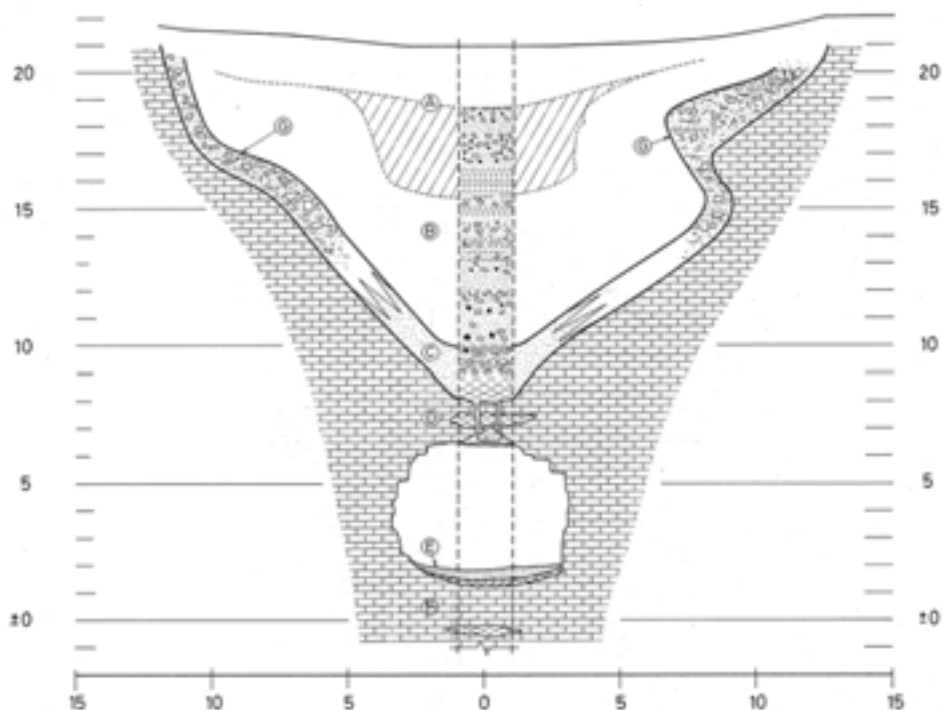
Fig. 22. Locality 2. Tentative section of the Øster Sundby valley before collapse of an assumed cavity. Key as in Fig.17.

Possible explanations of the subsidence might include 1) compaction of underlying soft sediments such as peat or clay rich in organic matter, 2) melting of remains of glacier ice in the deeper parts of the valley, or 3) collapse of a cavity in the chalk. Options 1) and 2) are not supported by sedimentary evidence as there was no trace of organic sediments or genuine till deposits. This leaves option 3) as the most likely explanation. For instance, the bed marked D in figure 19 may represent the roof of a collapsed cave. A tentative profile of the valley before the collapse of an assumed cavity is shown in figure 22.

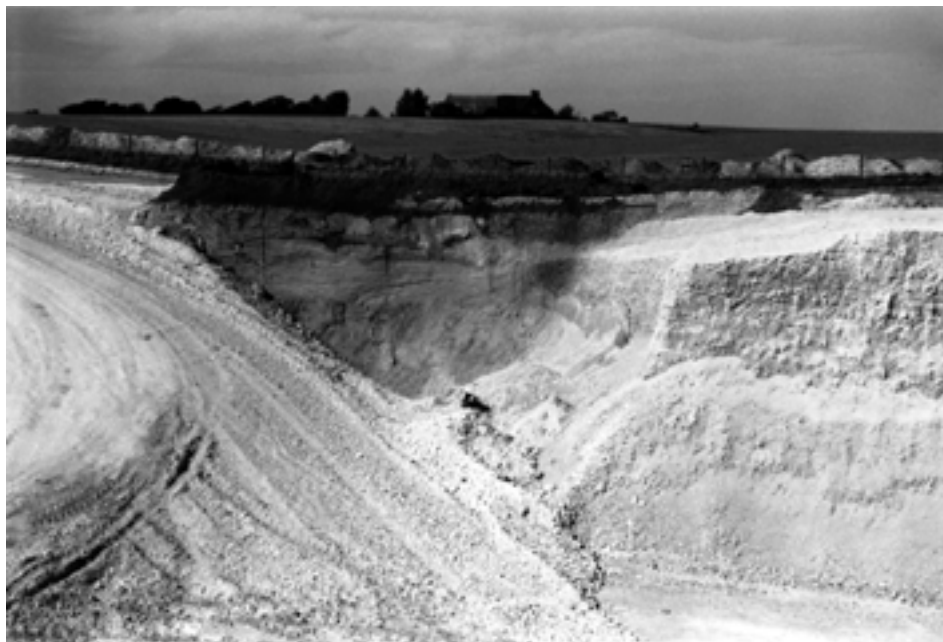
Fig. 23. Locality 6. Øster Sundby valley cross-section. Note spade for scale.

At locality 6 the chalk wall of the valley was vertical or slightly overhanging (Fig. 23). The valley fill

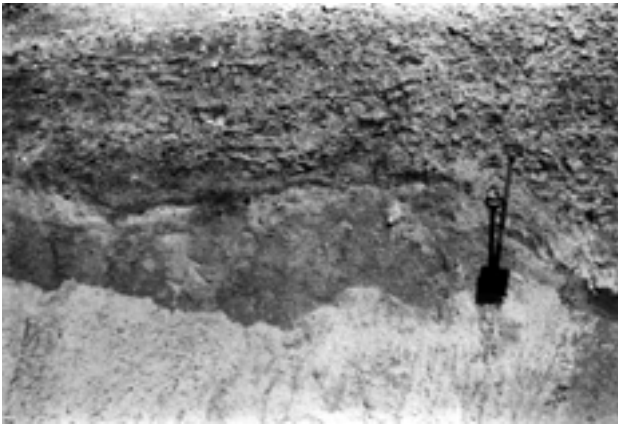
Fig. 24. Locality 6. Close up of the sidewall of the easternmost branch of the Øster Sundby valley. The chalk (at top of the photograph) is covered by greyish brown slightly argillaceous pebbly sand, and towards the axis of the valley by sands with chalk fragments (bottom of photograph). In the axis of the valley are alternating beds of fine sand and chalk fragments.

comprises greyish brown slightly argillaceous pebbly sand (Fig. 24). Towards the axis of the valley sand with chalk fragments occurs and in the axis alternating beds of fine sand and chalk fragments having much the same appearance as the sand at locality 2.

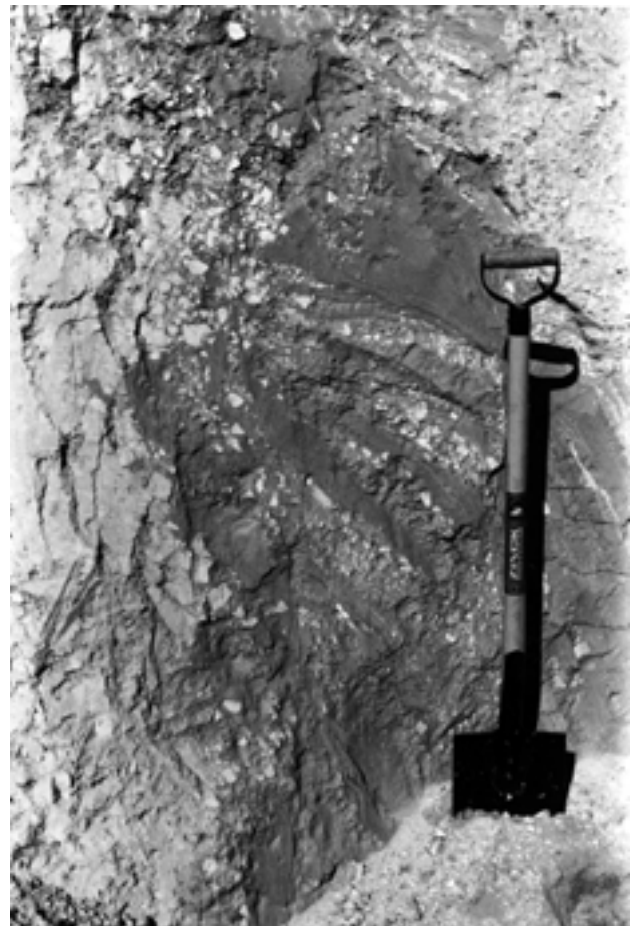
Fig. 25. Locality 7. Close-up photograph of valley-fill sediment and contact to the chalk wall in the westernmost branch of the Øster Sundby valley (Figs 2, 4).

were laid down by series of small debris flows (Fig. 25). Angular chalk fragments that are imbedded in the sand outline the structural details and the assumed development of the sediment package. The succession seems to have been deposited in an open valley incised into the chalk. Clayey and silty sand was deposited in the valley by debris flows alternating with beds formed by fall of chalk pebbles from the fractured walls. Also at this locality a subsidence of the sediments in the valley has occurred. This happened mainly but not exclusively by small scale faulting c. 0.5 m from the chalk wall (Figs 26, 27). The distribution of the chalk fragments indicates drag, draw-out and vertical displacement of the beds along the faults. In the axis of the valley Late Glacial streams deposited horizontally bedded sand with chalk pebbles (Fig. 28). The data from locality 6 and 7 on the uppermost part of the valley support the observations from locality 2, including the subsidence of Late Glacial sediments, but they yield no details of the subsurface drainage system.

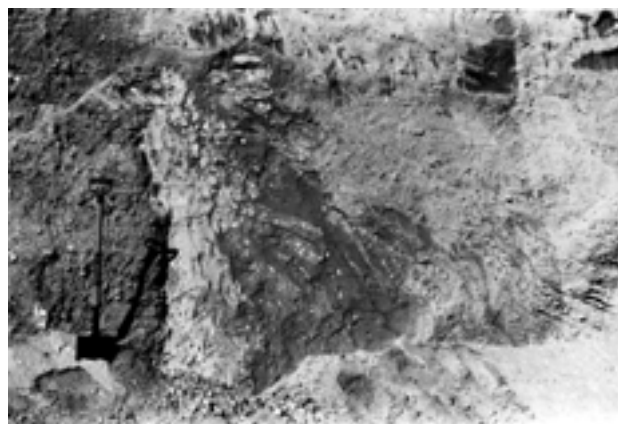
Fig. 26. Locality 7. Photograph of section in the westernmost branch of the Øster Sundby valley showing minor faults and subsidence structures.

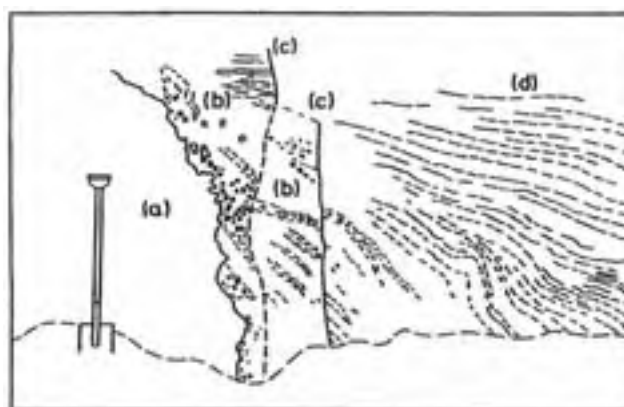
Fig. 27. Locality 7. Explanatory sketch to the photograph figure 26. (a) Chalk; (b) Stratified sand and silt with chalk fragments – possibly a debris flow deposit; (c) Faults; (d) Stratified sand and gravel. Note the subsidence structures.

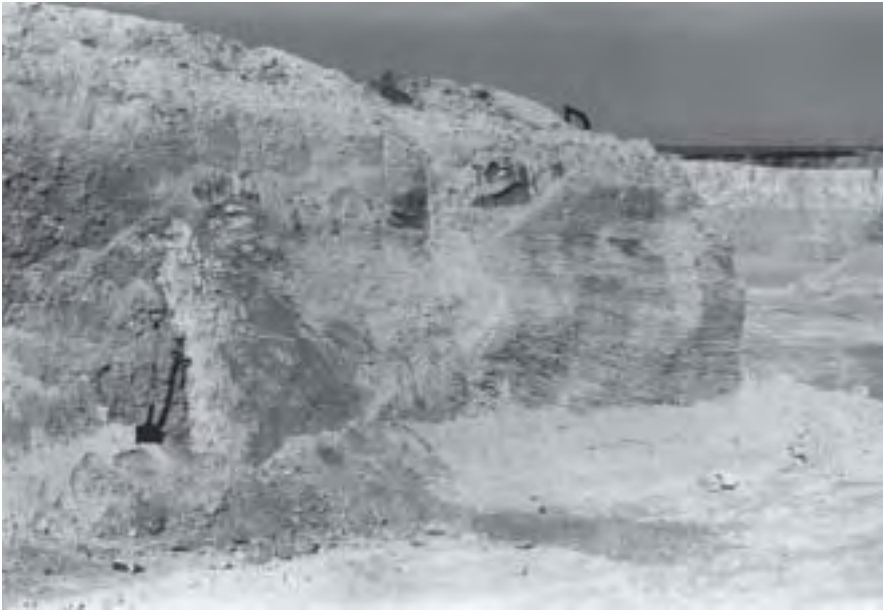
Fig. 28. Locality 7. Photograph of the westernmost branch of Øster Sundby valley showing sediment structures across the section.
