Bigger bugs in BART?

Six months in partial service have raised questions about BART's automation and its safety features

Gordon D. Friedlander Senior Staff Writer

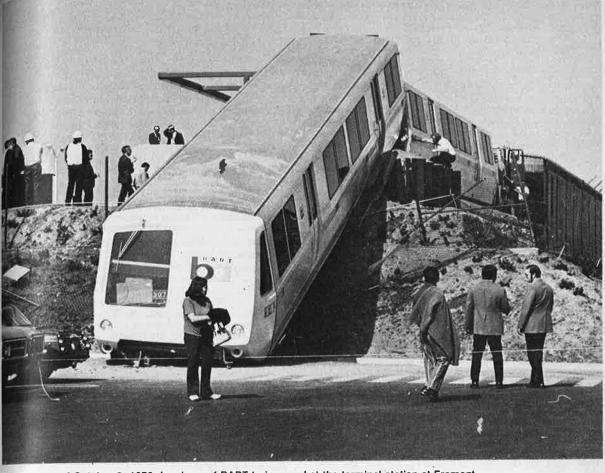
The incident of October 2, 1972. Lead car of BART train overshot the terminal station at Fremont and came to rest on a sand embankment following a failure in the ATC system. (Photo courtesy Lonnie Wilson, Oakland Tribune.)

On October 2 of last year, a southbound BART train operating under the computer-controlled ATC overshot the Fremont terminal and plunged the lead car onto a sand embankment. The train's "attendant" (BARTD's term for train operator, or its "sometime" motorman) barely managed to override the ATC manually before impact. In those final desperate seconds he may have realized that no deus ex machina would come to his aid and that all remaining divinity lay within himself. Fortunately, there were no fatalities or even serious injuries as the result of this incident. Although most of the passengers were just "shook up," the repercussions of that accident are a continuing subject of rather heated de-

[speed] zone in which the train was approaching the Fremont Station. Examination and detailed tests showed that there was an intermittent short in the crystal oscillator due to its mounting within its case which caused the oscillator to give an incorrect speed signal. Various tests showed that this ranged between 40 and 70 mi/h [64 to 113 km/h] instead of the correct speed of 27 mi/h ... It was further verified him X-ray examination, which showed that an intermittent short was possible because the crystal was not in the proper location within its case "

Post's investigative team also delved into the Fremont Station incident, and recommended that, because the crystal oscillators may transmit erroneous commands, the speed-control element should be redesigned. The report states in this context: "Contrary to the public position of BART and PBTB, all evidence available to us indicates that the speed-control circuits on all transit cars ... do not possess required fail-safe features and have not been adequately qualified for reasonable assurance of passenger safety.'
