# CARDIFF CITY CENTRE

## CONSERVATION AREA APPRAISALS

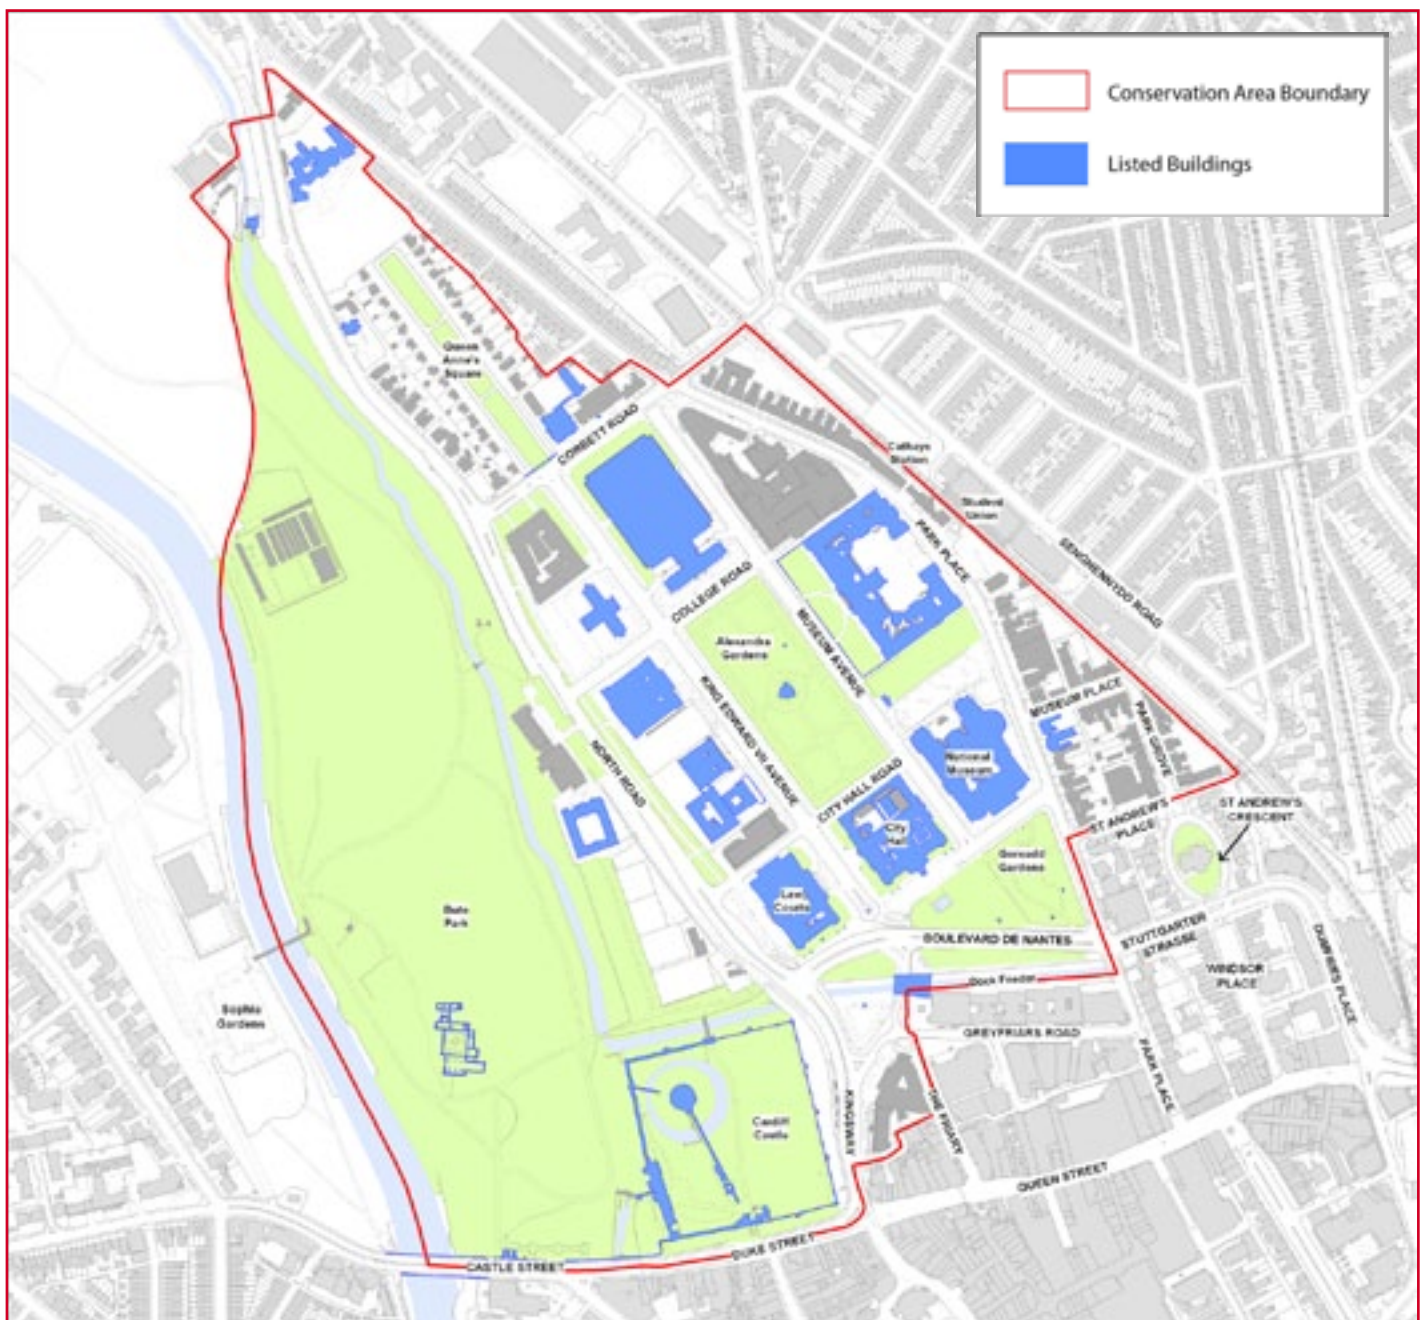
Map1: Cathays Park Conservation Area Boundary, designated 1975, extended 1992

Cathays Park Conservation Area was designated in 1975 and extended in 1992 to include Blackweir Farm to the west, Nazareth House to the north and the Prudential Assurance Building and Baltic House (now the Hilton Hotel), to the south.

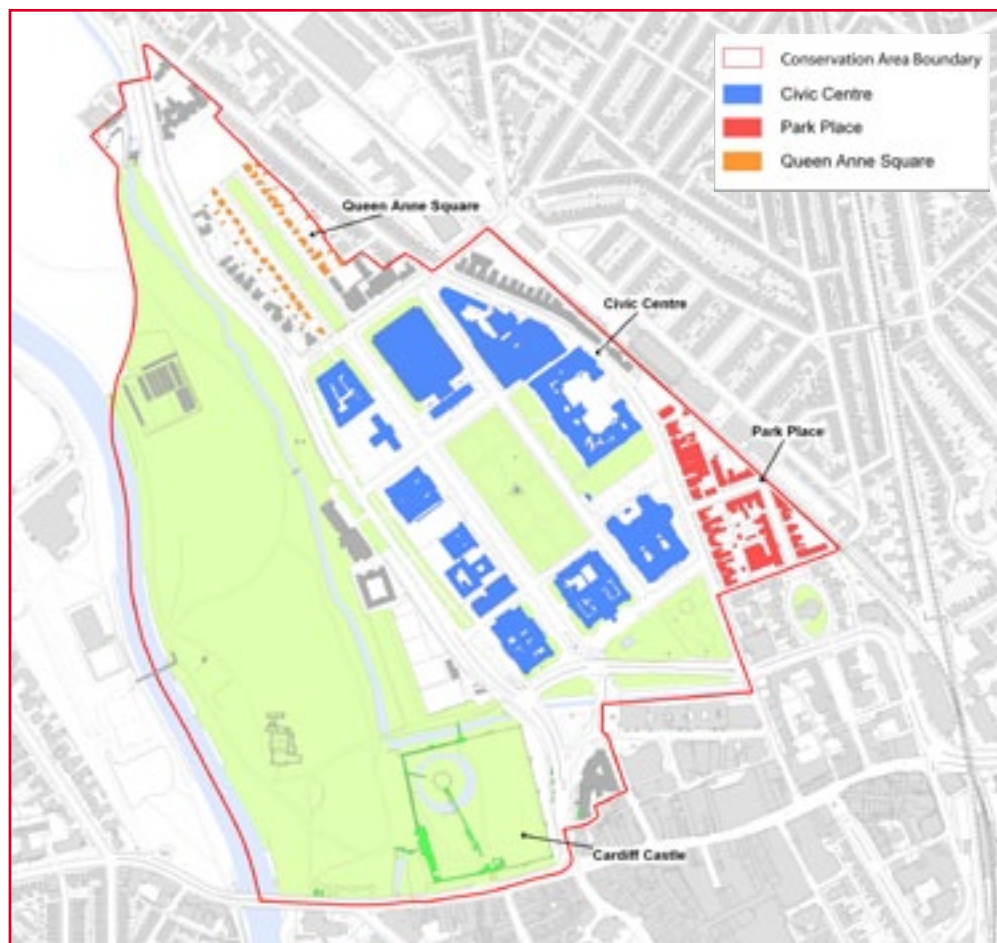
### Map 2: Grouping of Buildings

- The Civic Centre: a unique grouping of grand Civic buildings set within a formal landscape setting.
- Cardiff Castle and its enclosing walls.
- The two storey houses at Queen Anne Square, which are set around a shared lawn area and away from the public realm.
- Park Place, Museum Place and Park Grove: where roads have regular, narrow plot widths and a strong relationship with the public realm.

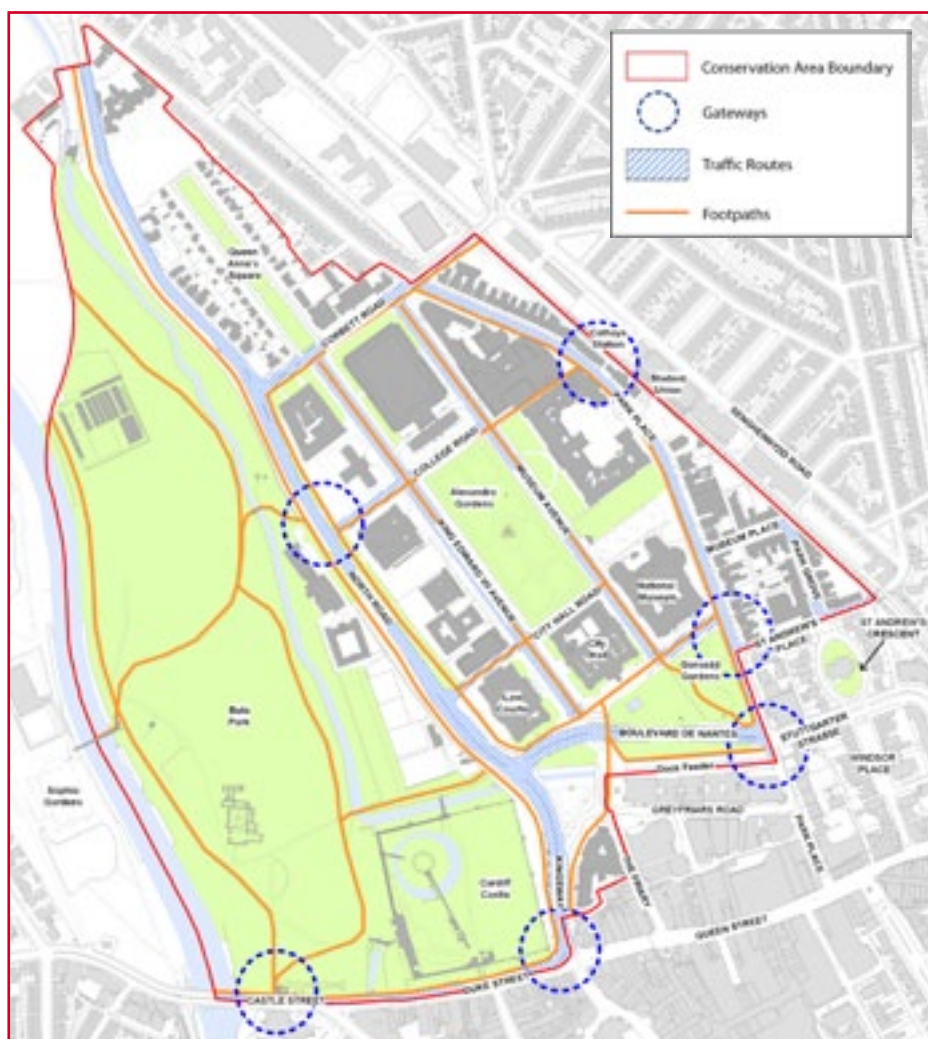
### Map3: Movement

- North Road, Park Place, Boulevard de Nantes, Kingsway, Corbett Road and Duke Street / Castle Street provide the main vehicular routes to surrounding areas.
- Secondary roads which provide access though the Civic Centre are: King Edward VII Avenue, Museum Avenue, College Road, City Hall Road and Gorsedd Gardens Road.
- A network of public footpaths and cycle routes (including the Taff Trail) pass through the area and provide access to North Road and Blackweir in the north, Senghennydd Road in the east, the city centre in the south and Sophia Gardens in the west. Some routes are restricted to park opening hours.
- There are three pedestrian underpasses that link the Civic Centre to: Bute Park (North Road Underpass), Cardiff Castle (Kingsway Underpass) and the city centre (Boulevard de Nantes Underpass).
- A water taxi landing stage at Bute Park provides access to Cardiff Bay.

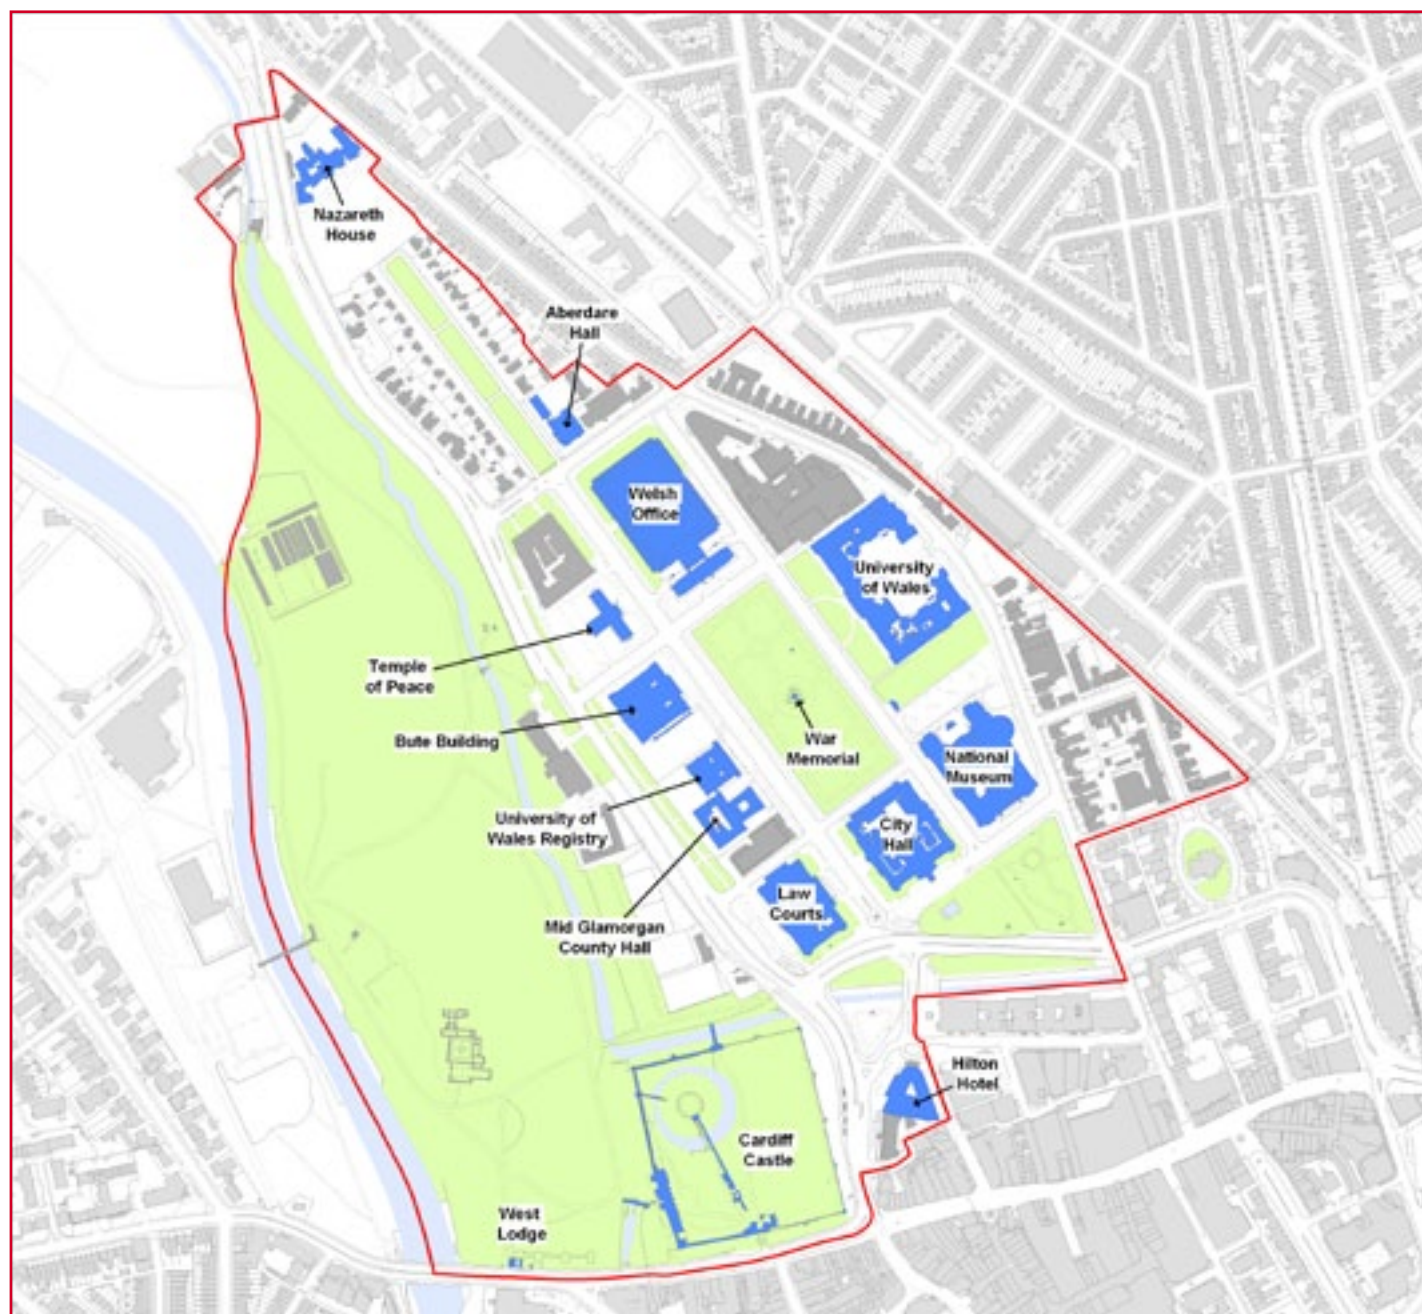
Map 4: Landmark Buildings

Whilst many buildings within the Conservation Area can be identified as having these qualities to some degree, several buildings exhibit them to a greater degree than others; it is these buildings that have been identified as Landmark Buildings and are briefly described below. These structures are generally of the highest architectural quality within the Conservation Area.

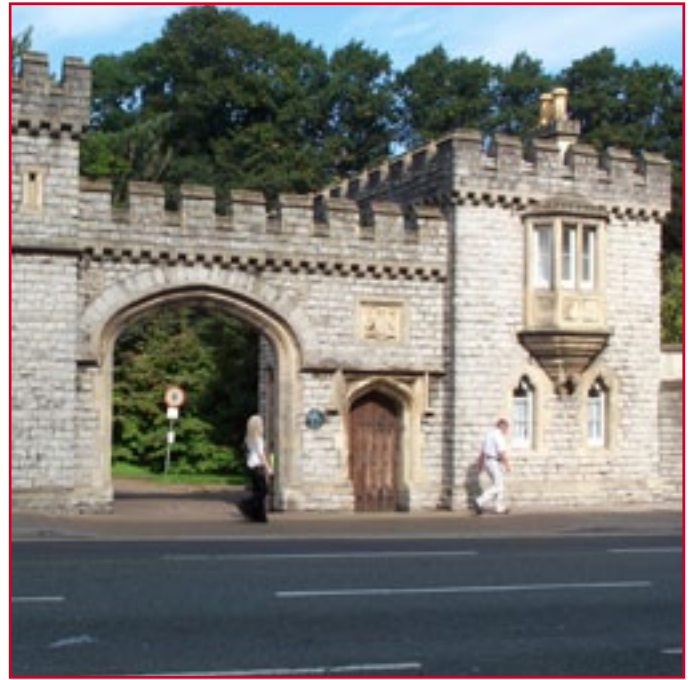
### Cardiff Castle:

The south west face of the castle is dominated by the array of towers created by William Burges for the 3rd Marquis of Bute.

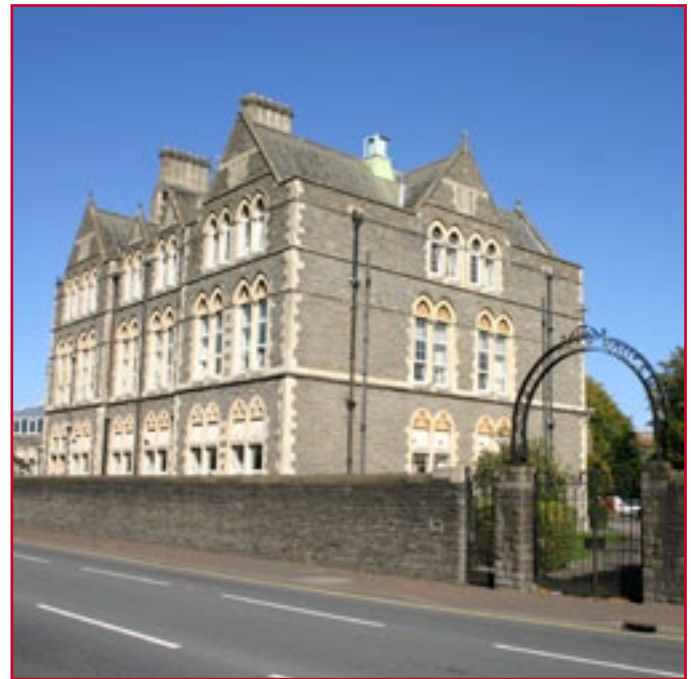
### Nazareth House:

Built in 1875 by John Prichard for the 3rd Marquis of Bute as an orphanage. Pennant with Bathstone dressings create a strong gothic character for this substantial building.

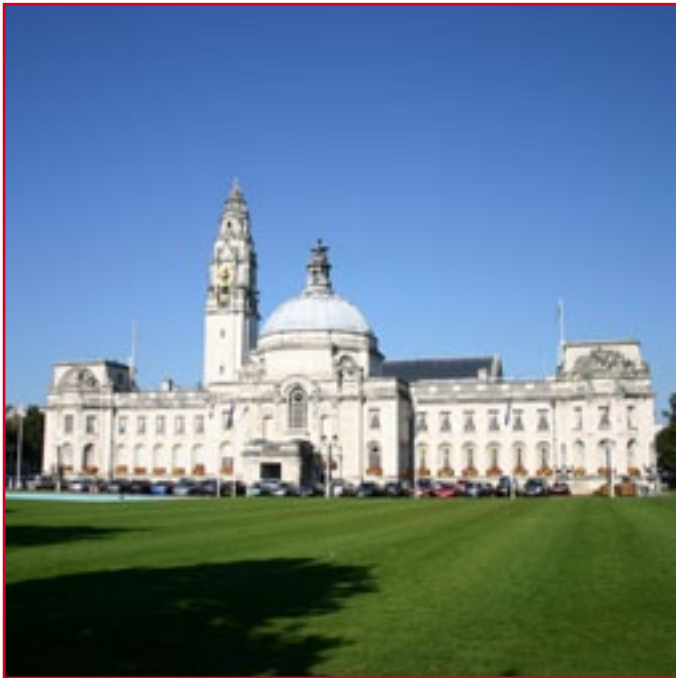
### City Hall:

Faced in Portland stone, City Hall (formerly Town Hall) with its tower and dome is a flamboyant city landmark and symbol of Cardiff's confidence at the beginning of the 20th century. Designed by Lanchester, Stewart & Rickards. Built 1901-04.

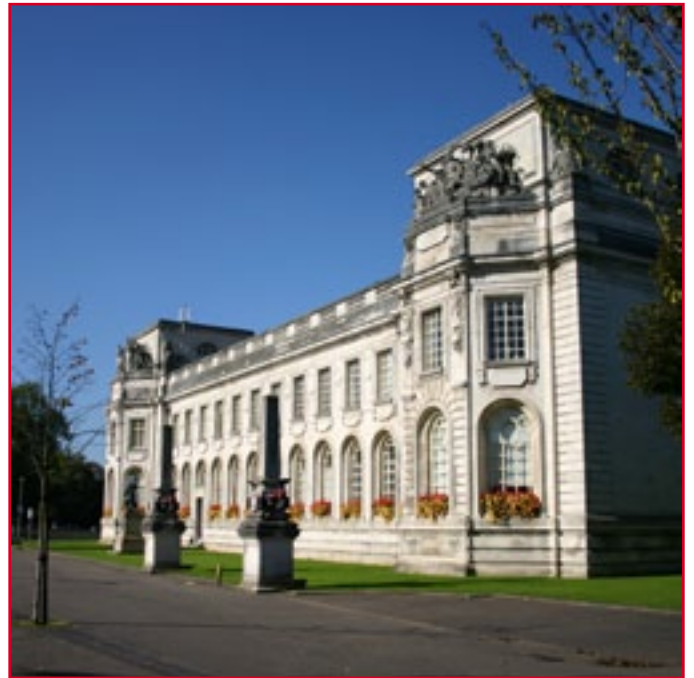
### Law Courts:

A two storey quadrangular building in a Baroque style, faced in Portland stone and heavily decorated with moulded architraves and monumental figures on top of its corner bays. Designed by Lanchester, Stewart & Rickards. Built 1901-04.

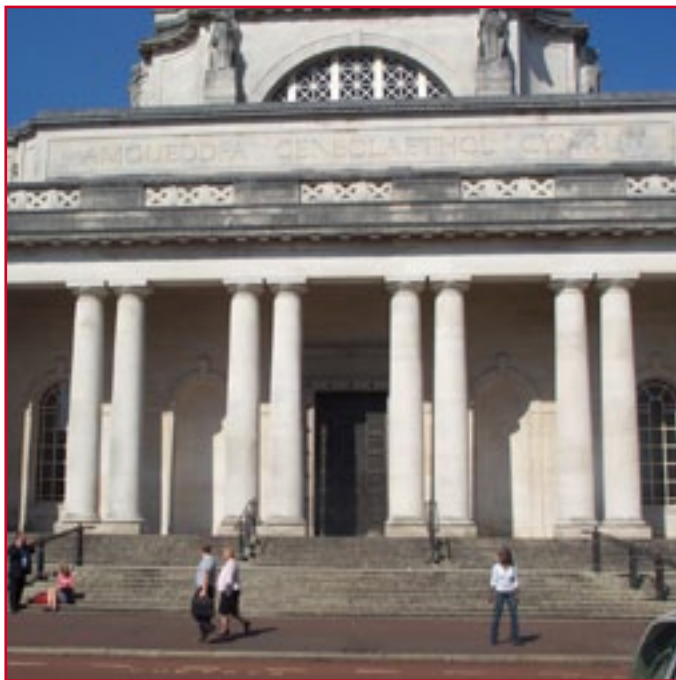
### The National Museum of Wales

presents a powerful frontage to Gorsedd Gardens, with an expansive flight of steps leading to a recessed Doric portico. Designed by Smith and Brewer. Built from 1910 onwards.

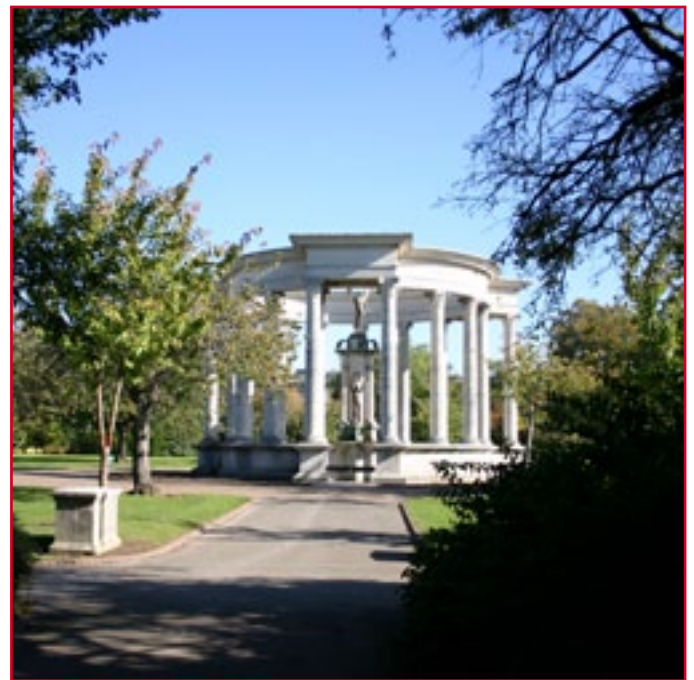
### The Welsh National War Memorial

is a restrained circular colonnade set around fountains and bronze figures. It is the centre point of the Civic Centre. Designed by Sir Ninian Comper. Built 1924-28.

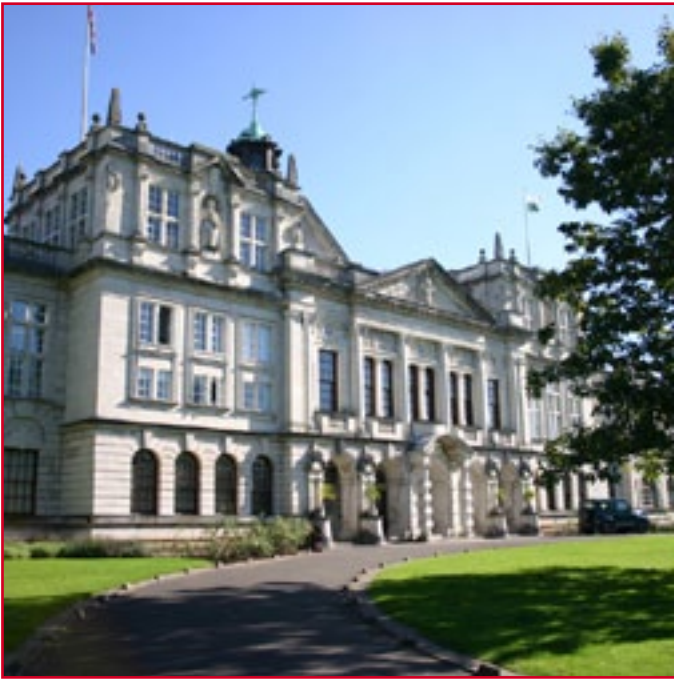
### University of Wales:

Started in 1903, but not completed till the 1960's, the University of Wales by W D Caroe is built in the style of Wren, using a wealth of classical references on its western Museum Avenue elevation.

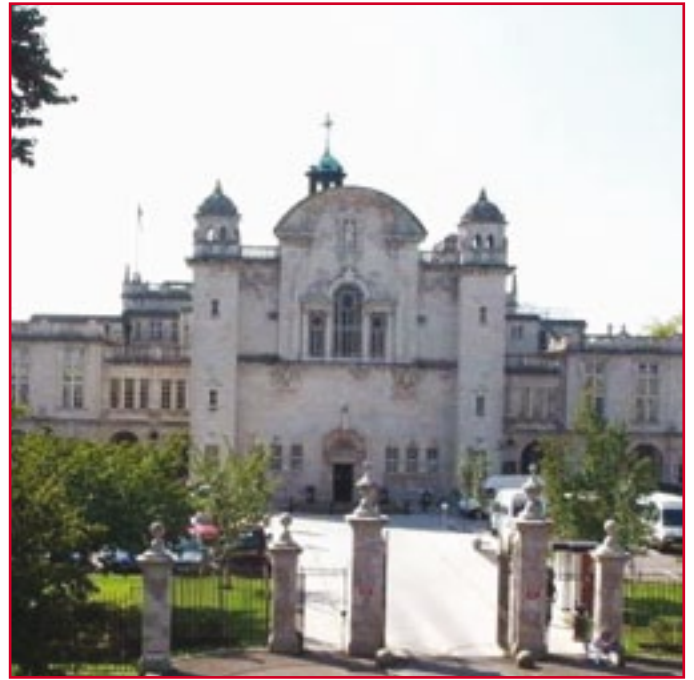
### University of Wales:

The Park Place façade of the university building is plainer though its central library with side towers and circular pediment presents a striking frontage to the eastern quadrangle.

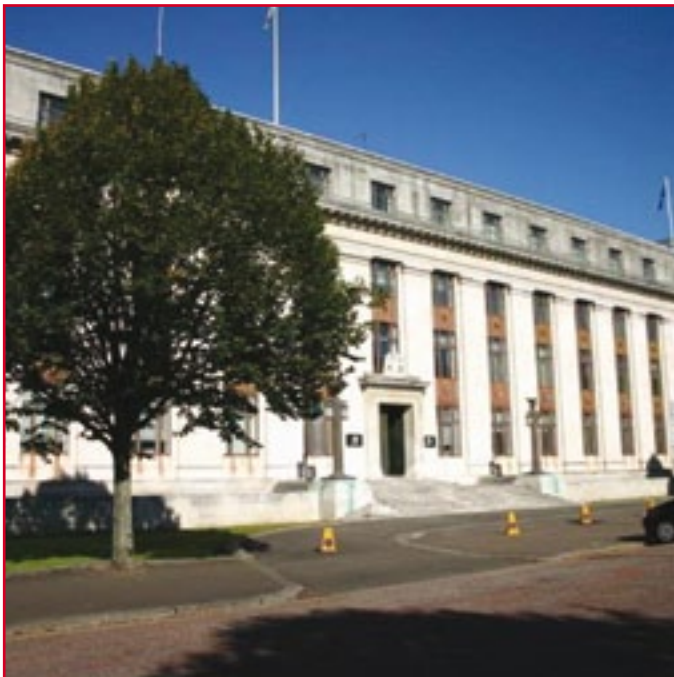
### Welsh Office:

The 1930's front block to the Welsh Office is faced in Portland stone and is an important part of the building composition around Alexandra Gardens. Designed by P.K. Hanton. Built 1934-38.

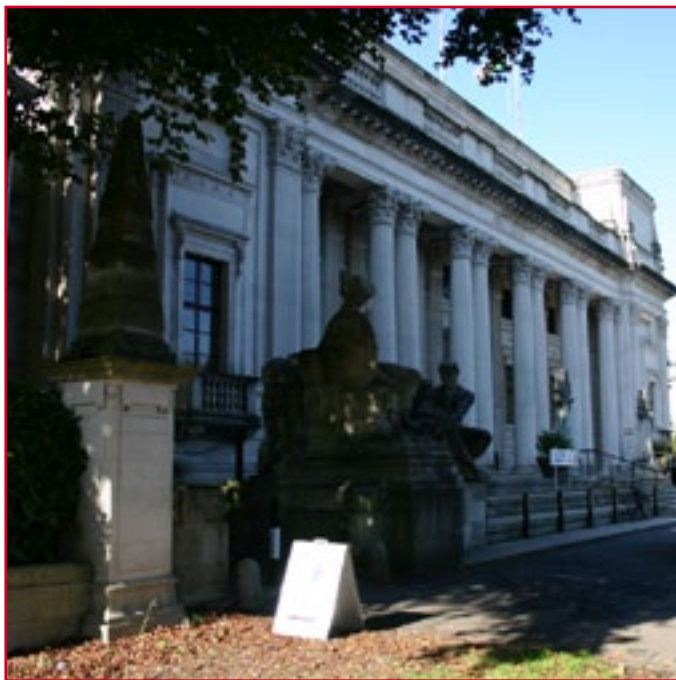
### The Temple of Peace

was built between 1937 and 1938 and designed by Percy Thomas who used Portland stone to create a building of classical proportions but with little decoration.

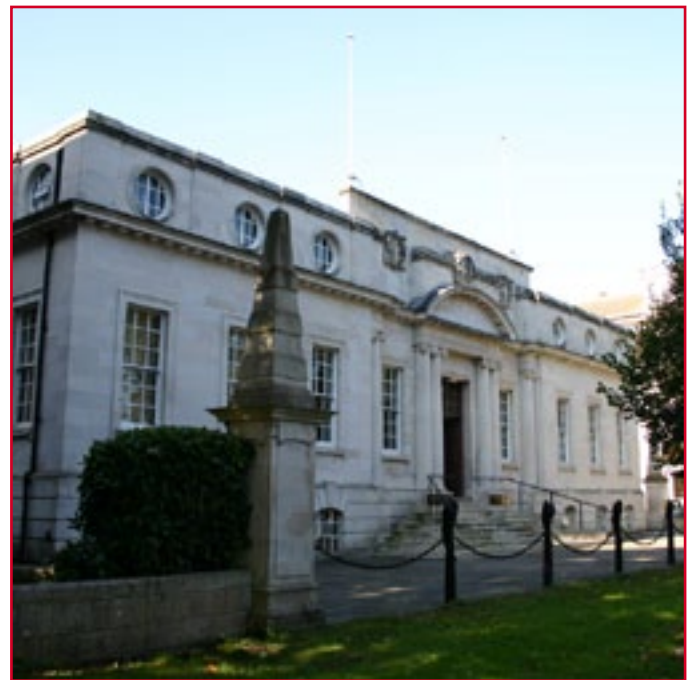
### The former Glamorgan County Hall

is built in a beaux arts classical style. The steps and sculpture to either side present a gracious face to the Civic Centre. Designed by E.V. Harris and T.A. Moodie. Built 1908-1912.

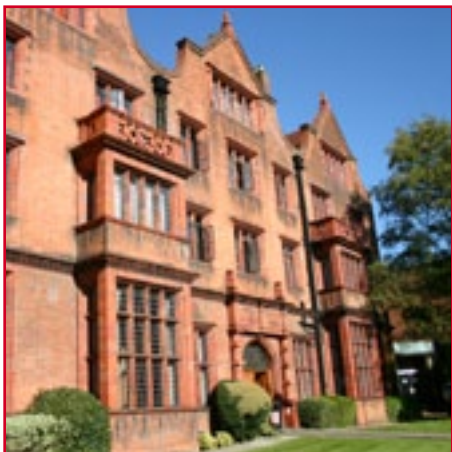
Aberdare Hall: Brick with terracotta dressings with a strong Jacobean character.

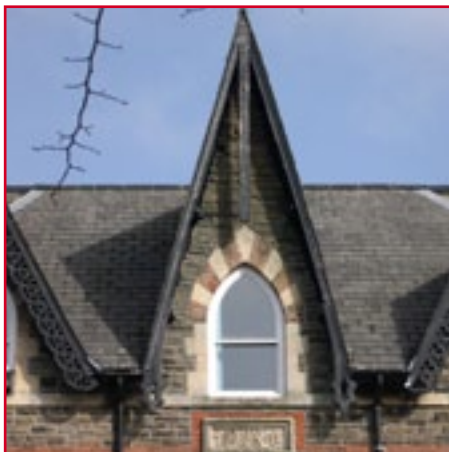
Brick and stone is used to decorative effect around this gabled dormer on Park Place

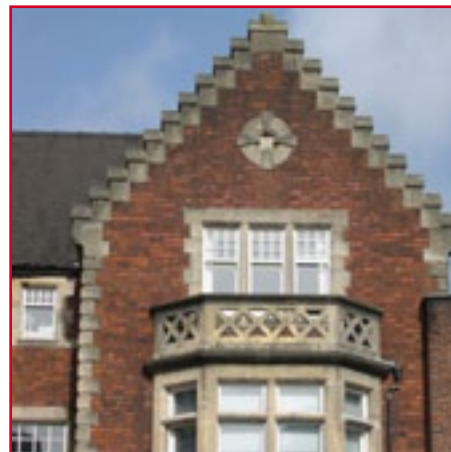
Gables with bays are common on Park Place. This later brick one uses a crop stepped gable edge.

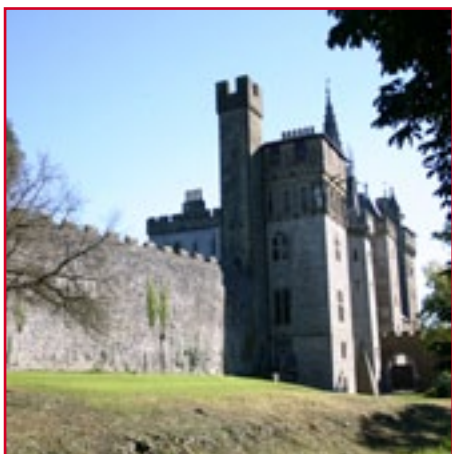
Fantasy towers and spires piled up on the castle's south west corner.

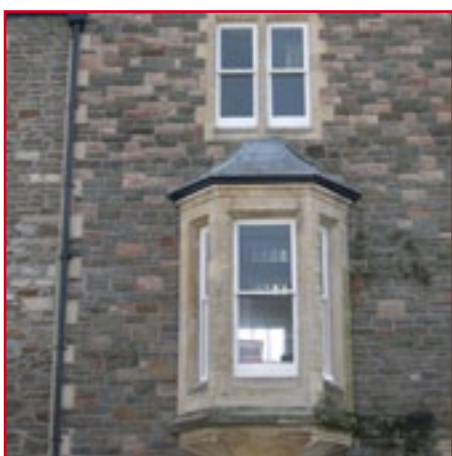
34 Park Place, a bath stone oriel window overlooks Museum Place.

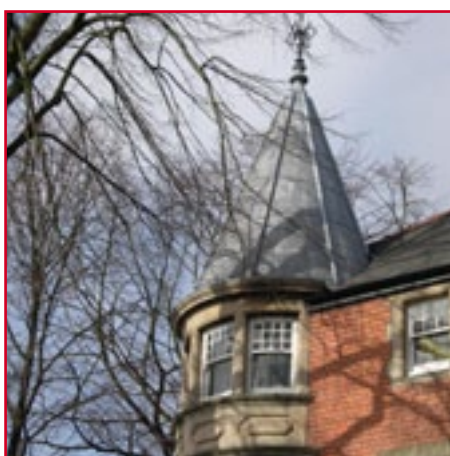
A lead covered turret turns the corner on Park Place.

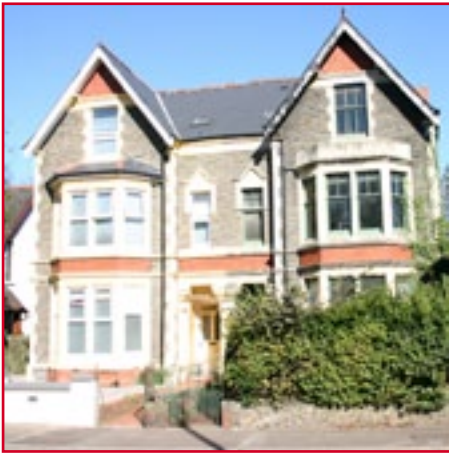
Semi detached houses on North Road.

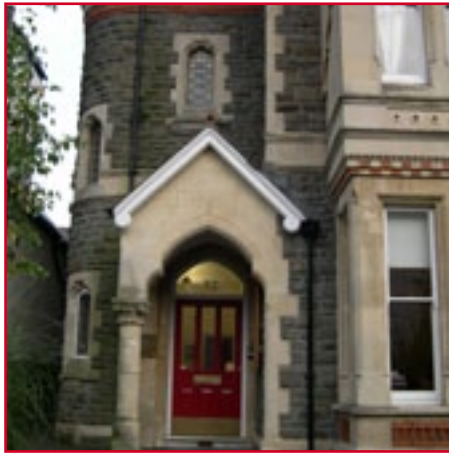
A bath stone porch on Park Place with pennant stone behind.

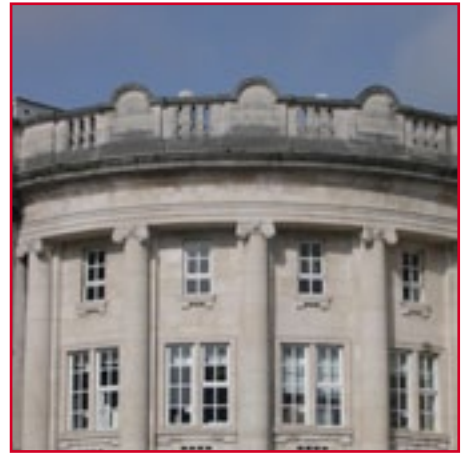
Convex projections define the corners of the University Quad.

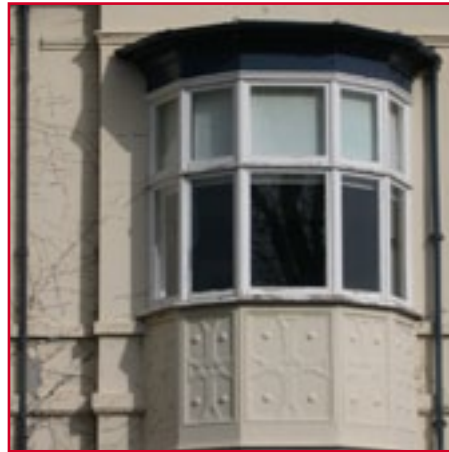
A mid 19th C stuccoed bay with decorative finish.

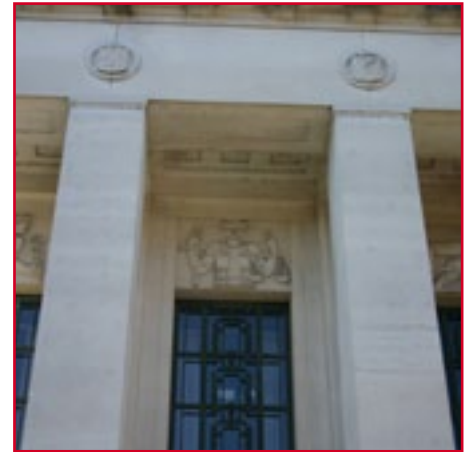
Tall bronze windows lie behind 4 square pillars at the Temple of Peace.

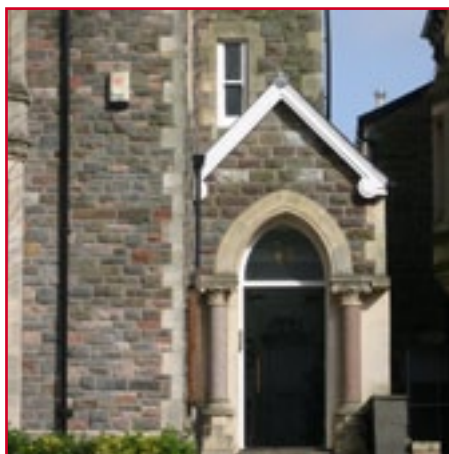
A gothic arched doorway at Park Place.

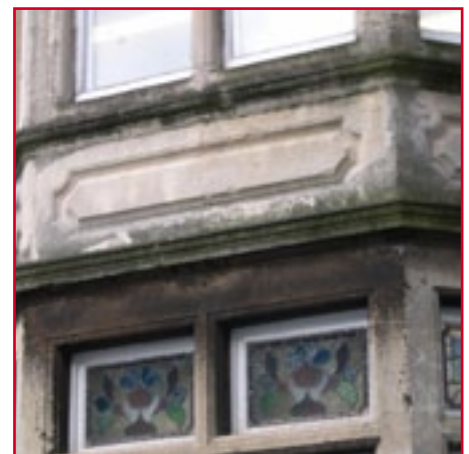
Leaded lights within a stone bay.

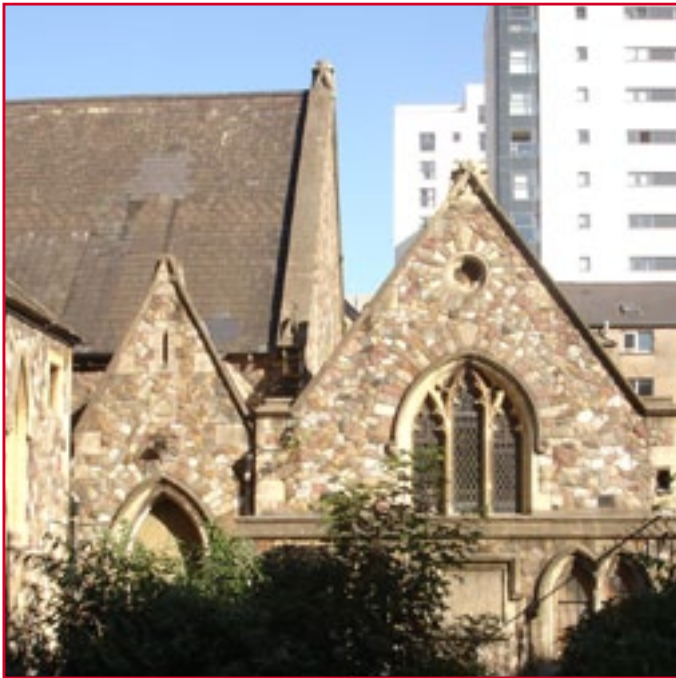
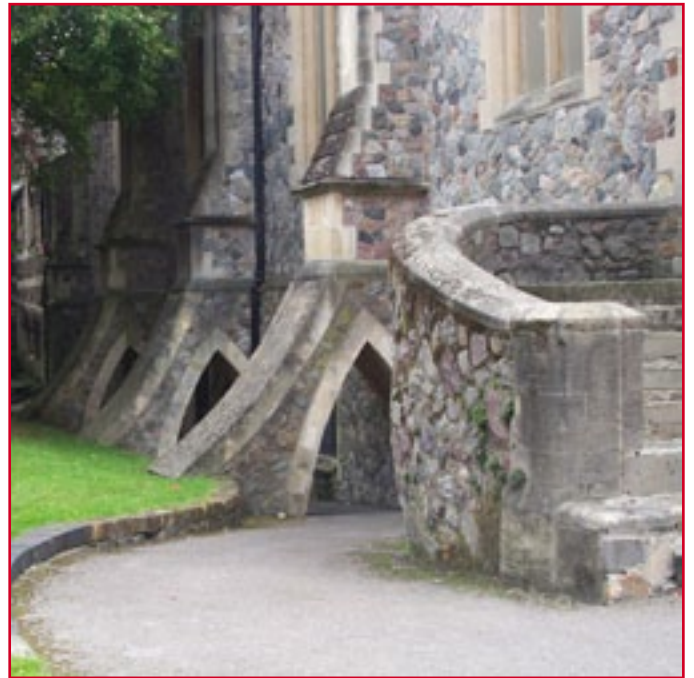
### Ebeneser Chapel, School Room and Boundary Wall (29 Charles Street)

Designed by R. G. Thomas of Newport, Ebeneser Chapel was opened in 1855. It is built in a Gothic style and faced in multi-coloured rubble with Bathstone dressings and details. The building is notable for its arched buttresses at ground level and the impressive wrought iron decorative hinges on its doors. The School House to the rear and its enclosing boundary wall are built in a similar style. The grassy banks within which the church is set create an attractive setting for the church, its colourful stonework and supporting buttresses.

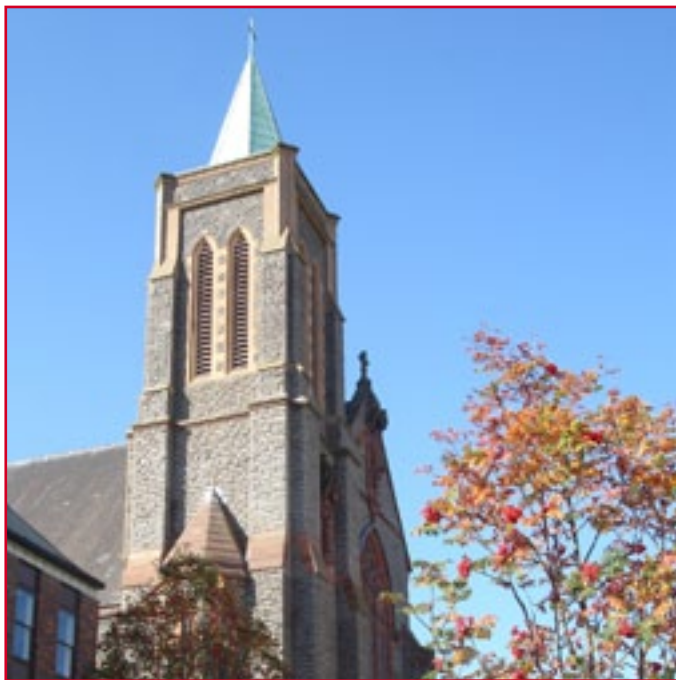
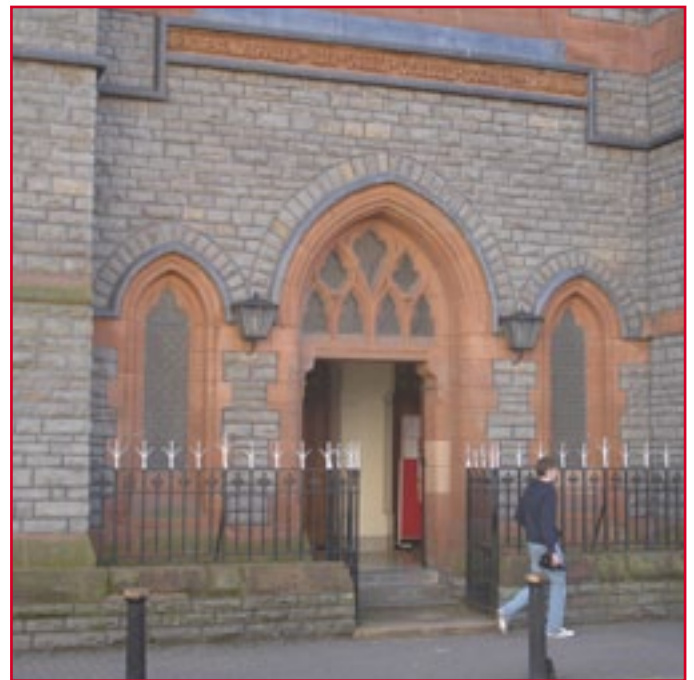
### St. David's Roman Catholic Cathedral (36 Charles Street)

This was built in 1884-1887 by the younger Pugin of Pugin & Pugin Architects as a Roman Catholic parish church. It was raised to cathedral status in 1920. It is constructed in rock faced Pennant with red sandstone dressings. Its towers and turrets were re-designed following bomb damage, the copper tower replacing the former bellcote. The stonework is crisp and of a high quality but has a sombre presence in the street scene.

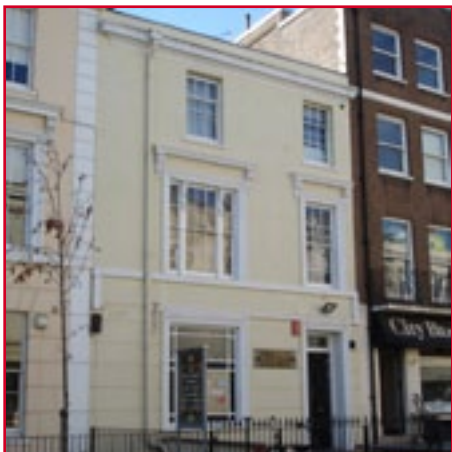
Rendered building with painted stucco detailing and sliding sash windows.

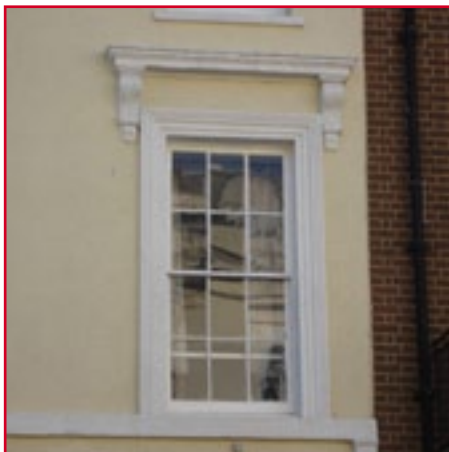
First floor 12 pane sash window with stucco architrave.

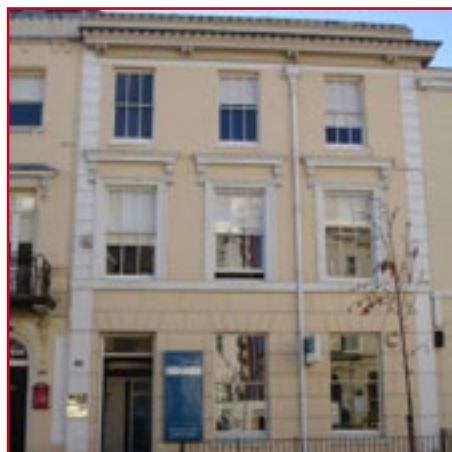
Windows in an Italian style with deep bracket cornice and banded pilasters.

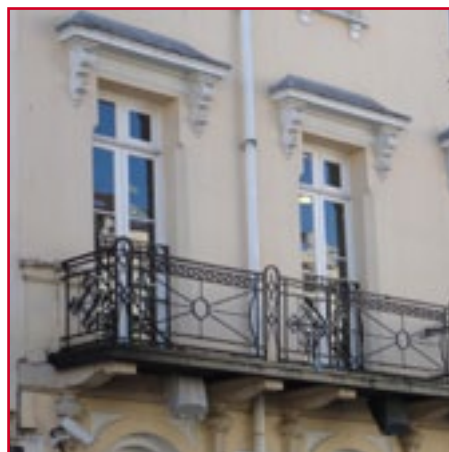
Wrought iron balcony across three door windows under bracketed cornices.

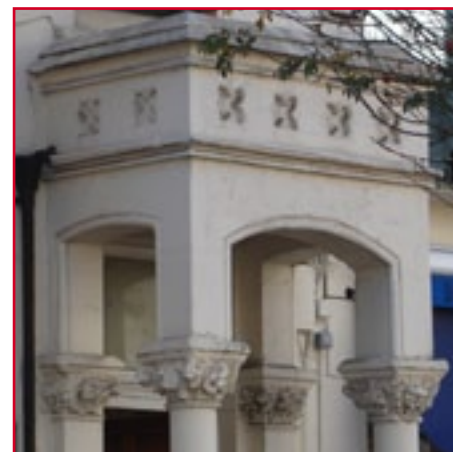
Open porch with quatrefoil banding and columns with annulets and foliage capitals.

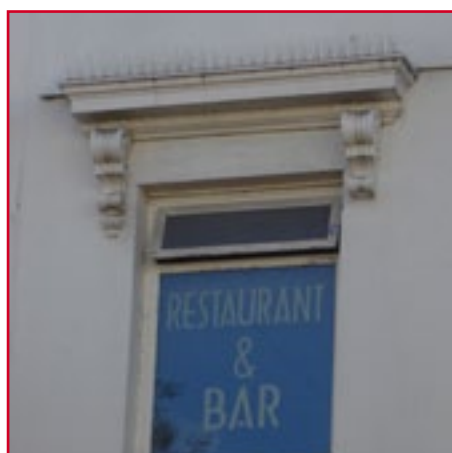
Bracketed cornice above window.

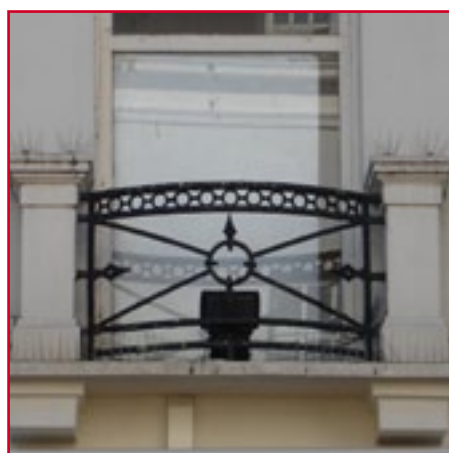
Convex iron frontal across first floor window.

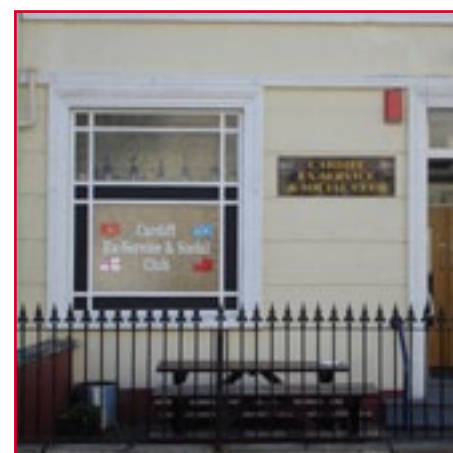
Iron railings at front of property.

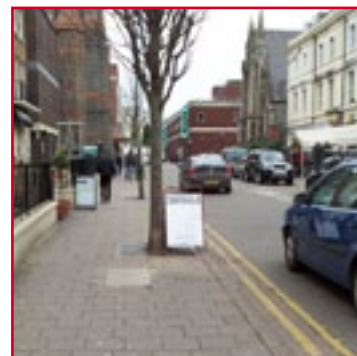
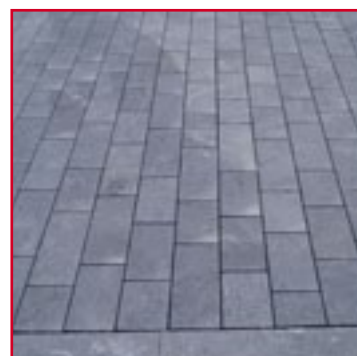
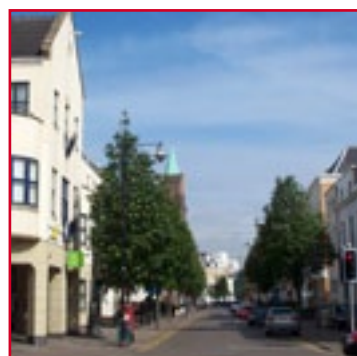
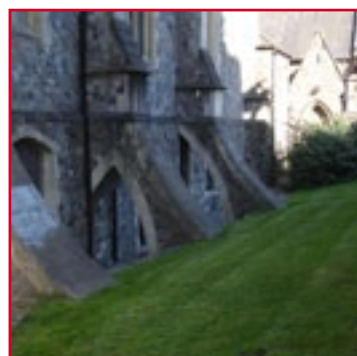
- Standard Pavements along Charles Street.
- New paving at Cathedral Walk.
- Trees contribute to the character of the area.
- Green space around Ebeneser Church.

The Street has been the subject of partial pedestrianisation. Within the Conservation Area traditional paving has been replaced with manmade, late twentieth century surface materials which are tired in appearance, the latter point highlighted by two recent public realm enhancement schemes immediately adjoining the Conservation Area both of which incorporate the use of natural materials.

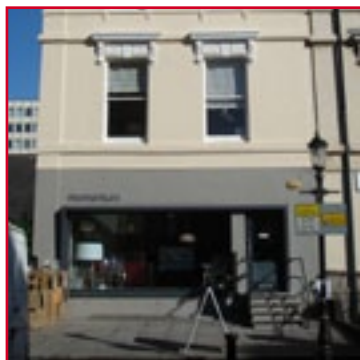
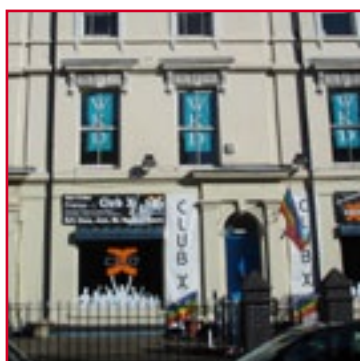
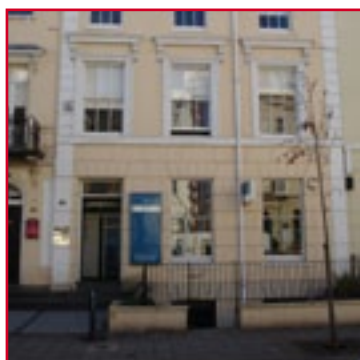
- Altered ground floor frontage.
- Dominant banners and window displays.
- Original building façade

- Commercial uses create a demand for signage to promote their presence; however, poorly designed signage can have a negative impact on the character and appearance of the building and the Conservation Area.

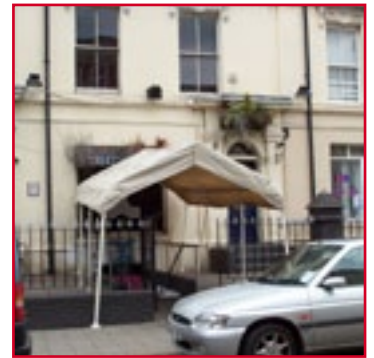
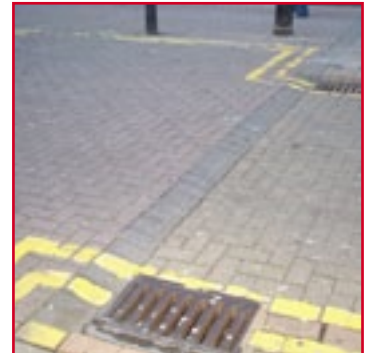
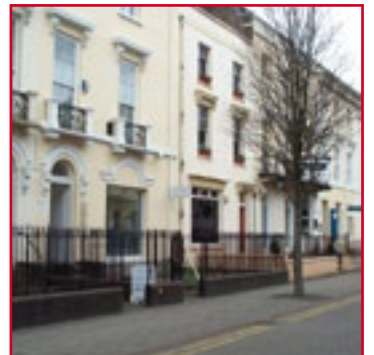
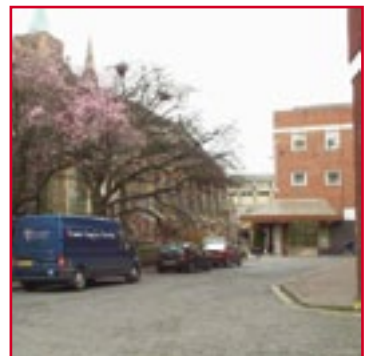
- Entrance canopy.
- Existing road materials.
- Paving lacks character.
- Road to the side of Ebeneser Church.

- Seek to enhance the public realm at the street's junction with Bridge Street to improve pedestrian priority, enhance views and aid legibility.
- Seek to retain and enhance the historic character of the street through reducing the impact of vehicles using the area.

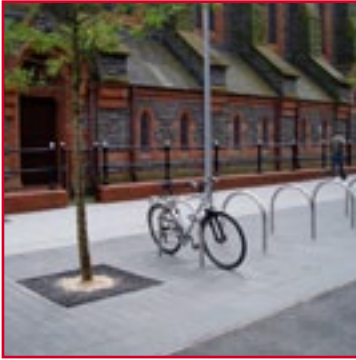
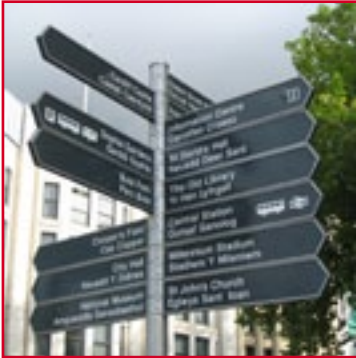
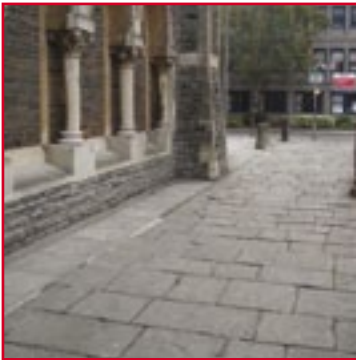
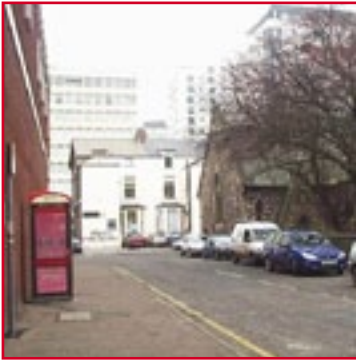
- Paving enhancements along Cathedral Walk.
- Pedestrian Signage at Queen Street.
- Historic Pennant Paving at Windsor Place.
- Public realm to the side of Ebeneser Church.

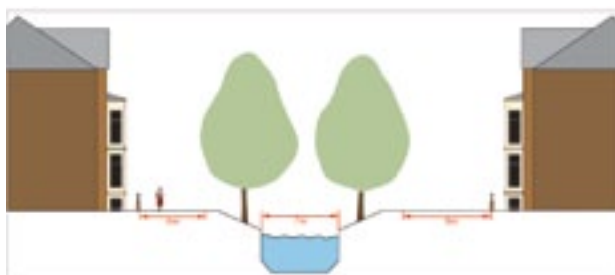
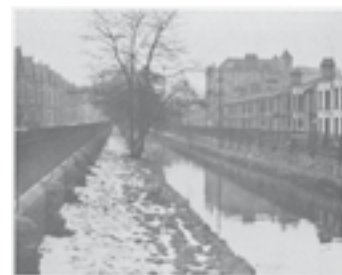
Churchill Way, Circa 1948

The scale of Churchill Way (some 33m wide) creates an imposing open streetscape. The former layout was dramatically different, with the open water of the East Bute Dock Feeder and its associated iron railings and planting running north to south along the length of the street. The present form of the street with two carriageways, parking areas and a central reservation has been in place since 1949 and forms an important and significant part of the City Centre streetscape.

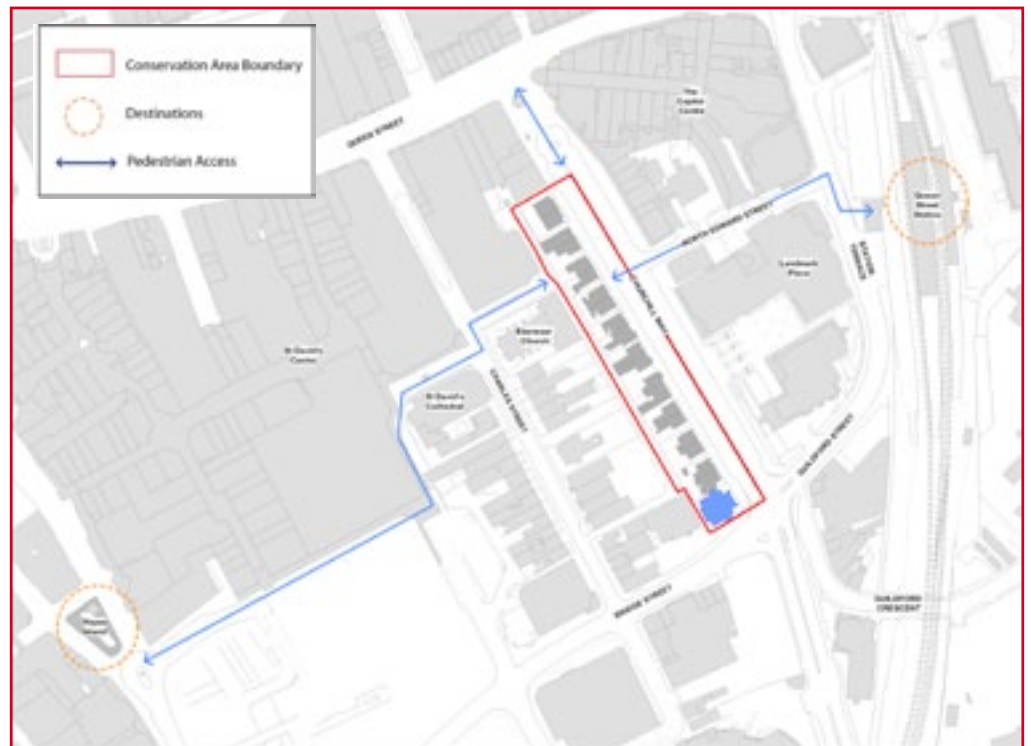
### Map 2: Movement

Whilst pedestrian movement is relatively easy with wide, if slightly cluttered, pavements, the layout of plots prevents any east-west pedestrian movement between Charles Street and Churchill Way.

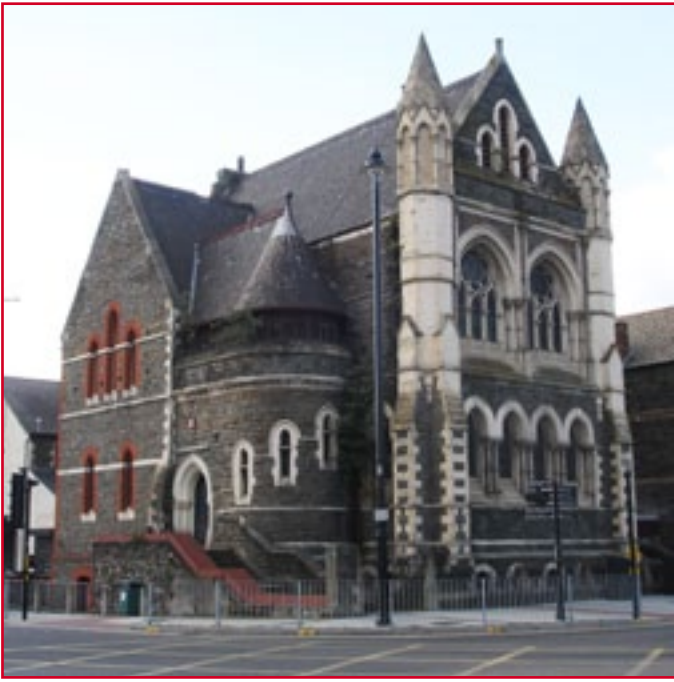
**The Former Welsh Presbyterian Chapel  
(46 Churchill Way)**

Built 1877 by architect Henry C. Harris as a Welsh Calvinistic Methodist Chapel in an Early French Gothic style, showing strong influences from the architect Williams Burges.

The architect has used Pennant stone in a French gothic style; towers, turrets and decorative stair towers rise above a basement area.
