# CARDIFF CITY CENTRE

## CONSERVATION AREA APPRAISALS

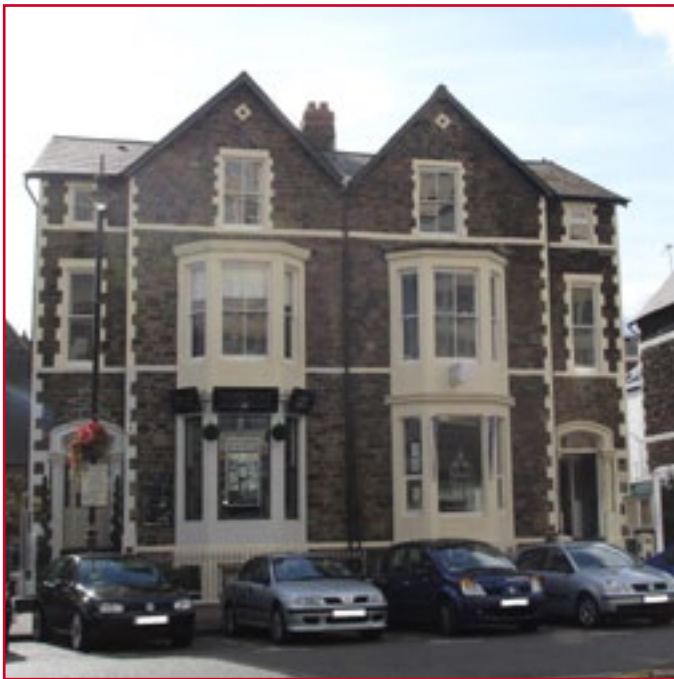
**Victorian Villas, 6 - 44 Churchill Way (Evens)**

Houses are faced in Pennant stone, patterned by Bath stone dressings in bays, gables and arched doorways.

Houses on Churchill Way are faced in hammer dressed Pennant stone, partnered by Bath stone dressings with canted bays, gothic style arches and gabled roofs. Whilst the overall style is the same between pairs, there are variations in the combination of architectural elements and detailing, especially on porches, gables and window bays.

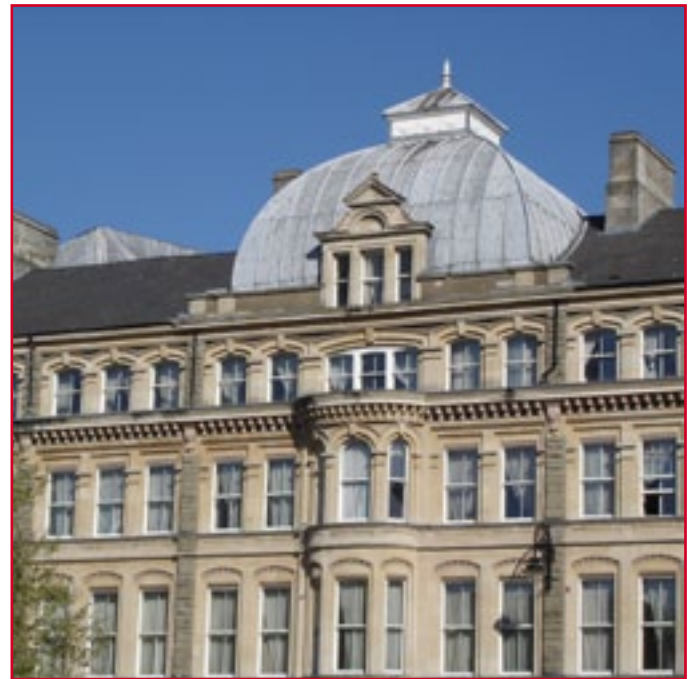
**Park Hotel, Park Place / Queen St**

Building dated 1884 featuring Forest of Dean sandstone (ground floor) and Pennant sandstone, Bath stone and terracotta (above). Listed as a well preserved French Renaissance style hotel by leading local architects. Of note: pavilion roof and decorative detail.

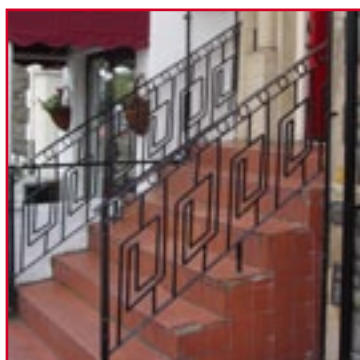
Whilst signage, extensions and alterations to boundary treatments have altered over time they have not until recently undermined the overall consistency of the group. Some modern signage on buildings and at street level is inappropriate to the style of building and creates an impression of unnecessary clutter.

The street frontages (steps and forecourts) of some properties have been effectively restored with appropriate tiling and replacement railings. Others are in a very poor state of repair; some front steps have lost their original balustrades and are often resurfaced in inappropriate period tiles or materials such as black slate. Security cages over some basement windows also detract from the quality of the townscape.

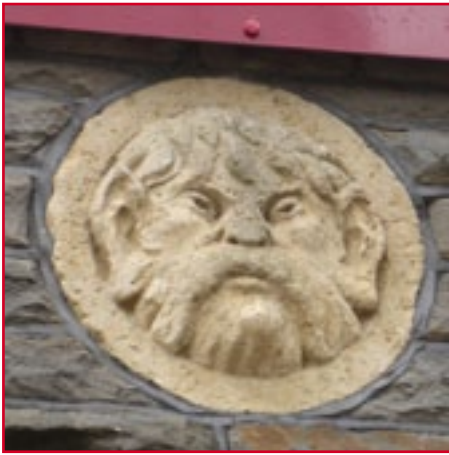
Many houses retain decorative stonework with a gothic influence.

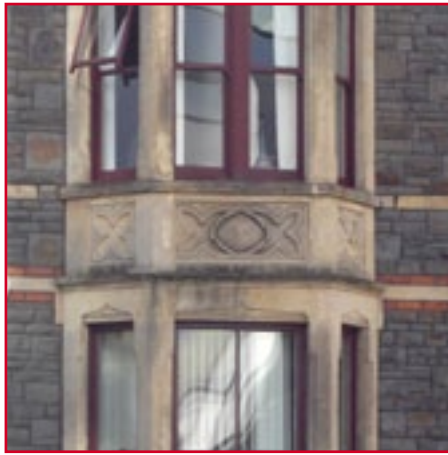
Bathstone bays with decorative panels.

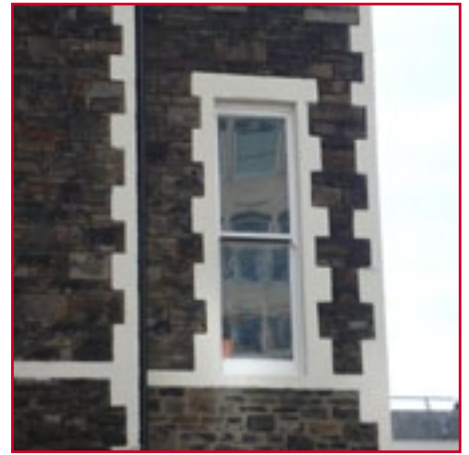
Painted Bathstone and hammer dressed Pennant stone.

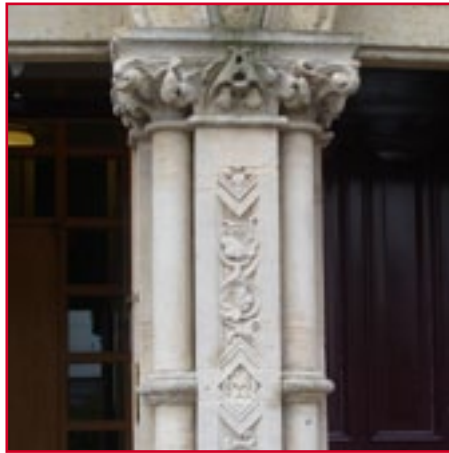
Carved Bathstone pillars support arched doorways.

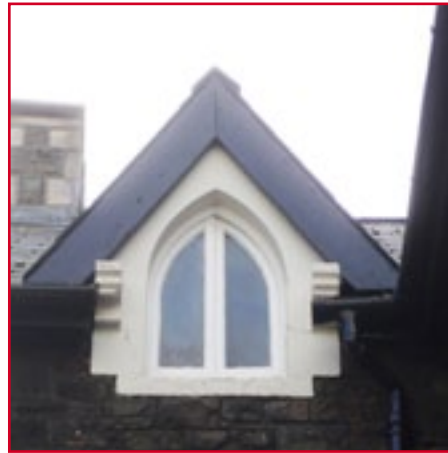
A Gothic revival Lancet style dormer window.

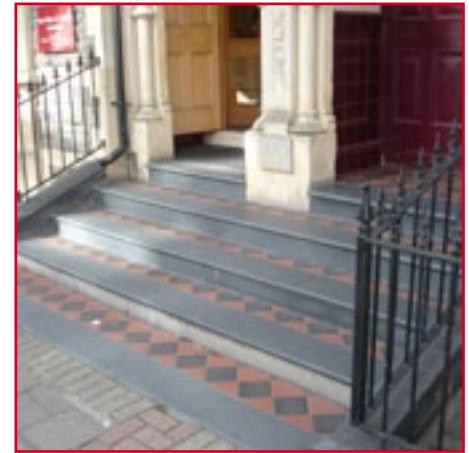
A modern restoration of tiled steps to a paired porch area.

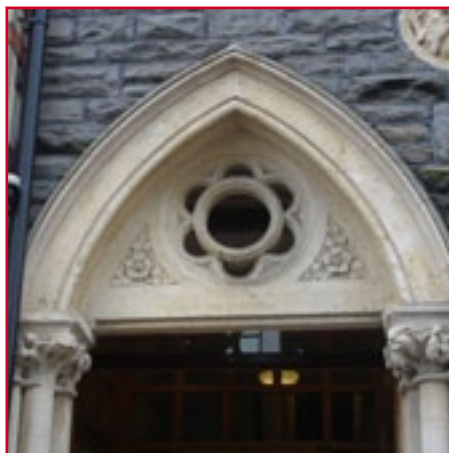
A door lintel, supported by capitals with decorative stonework above.

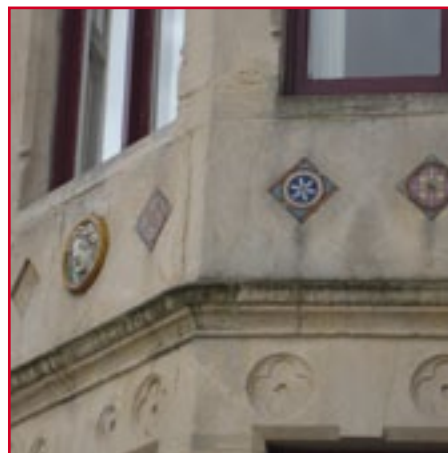
Window bay with Victorian appliqué decorative tile work.

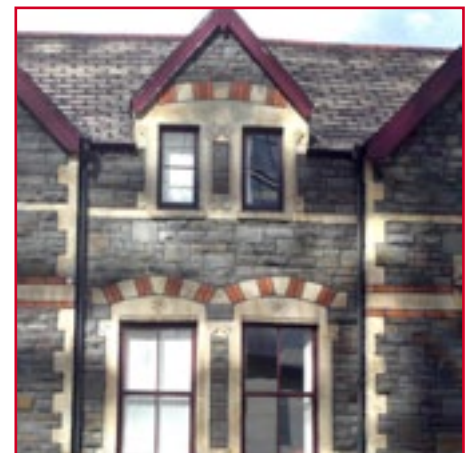
Double dormer with Bathstone and red brick decorations.

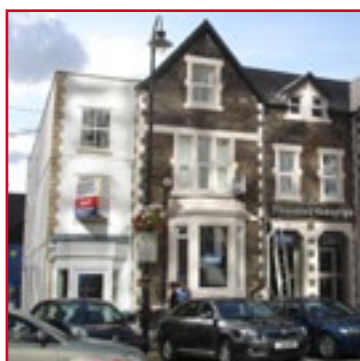
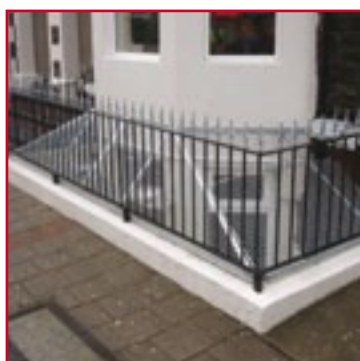
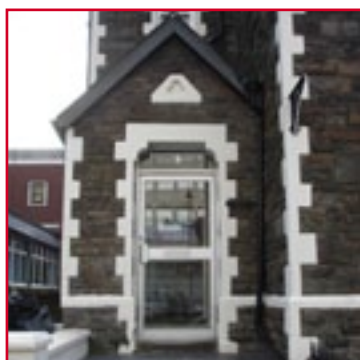
- Infill development between villas.
- Variety of forecourt boundary treatments.
- Loss of original detailing.

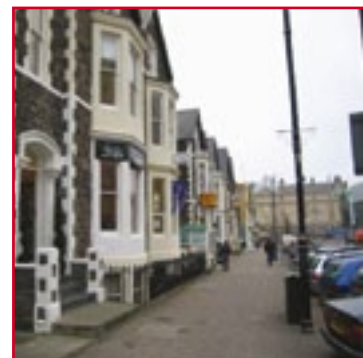
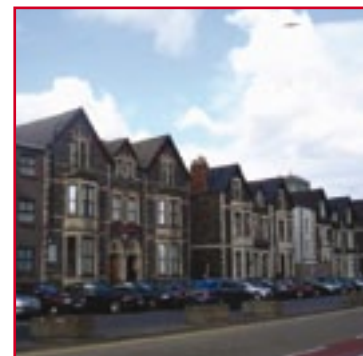
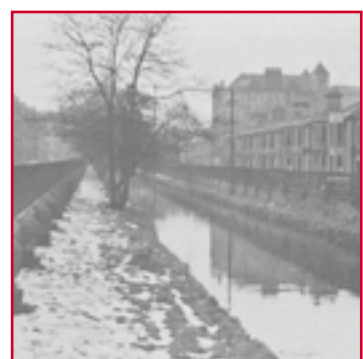
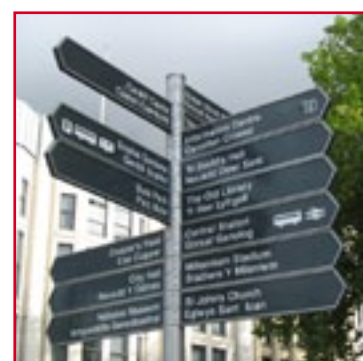
- Existing public realm along Churchill Way.
- On street parking throughout the area.
- No promotion of the path of the dock feeder.
- Pedestrian Signage at Queen Street.

- The use of standard pavements along the pavement does not promote or enhance the character of the Conservation Area.
- Wesley lane is in a poor condition with setts/cobbled surfaces patched or covered with other materials.
- Street furniture and signage is uncoordinated, poorly located and visually clutters the street.
- Car parking impacts on the character and appearance of the Conservation Area through the continuous presence of vehicles along the length of the street.
- The layout of car parking bays results in vehicles encroaching on the pavement.
- Scope exists for enhancement of the centre of Churchill Way. Design of the public realm makes little/no reference to the culverted dock feeder along the centre of Churchill Way.

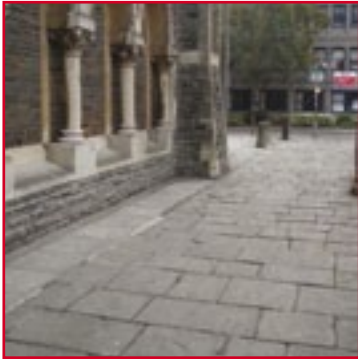
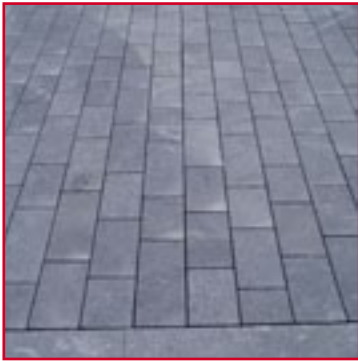
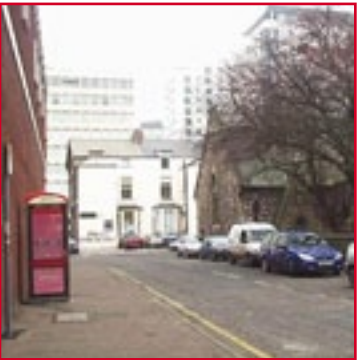
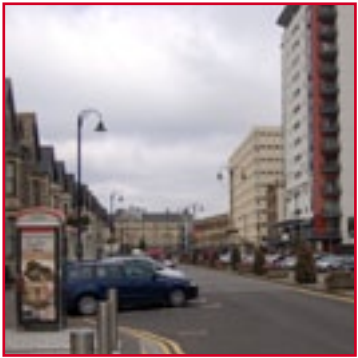
- Historic Pennant Paving at Windsor Place.
- New paving at Cathedral Walk.
- Public realm to the side of Ebeneser Church.
- The area lacks permanent 'greenery'.

- Encourage the use of high quality street furniture and natural paving materials, such as pennant paving, that contribute to and respect the character of the Conservation Area, its historic context and listed building. In the case of rear lanes, recognise the significance of original setts/cobbles and plan for their retention.

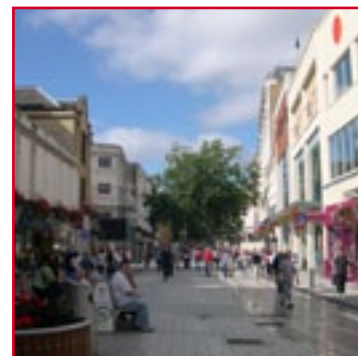
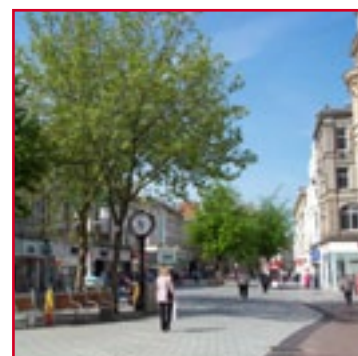
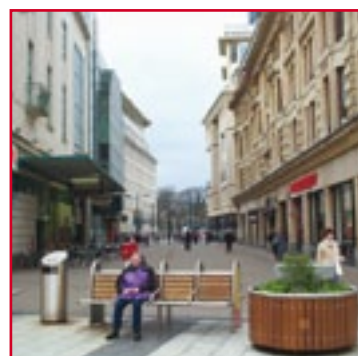
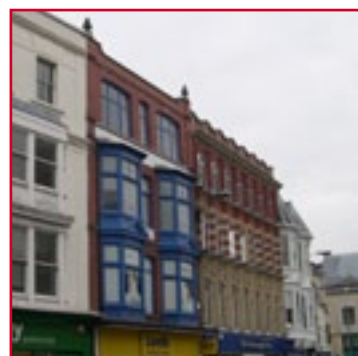
- Building heights and enclosure of the street.
- Queen Street public realm.
- Side Street (The Friary).
- Burgage plots (St Johns Street)

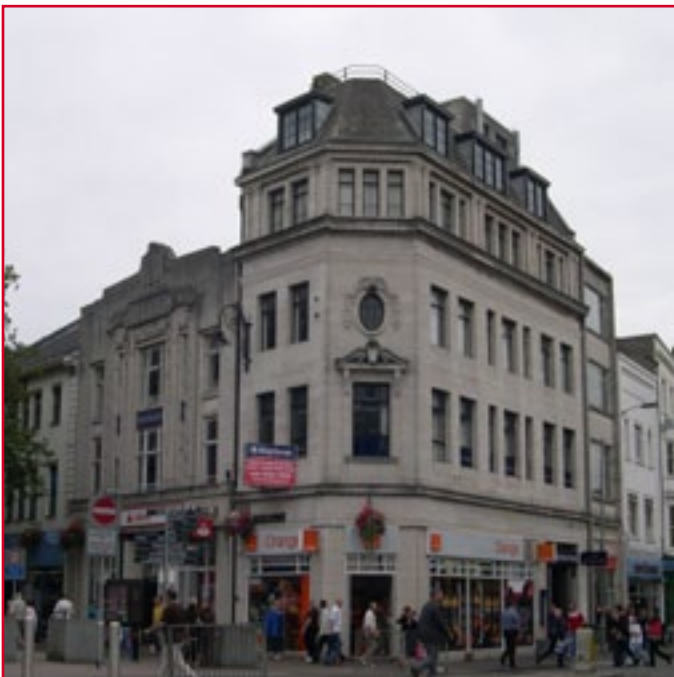
### 2 Queen St:

A locally listed prominent corner building of Portland stone: Of note: its decorative stonework on the corner flank.

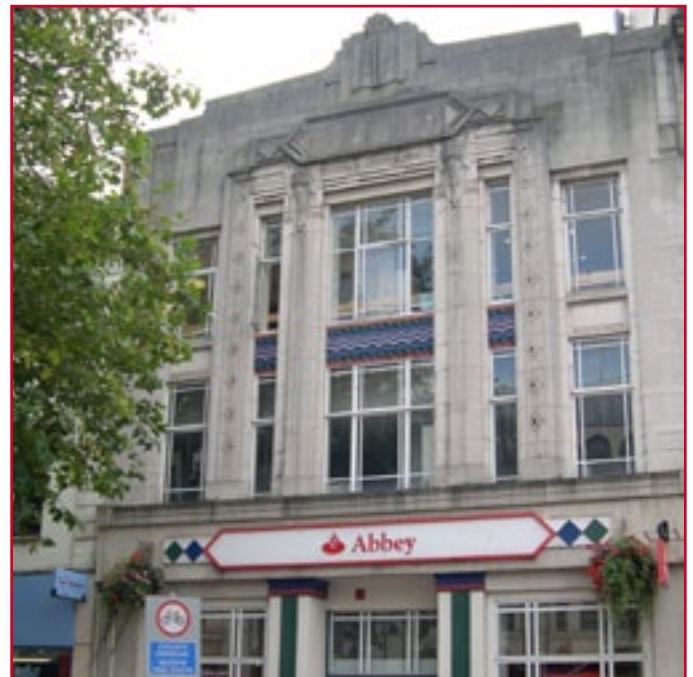
### 4-6 Queen St:

A locally listed stone faced Art Deco building. Of note: a large central window to each level, stepped roofline, decorative detail.

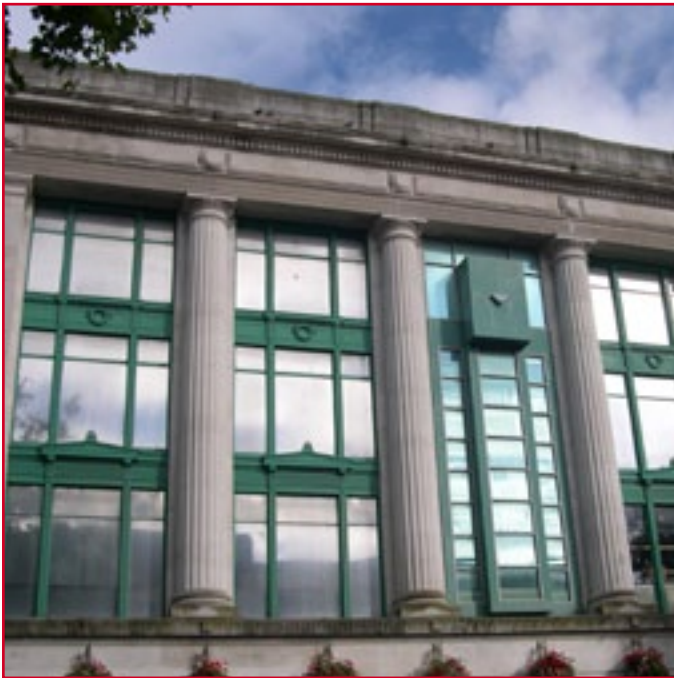
**Frontage of 11-13 Queen St:**

Interwar building of Portland stone listed as a fine classical department store front. Of note: columns and stone detailing.

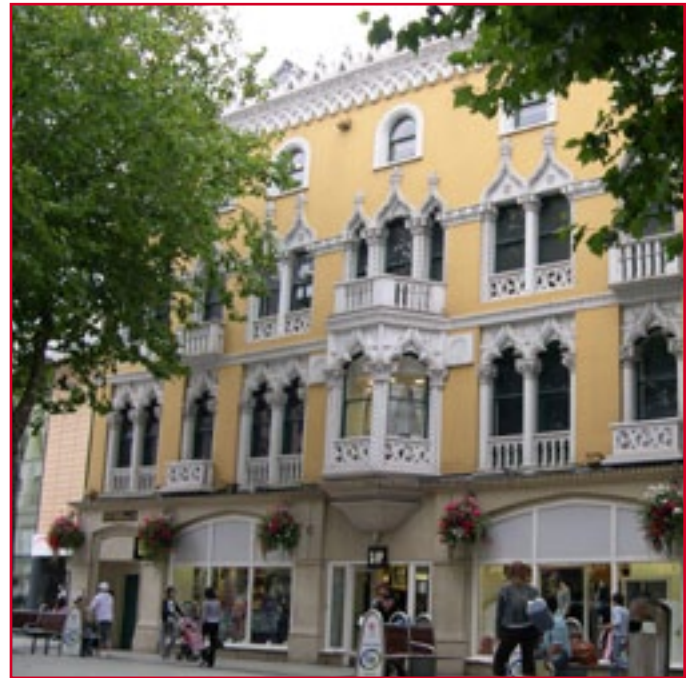
**Queen Street Chambers 24-26 Queen St:**

Built in 1878 of Portland stone and stucco and listed as a striking example of Venetian Gothic architecture. Of note: moulded ornamental features and window detail.

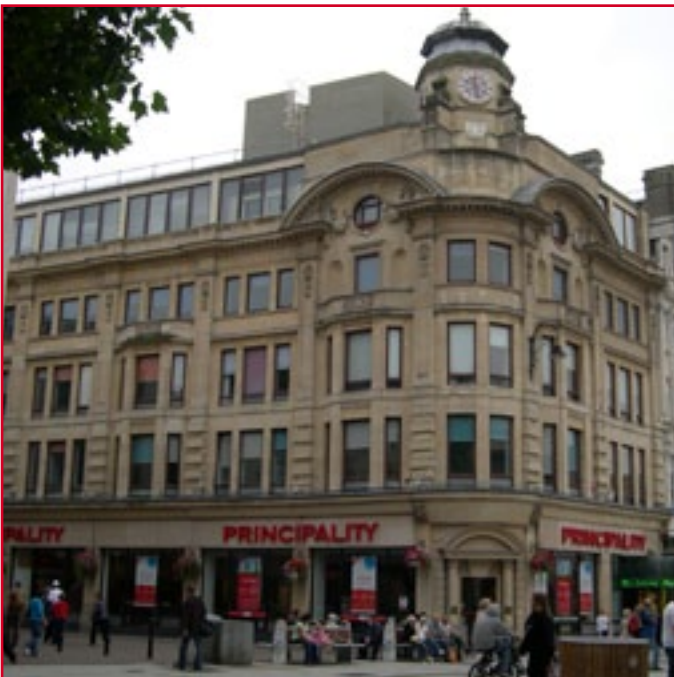
**Principality Buildings 29 Queen St:**

Built in 1914 of Ridge Park stone (a type of Bath stone) and featuring Cornish granite. A locally listed 5 storey building. Of note: clock tower, columned entrance, expanse of windows and decorative stonework.

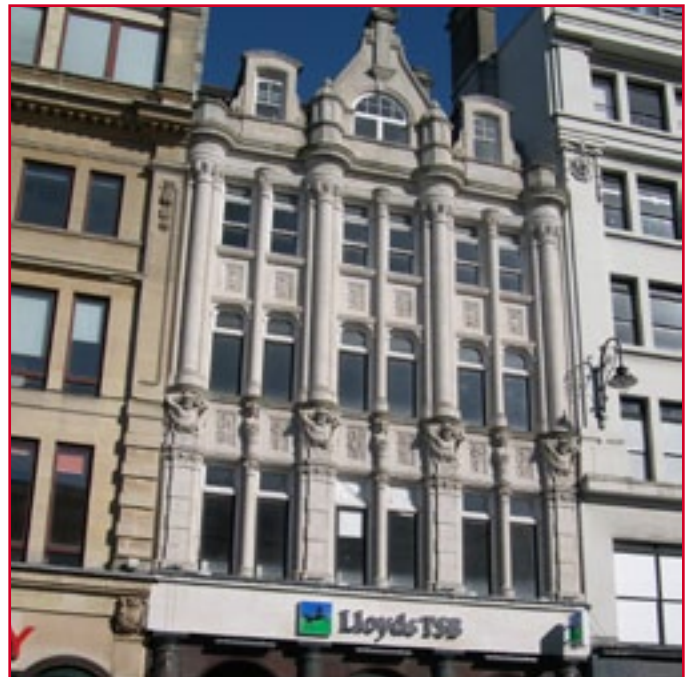
**Lloyds Bank, 31 Queen St:**

Portland stone, blue larvikite and red granite building listed as an elaborate late Victorian commercial building. Of note: panels between windows, a band of figures and variety of stone.

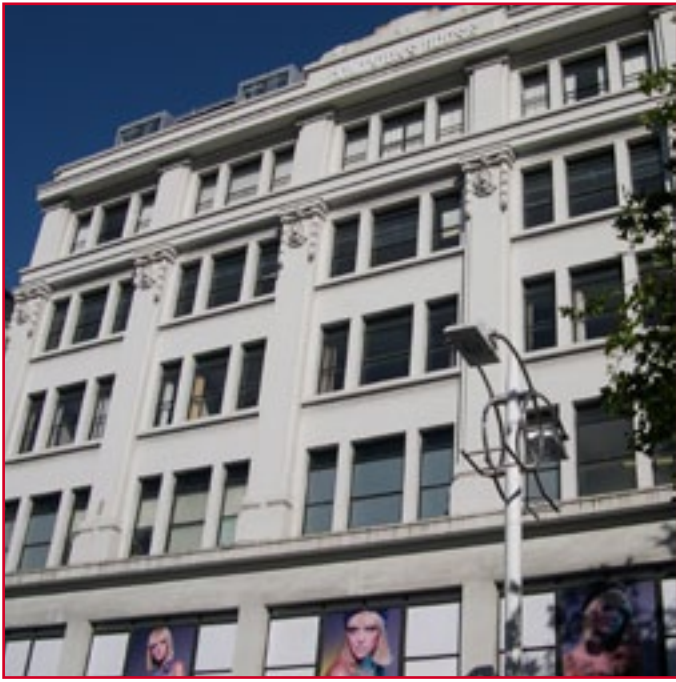
**Dominions House (Arcade) 33-39a Queen Street:**

1921 imposing 4 storey stone building accommodating an arcade of shops of appropriately styled shop fronts. Of note: arcade and lion head carvings.

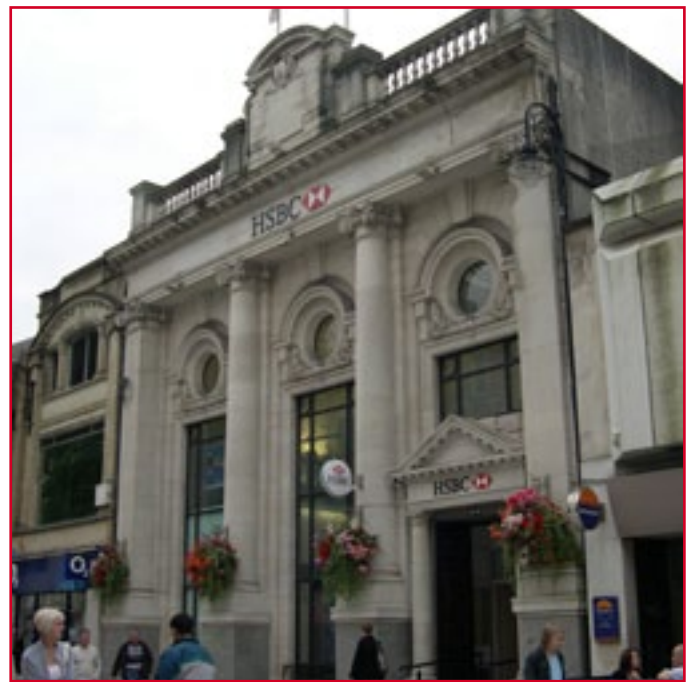
**HSBC 56-58 Queen St:**

Built in 1919 of Portland stone and grey Cornish granite; listed as a monumental commercial building from the height of Cardiff's commercial power. Of note: tall single storey classical building.

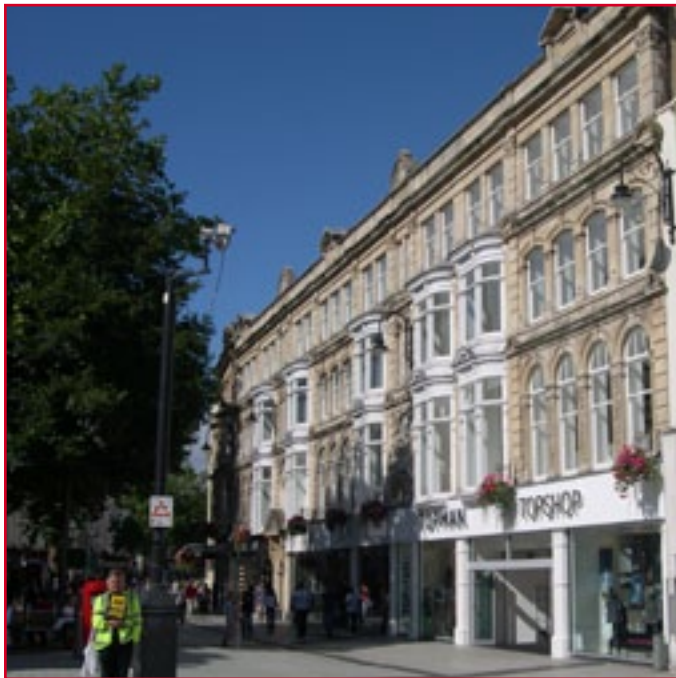
**Andrews Buildings 63 - 77 Queen St:**

Building dated 1896 faced in Bathstone listed for its extensive frontage and as an ambitious development of Solomon Andrews. Of note: oriel windows and stone detailing.

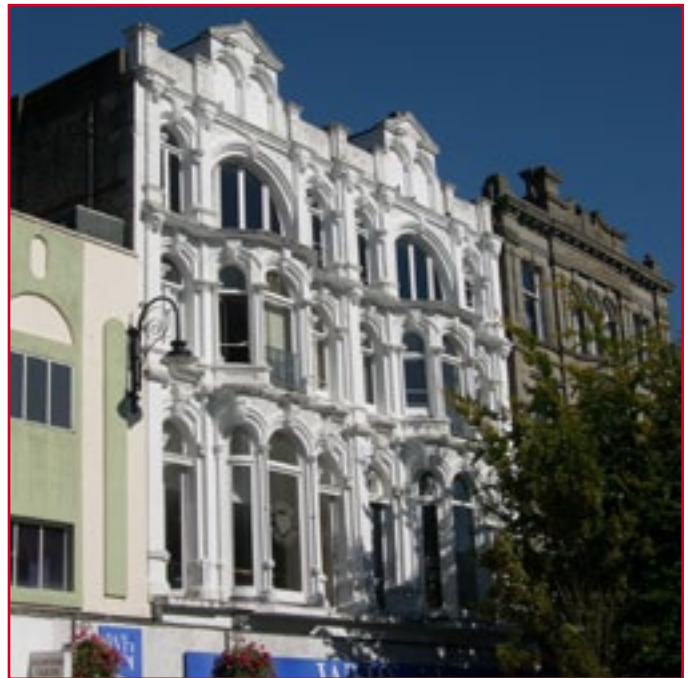
**83-85 Queen St:**

Built in 1885 of stone. A locally listed 4 storey building. Of note: bay windows and carved human heads.

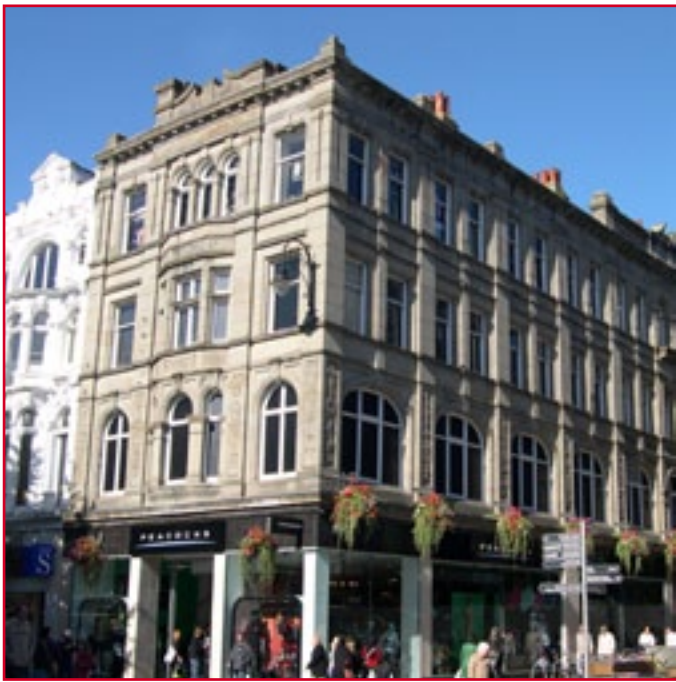
### 87 Queen St:

Built in 1899-1900 and faced with grey Forest of Dean sandstone. A locally listed 4 storey building. Of note: bay windows and vertical stone carved panels. Together with Royal Chambers it is an impressive corner building.

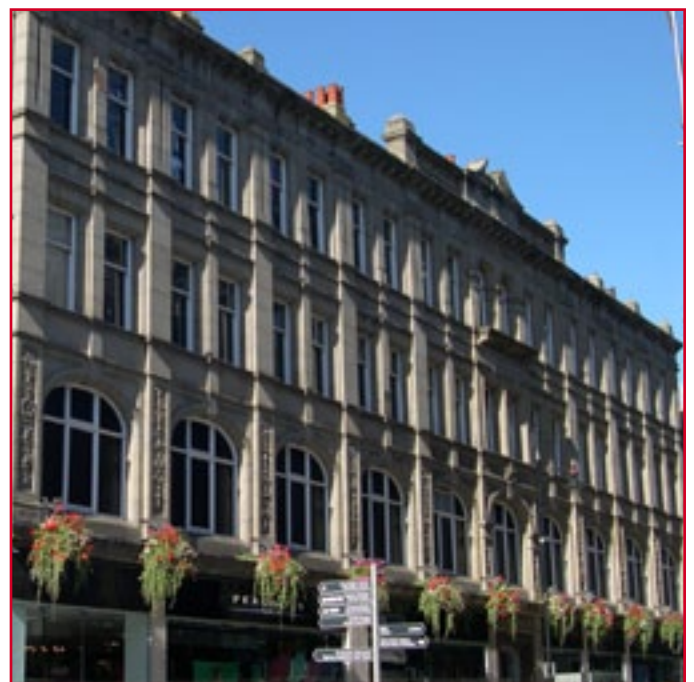
### 2-6 Royal Buildings

(Rest of 87 Queen Street), detailed opposite, known as Royal Chambers. Of note: Former entrance detailing and carved panels.

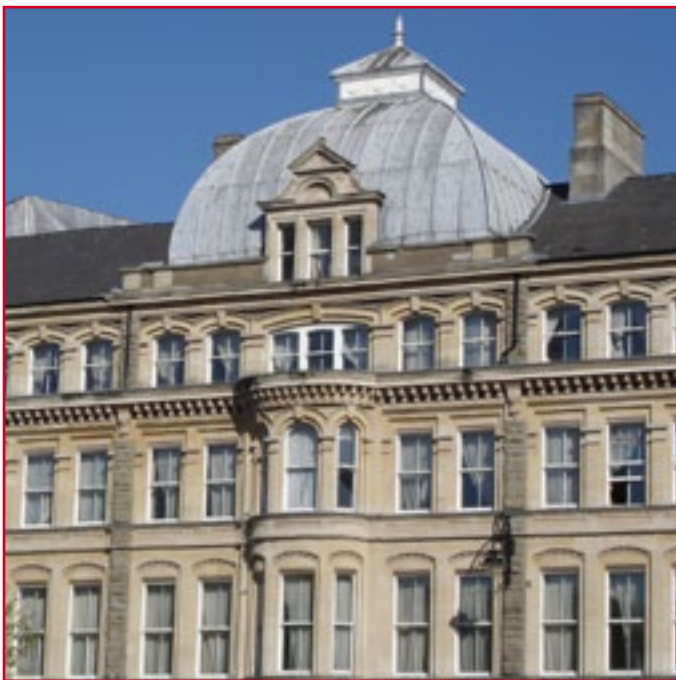
### Park Hotel, Park Place / Queen St:

Building dated 1884 featuring Forest of Dean sandstone (ground floor) and Pennant sandstone, Bath stone and terracotta (above). Listed as a well preserved French Renaissance style hotel by leading local architects. Of note: pavilion roof and decorative detail.

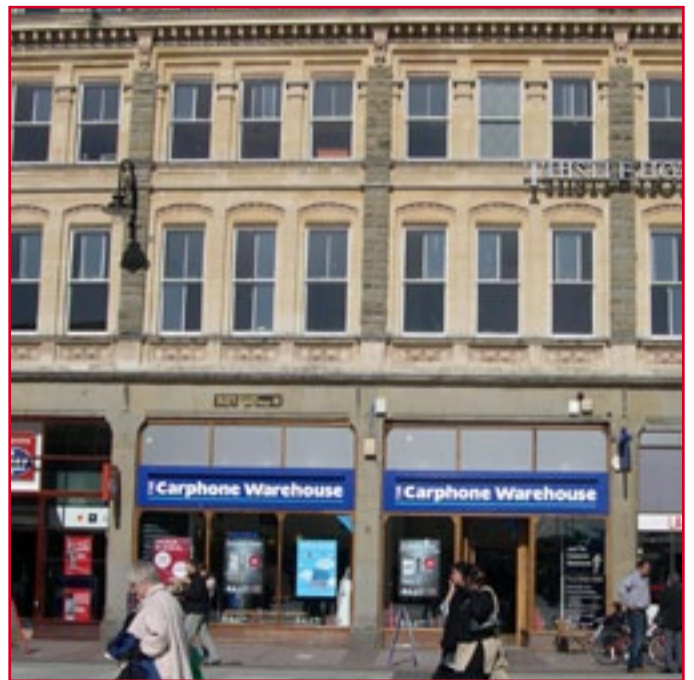
### Park Hotel Shops:

Listed as an integral part of the Park Hotel.

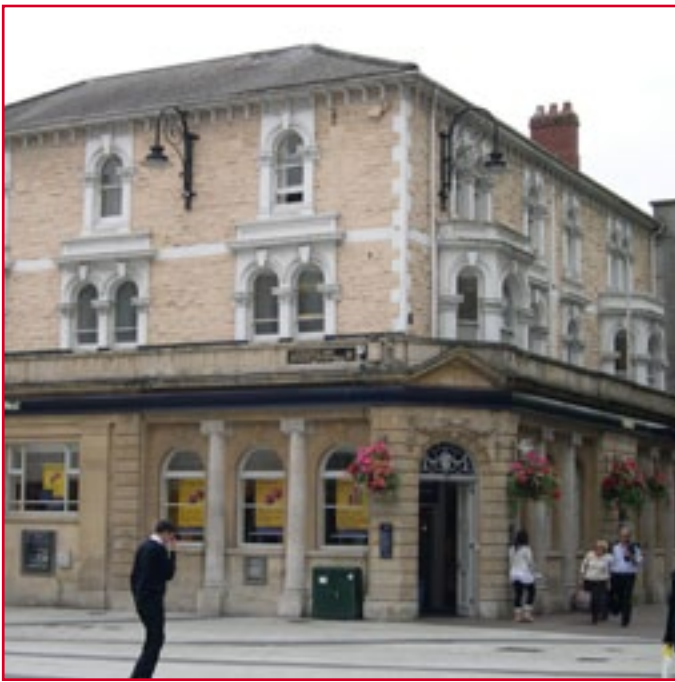
**Natwest Bank 94-96 Queen St:**

Bath stone (resistant variety) corner building retaining original ground floor façade. Of note: decorative Portland stone columns and ornate stonework

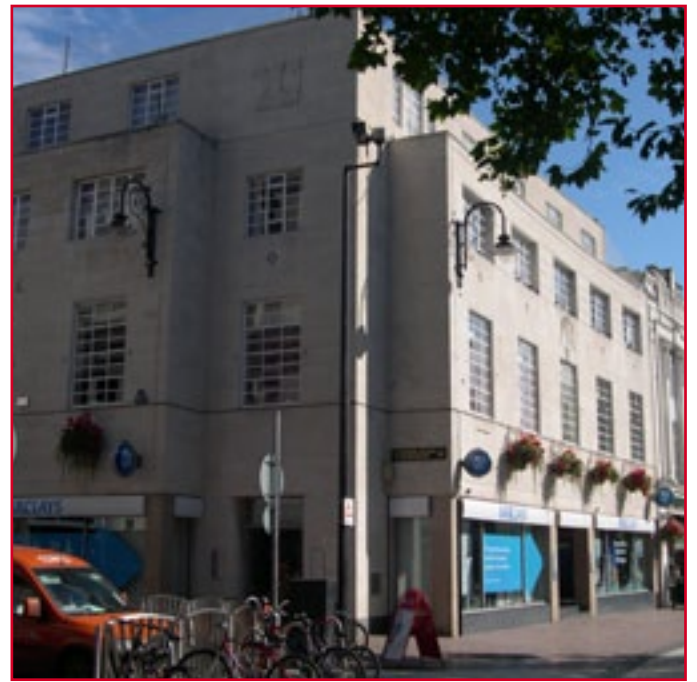
**Barclays Bank 121-123 Queen St:**

Attractive corner building faced in Portland stone. Of note: stone carved bank emblem and building shape.

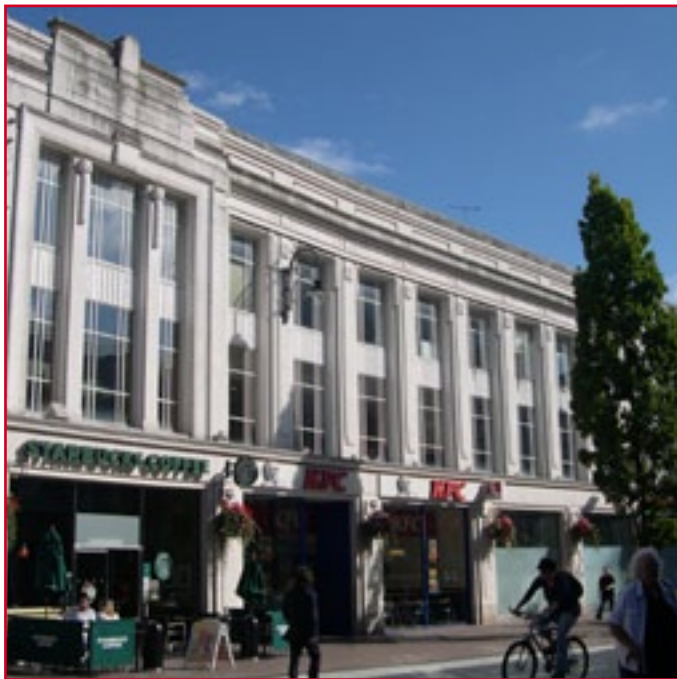
**125 – 137 Queen St:**

Remainder of the building of which 139 Queen St, detailed opposite, is a part. Of note are: Art Deco style, decorative stone detailing and gentle curved building line following the street alignment.

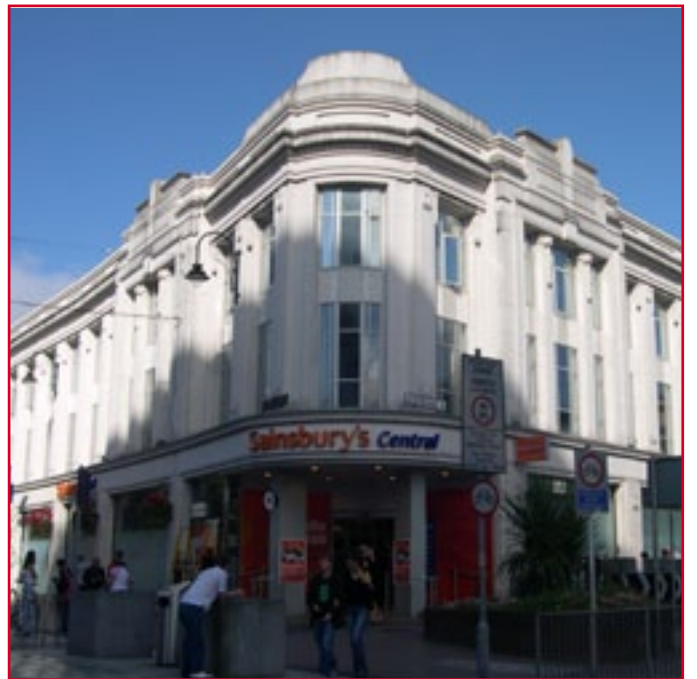
**139 Queen St:**

Built in the 1920s-1930s of stone in Art Deco style. Locally listed. Of note: decorative stone detailing and bow corner windows making it a prominent corner building.

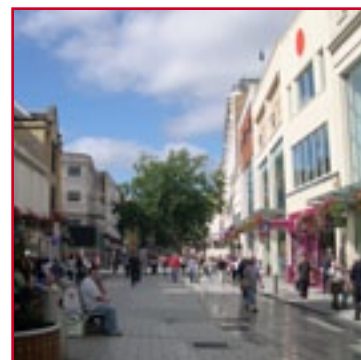
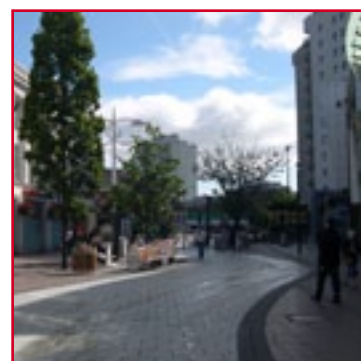
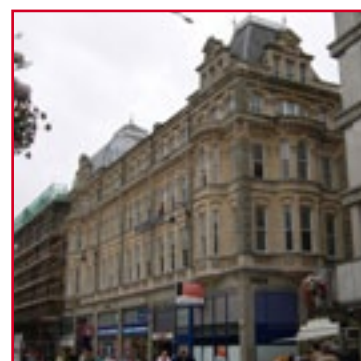
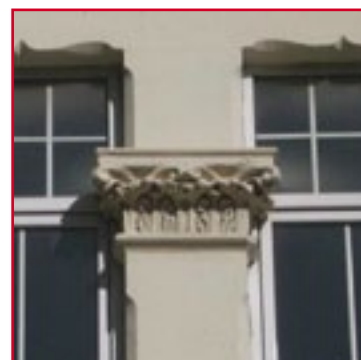
- Buildings open directly onto Queen Street.
- Queen Street has its own public realm identity.
- High quality architectural detailing at the Park Hotel.
- Carved stone detailing at upper floors.

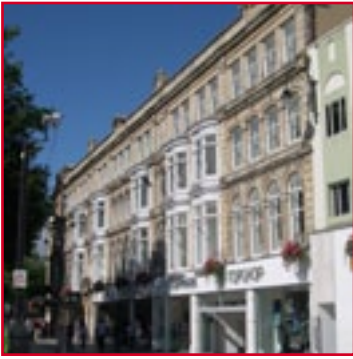
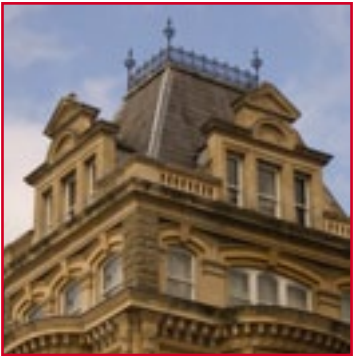
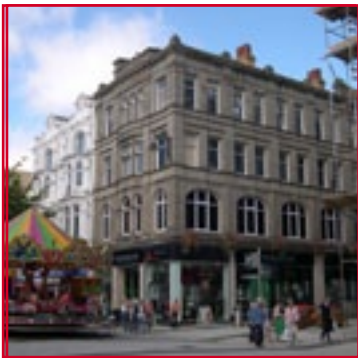
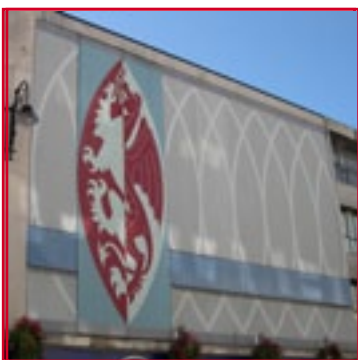
- Restored façade at upper floors (Andrews Buildings).
- Original roof detailing at the Park Hotel.
- Building that turns around the corner of Park Place.
- Frieze at the upper floors of 36-38 Queen Street.

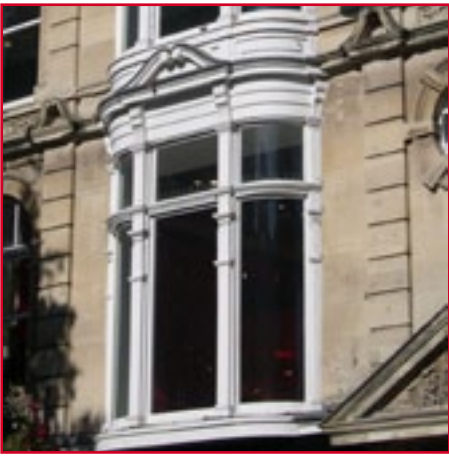
Victorian window detailing at the Andrews Building.

It is important that original architectural details of historic buildings are retained, maintained and sensitively enhanced as opportunities arise to ensure these assets of the Conservation Area are conserved. This is particularly important as new development generally does not replicate, either in terms of quality or quantity, the architectural detail of pre 1945 buildings.

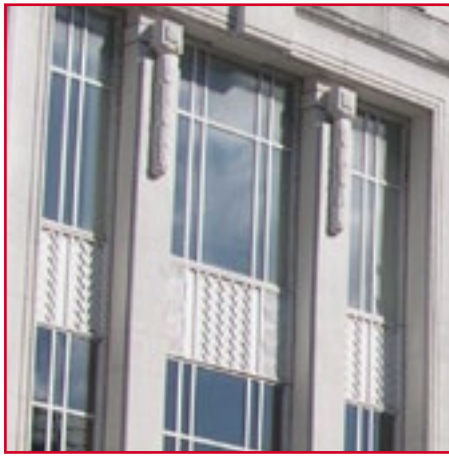
Art Deco window detail at 125-137 Queen Street.

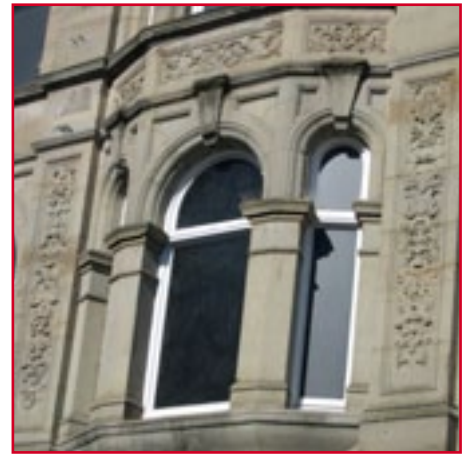
Carved frieze between windows at 87 Queen St.

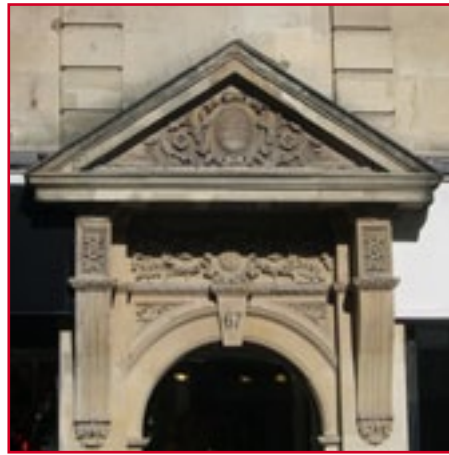
Carved stone over door-way, the Andrews Buildings.

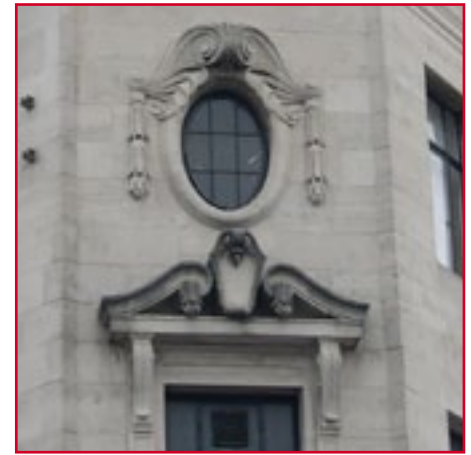
Carved stone around openings, 2 Queen St.

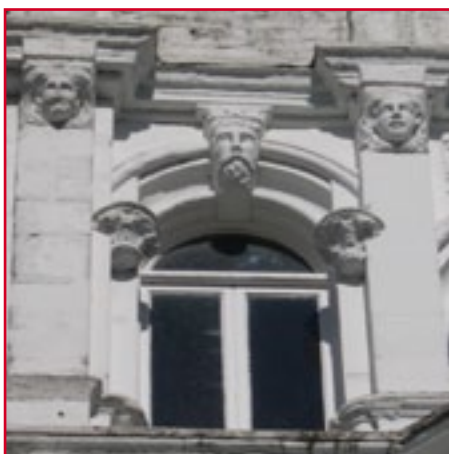
Carved heads at 83-85 Queen Street.

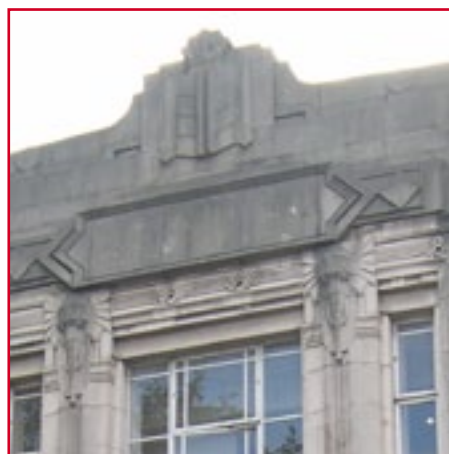
Art Deco frieze 4-6 Queen Street.

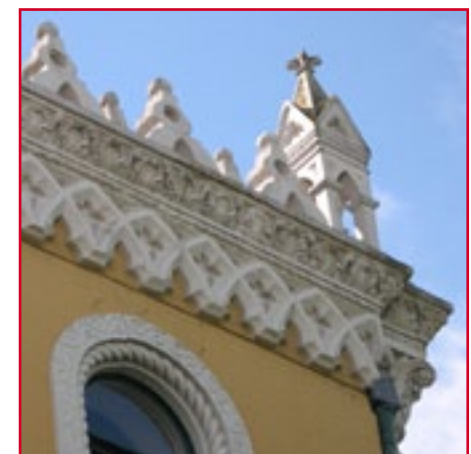
Stucco and stone Venetian Gothic style, 24-26 Queen St.

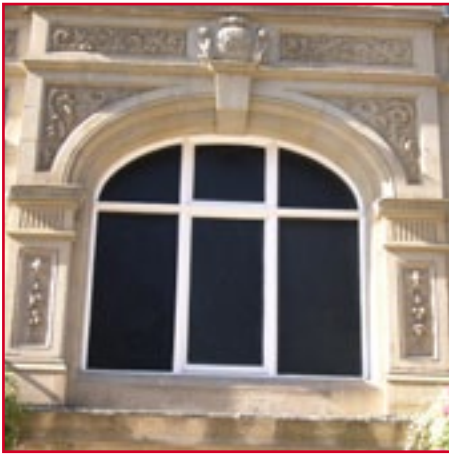
Elaborate Stone Carving at the Royal Chambers.

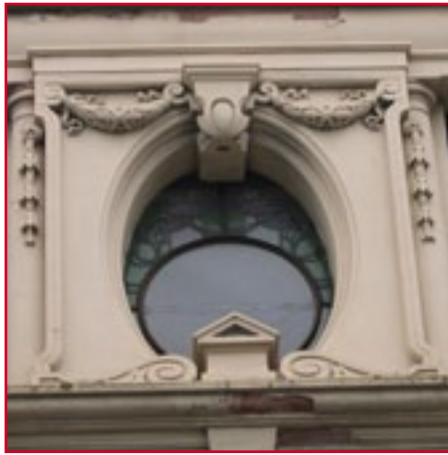
Ornamental window surround at 9 Queen St.

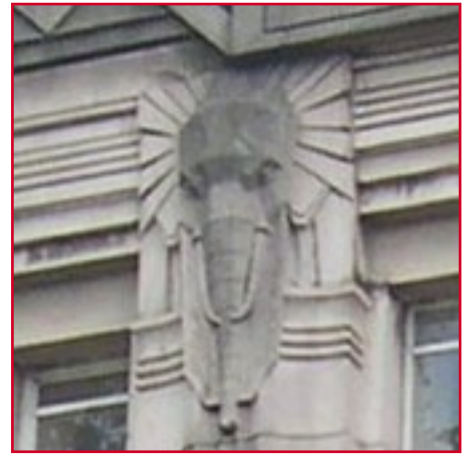
Upper storey detail on 4 - 6 Queen Street.

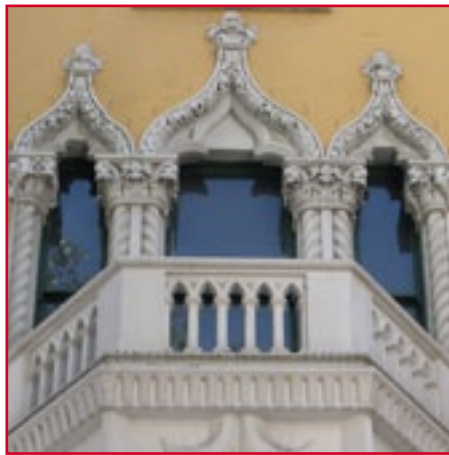
Stucco & stone window surrounds at 24-26 Queen Street

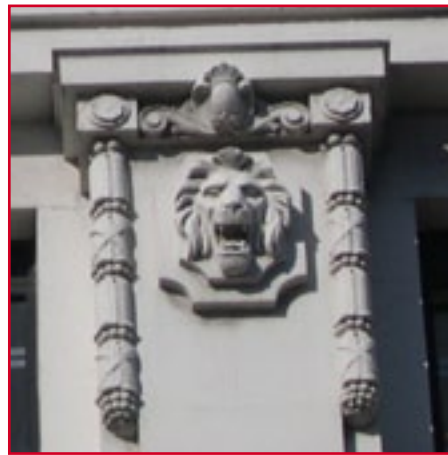
Lion head detailing, Dominions House / Arcade.

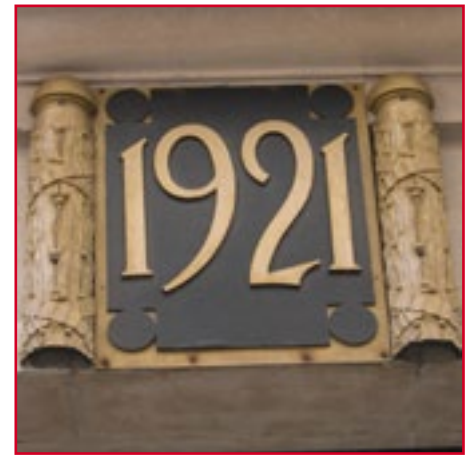
Feature over entrance to Dominions Arcade.

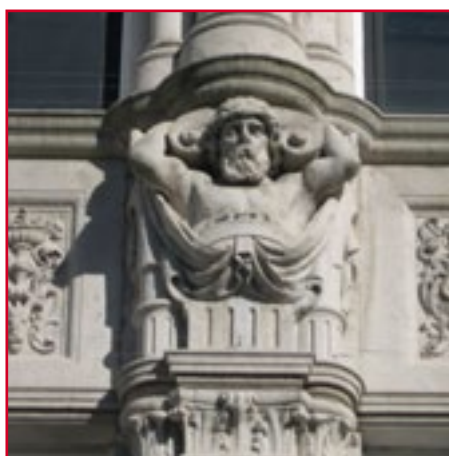
Carved figures at 31 Queen Street.

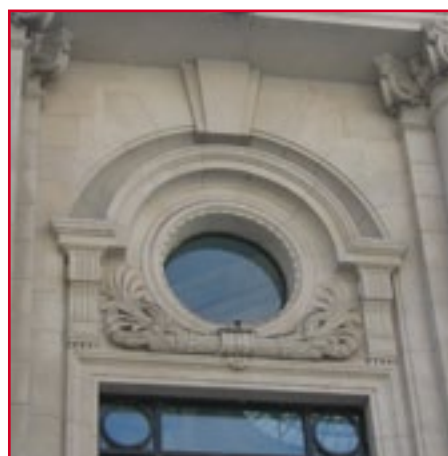
Carved stone around windows, 56-58 Queen St.

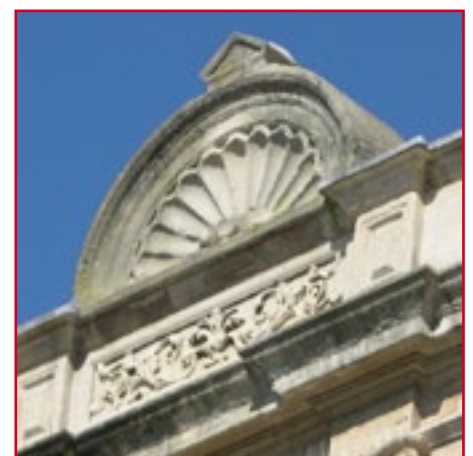
Roof Ornamentation on the Andrews Buildings.

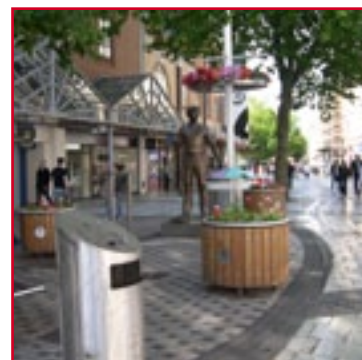
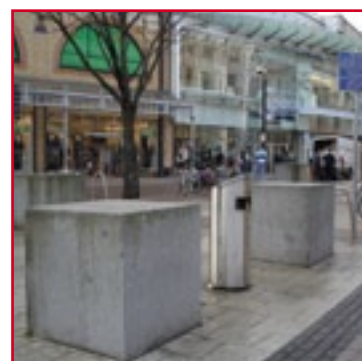
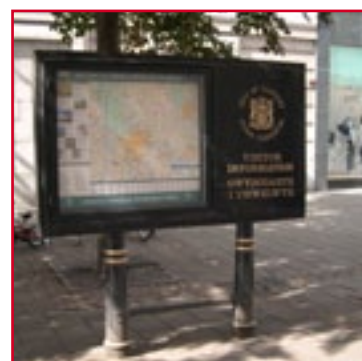
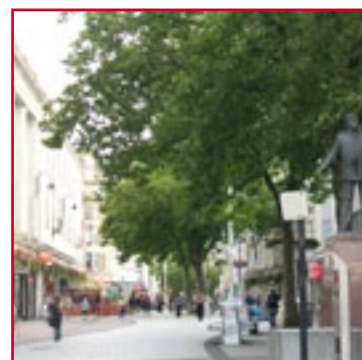
The public realm along the other side streets and at the eastern and western 'gateways' into Queen Street (Dumfries Place and Kingsway respectively) have no identity. They feature different and uncoordinated types of paving and street furniture, are all generally tired in appearance and late 20th century in design. Where Victorian style furniture is present it looks untidy, isolated, and paradoxically, out of place.

A variety of trees have been planted along Queen Street, Churchill Way, Park Place and Charles Street, softening the built environment and generally contributing to its character. Along Queen Street, their position, height, canopy spread and the street's curve means from different approaches they partially obscure upper storeys of numerous buildings, screening parts of the area's historic and architectural assets. Large planters of modern design also soften the area, but are unattractive when not planted. They can also act as obstacles to pedestrian movement.

- Street furniture within Queen Street.
- Street clutter at the junction of Dumfries Place.
- Outdated Victorian style street furniture.
- Street trees impact on views of upper storeys

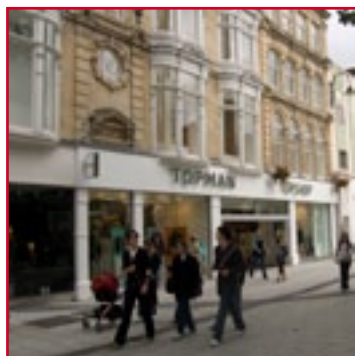
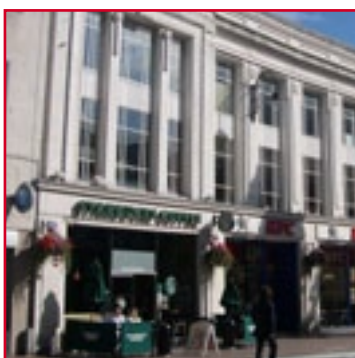
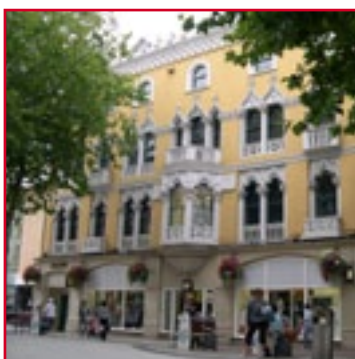
- Examples of relationships between ground floor shop frontages and upper floor historic facades.

- The ground floors of most buildings within the Conservation Area have been extensively altered. With regard to historic buildings, the majority of alterations do not relate well to the character of the building in terms of features, materials or style, with most ground floor alterations incorporating modern shop fronts and signage. The general effect of such alterations is the visual separation of the ground floor from the upper storeys. Accordingly, these alterations detract from the appearance of historic buildings and the historic character of the Conservation Area.

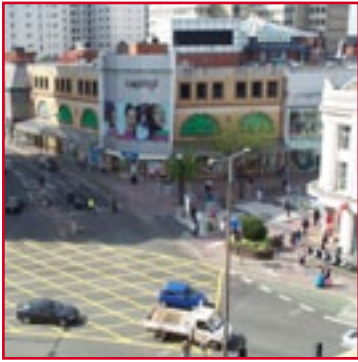
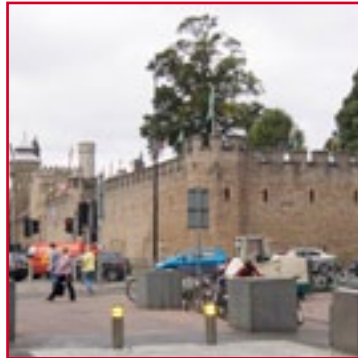
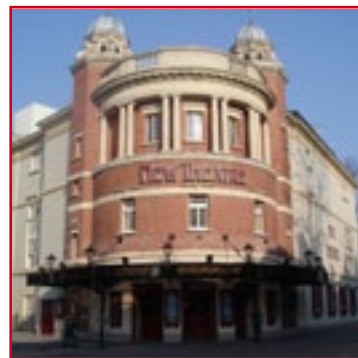
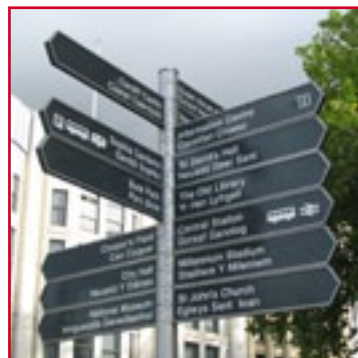
- Eastern Gateway at the junction of Dumfries Place.
- Western Gateway at the junction of Kingsway.
- New Theatre, Landmark Building along Park Place.
- Directional signage to surrounding areas.

- Whilst recently implemented public realm enhancement schemes have used traditional/natural paving materials, overall much of the public realm within the Conservation Area is of modern materials and design (late twentieth century and later). Generally, throughout the Conservation Area, furniture and paving varies in style and materials, typically reflecting trends prevalent in the era in which they were installed.

- Street furniture is found throughout the Conservation Area, particularly in Queen Street where it is located in many clusters along its length, including at junctions with side streets and at either end of Queen Street. The siting and amount of furniture can impede pedestrian flow and can act as a visual barrier.

- Whilst directional signage is found within the Conservation Area it is not always noticeable among the other street furniture due to its siting, smaller scale and individual design. Queen Street provides links to Queen Street Station, Central Station, Cardiff Castle, St Mary Street and Cardiff Bay, whilst Park Place and The Friary are key links to the Civic Centre and Cathays Station.

- Investigate the resiting of street furniture that acts as barriers to pedestrian movement.
- Improve pedestrian links at the gateways to Queen Street across Dumfries Place (Eastern Gateway) and Kingsway / Duke Street (Western Gateway).

- Review the content and location of existing directional signage and tourist information for visitors and shoppers within the area. Promote linkages to surrounding areas and destinations through improved signage and way marking including: the promotion of Park Place and The Friary as main pedestrian links to the Civic Centre and the links to Queen Street Station, Central Station, Cardiff Castle, St Mary Street / High Street and Cardiff Bay.
