# CARDIFF CITY CENTRE

## CONSERVATION AREA APPRAISALS

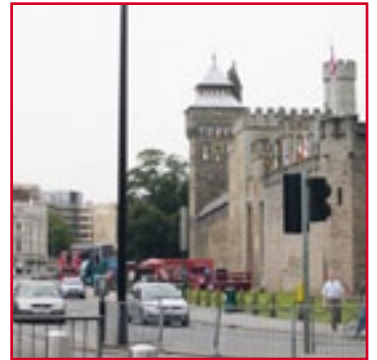
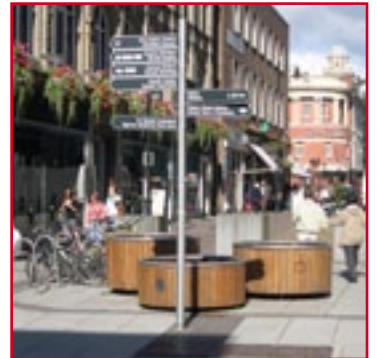
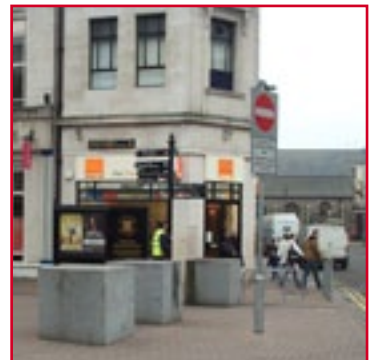
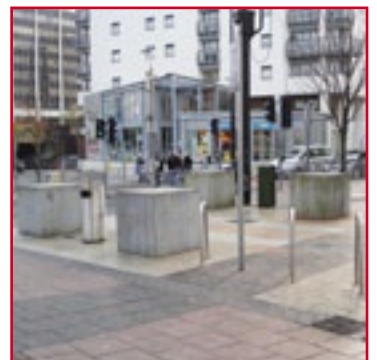
- Road between Cardiff Castle and Queen Street.
- Pedestrian signage at the junction of Park Place
- Impact of granite blocks at the western Gateway.
- Granite blocks and street furniture at the Eastern Gateway.

- Investigate the resiting of street furniture that acts as barriers to pedestrian movement.
- Improve pedestrian links at the gateways to Queen Street across Dumfries Place (Eastern Gateway) and Kingsway / Duke Street (Western Gateway).

- Review the content and location of existing directional signage and tourist information for visitors and shoppers within the area. Promote linkages to surrounding areas and destinations through improved signage and way marking including: the promotion of Park Place and The Friary as main pedestrian links to the Civic Centre and the links to Queen Street Station, Central Station, Cardiff Castle, St Mary Street / High Street and Cardiff Bay.

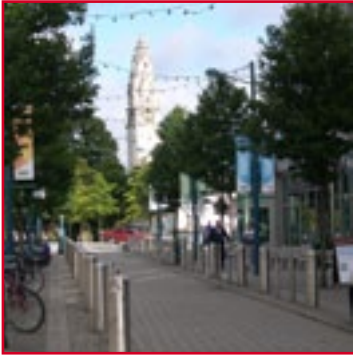
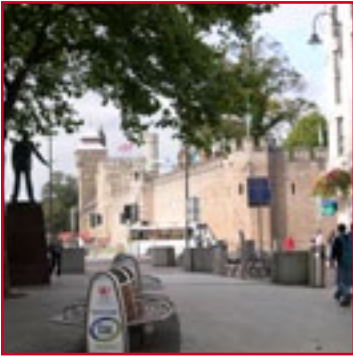
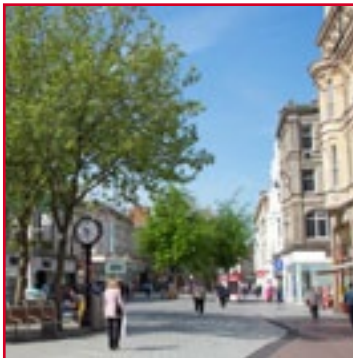
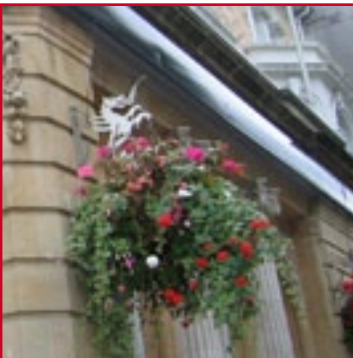
- View along the Friary of City Hall clock tower.
- View along Queen Street of Cardiff Castle.
- Street trees located along the length of Queen St.
- Seasonal planting along building facades.

- Where tree planting is proposed in future, take into consideration historic features, buildings and views.
- Request that tree maintenance programmes ensure tree canopies do not damage historic buildings.

- Seek to retain important views and maximise / enhance existing views along key routes to aid legibility, for example the location of the New Theatre at the corner of Park Place and the view of the Castle from Queen Street.

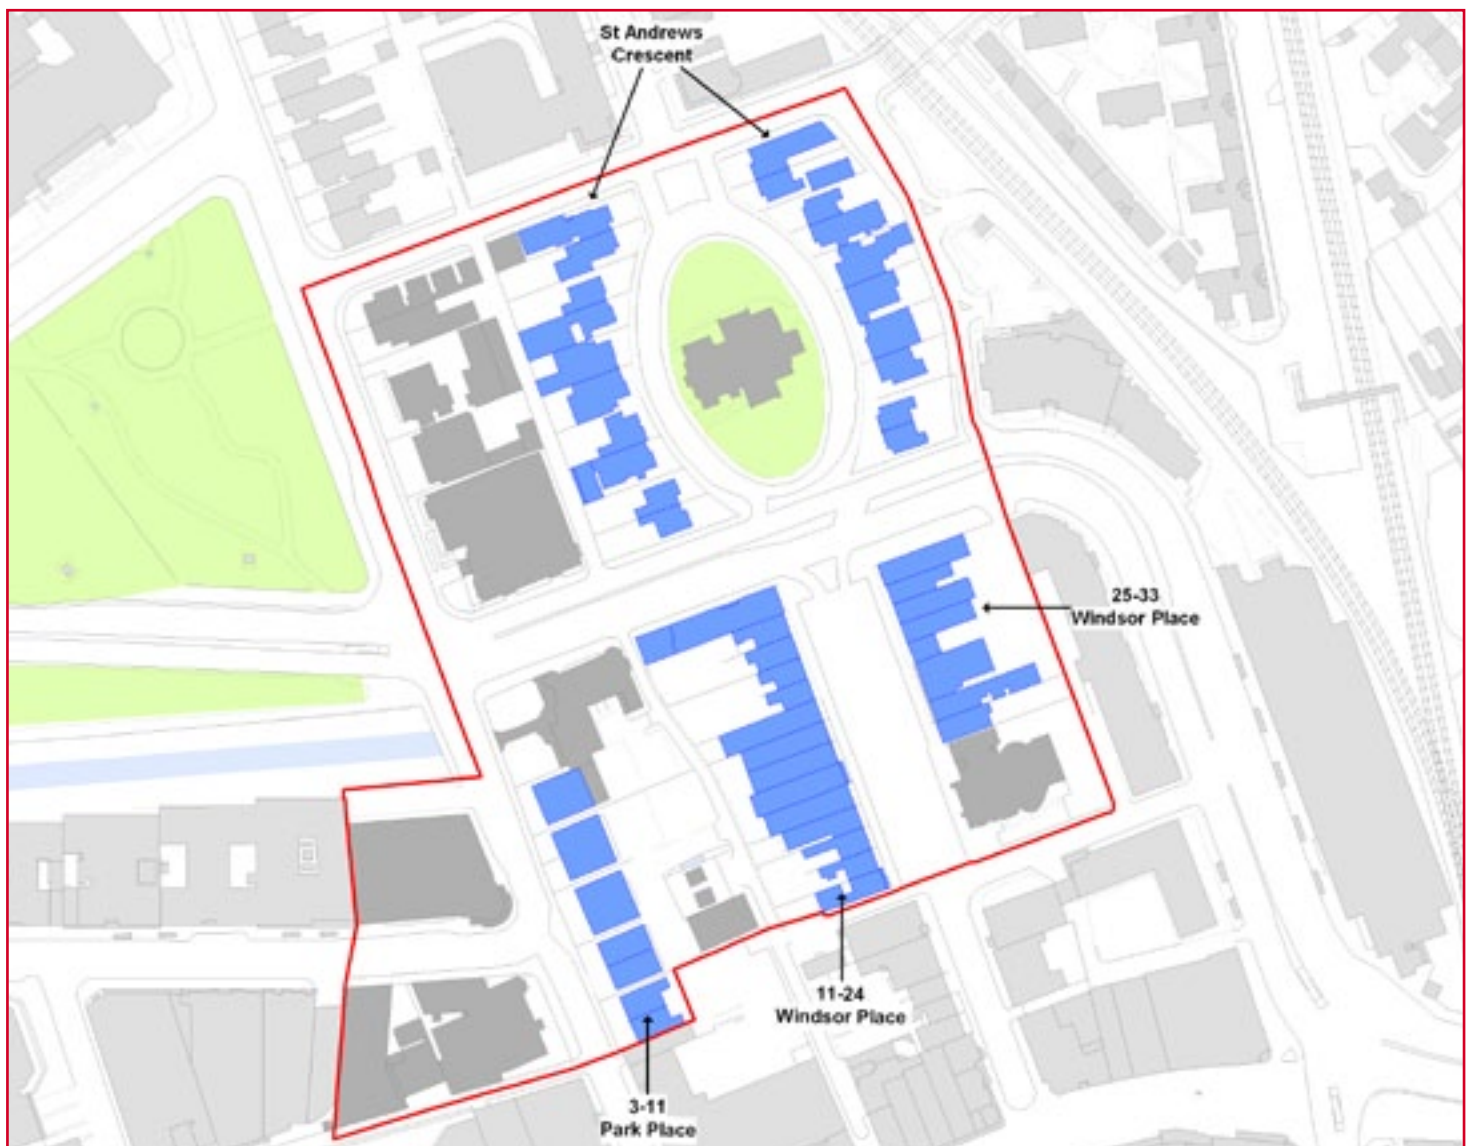
### Map 2: Grouping of Buildings

Buildings in the Conservation Area present strongly defined perimeter blocks, with regular, narrow plot widths and a strong relationship with the public realm.

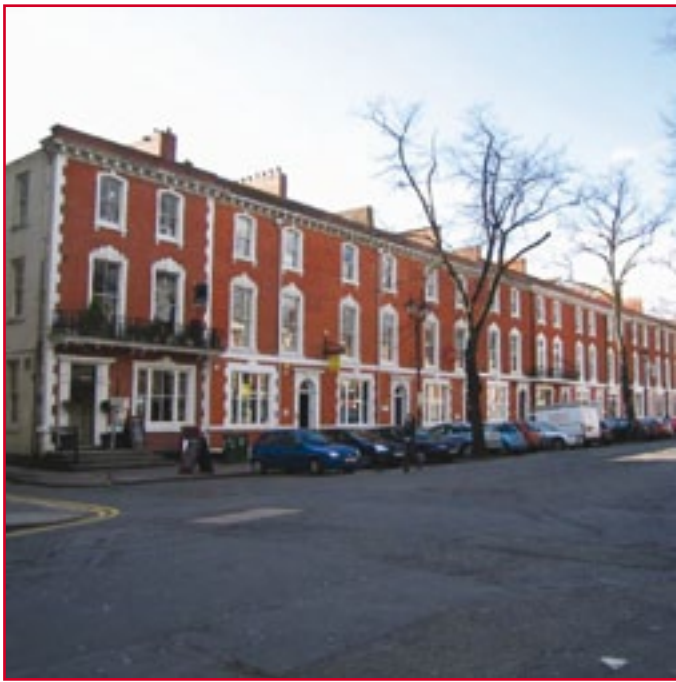
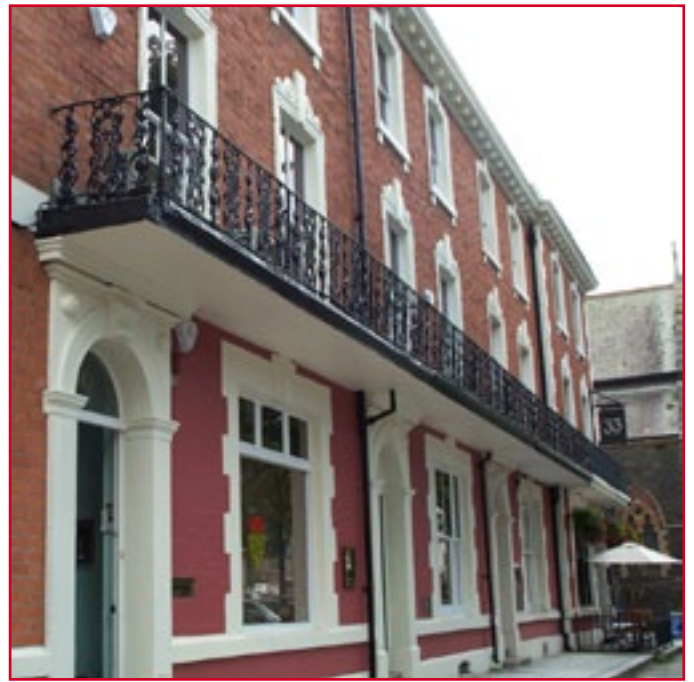
### 11-24 Windsor Place and 25-33 Windsor Place:

These Victorian terraces are the best preserved mid C19 houses in the centre of Cardiff and contribute significantly to the special character of the Conservation Area. The two rows of terraces face each other across a wide tree-lined street. Some of the properties have retained their balconies with decorative iron work.

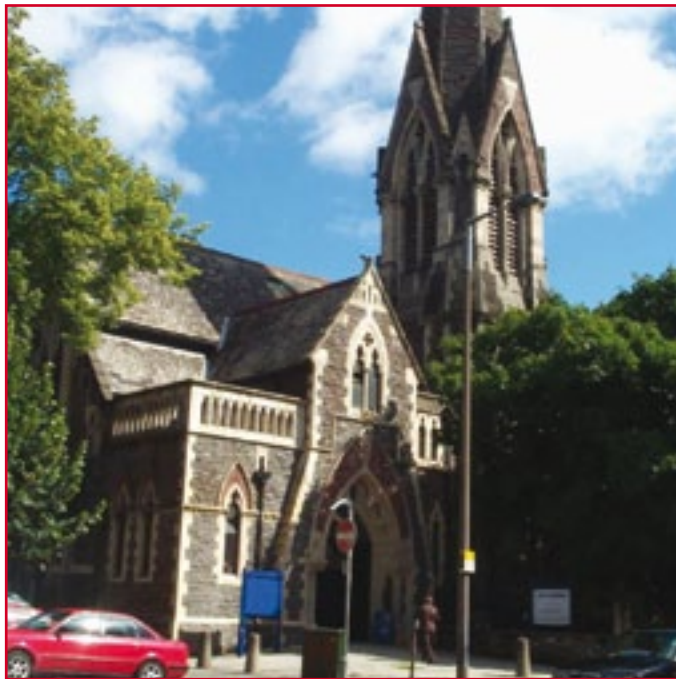
### City United Reformed Church, Windsor Place:

This church has a soaring octagonal spire and an impressive porch over the south door. It is of an early English Gothic design, but also displays the influence of north Italian architecture.

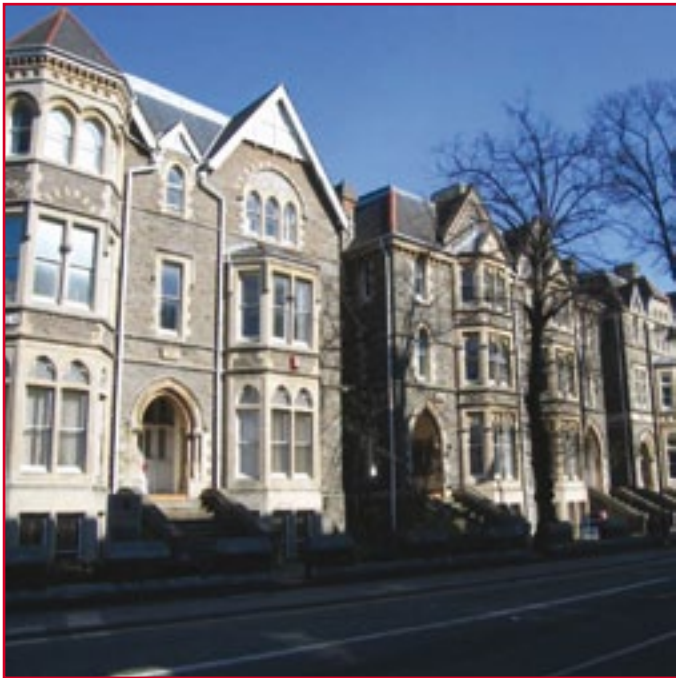
**3-11 Park Place:**

A group of well-preserved High Victorian middle class houses in the city centre, designed by the same architect. Arranged in four pairs of semi-detached and one detached house, these houses not only stand out as a unified group but also individually because of their architectural features and detailing which varies from pair to pair.

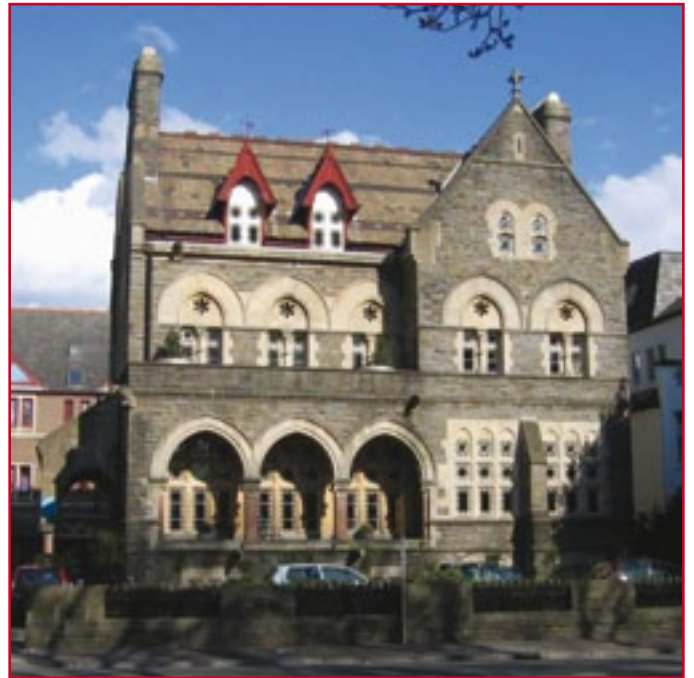
**20 Park Place (Park House):**

Built in 1871-1875 designed by William Burges. Considered the finest example of a town house designed by this architect, this building reflects Burges's distinctive, eclectic style. A Grade I listed building, the house is unique within the Conservation Area and has had a significant influence on domestic architecture of late Victorian / early Edwardian Cardiff.

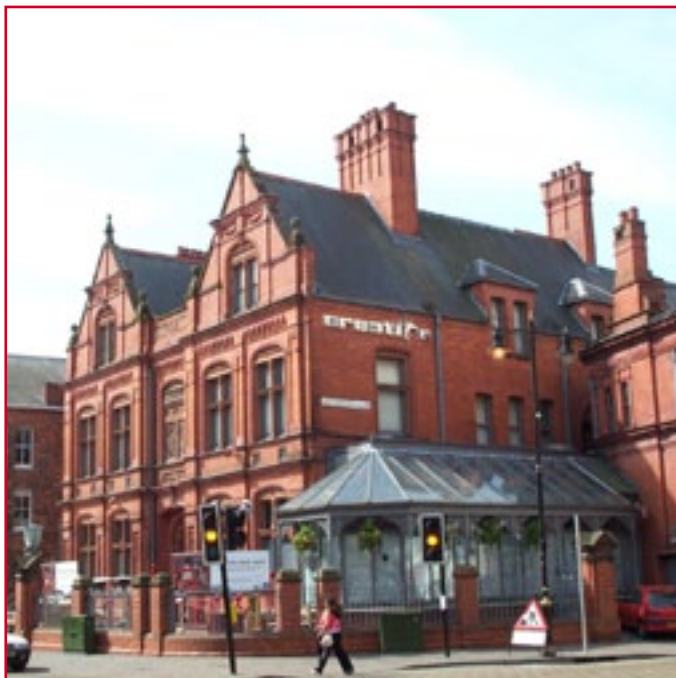
**South Wales Institute of Engineers, Park Place:**

Built in 1893 to the design of E. W. M. Corbett, the deep, rich colour of the pressed brick combined with decorative terracotta mouldings gives this building a lively presence on the street scene.

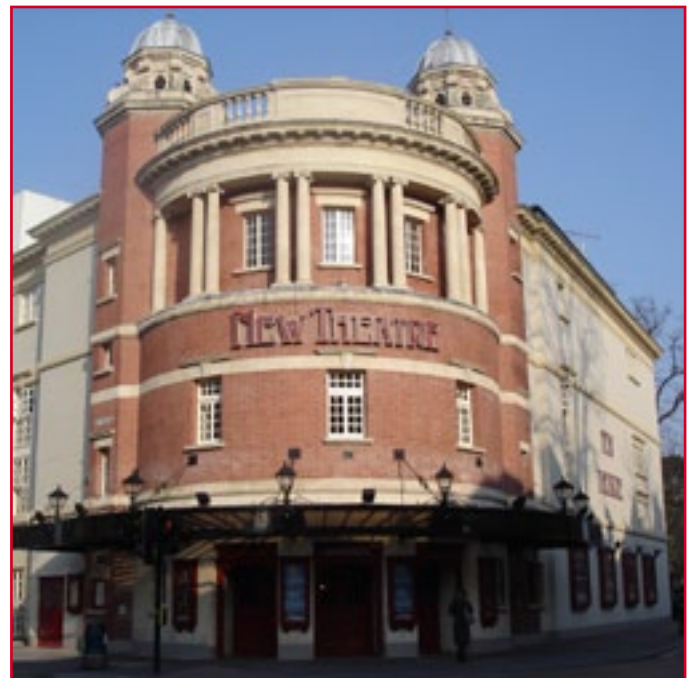
**New Theatre, Park Place:**

With its curved three-storey entrance bay, the colonnade of columns above the second floor and the octagonal domes on the roof, it is instantly recognisable and provides a vital landmark within the Conservation Area.

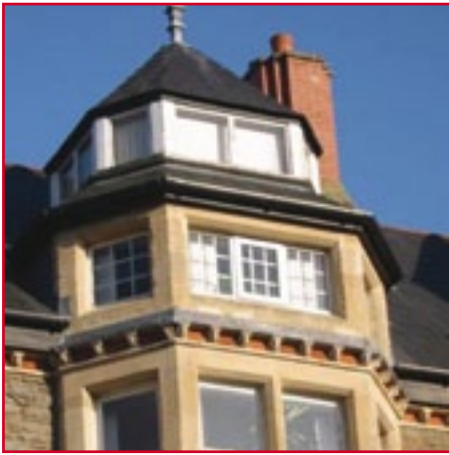
The bay windows of 3 – 4 Park Place are topped at attic level by a pyramidal roof.

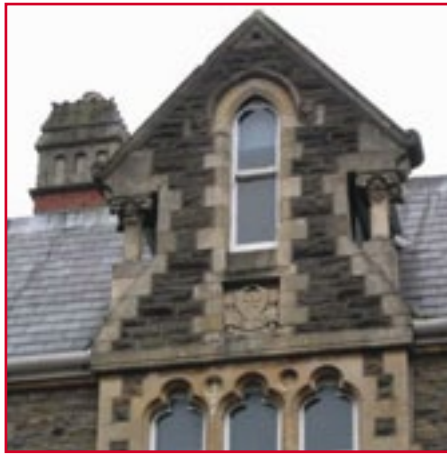
Dormer and chimney detail at 5 & 6 Park Place.

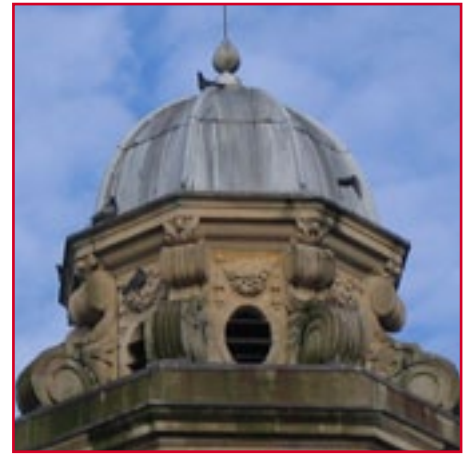
Octagonal turrets with ornate detail crown the roof of the New Theatre

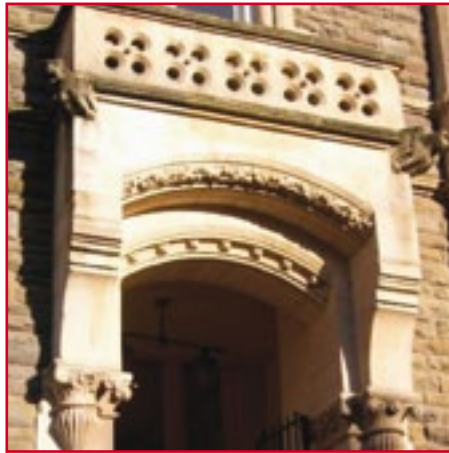
Bath Stone hood over doorway with ornate detailing including a fretted parapet and figurative carvings.

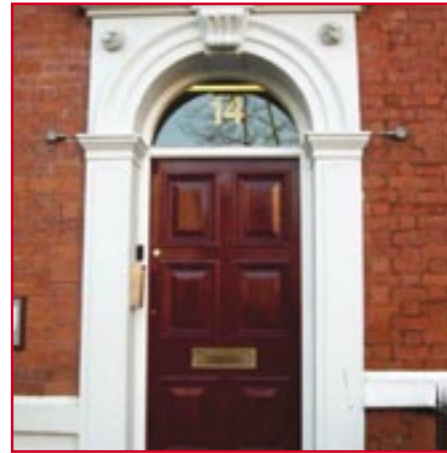
Restrained, classical detailing framing a door at Windsor Place.

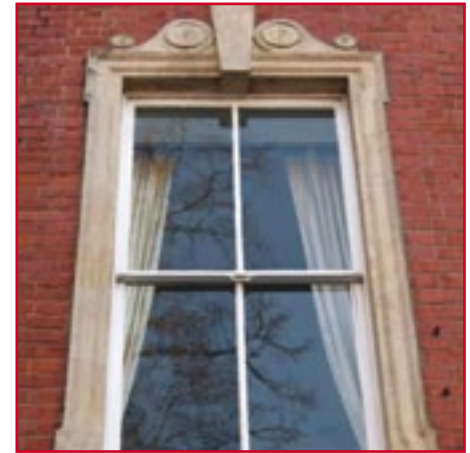
Windsor Place – first floor sash window with classical detailing in Bath stone

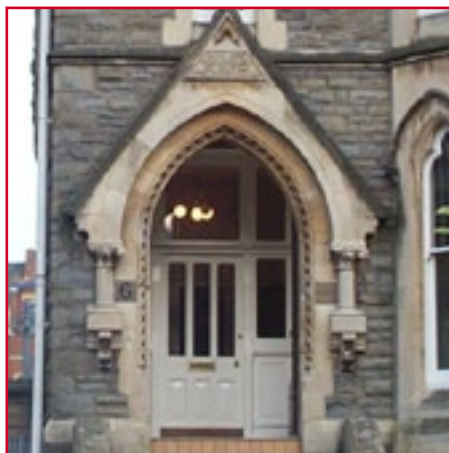
Decorative pointed arch, and Bath stone hood over recessed doorway – Park Place.

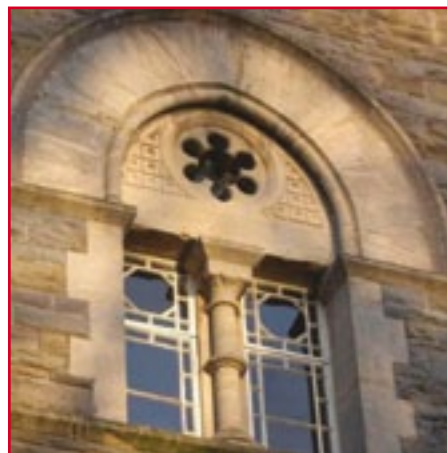
Bath Stone detailing is used to dramatic effect around an upper floor window – Park House

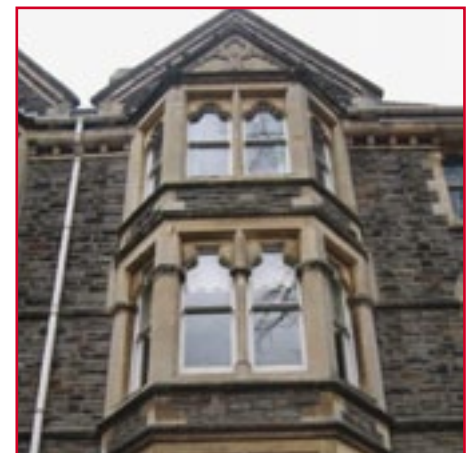
The strong shape of the window heads varies at each floor level – 9 & 10 Park Place

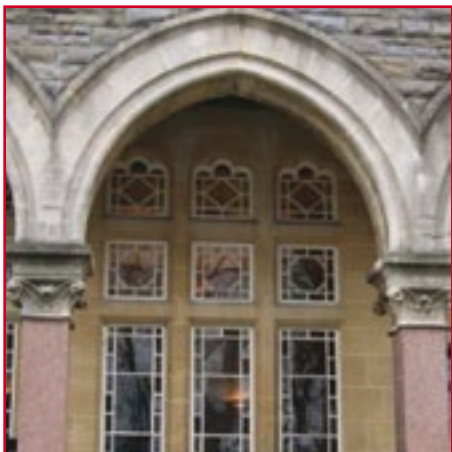
Park House – Pink granite columns and bath stone arches form an arcade on the front elevation.

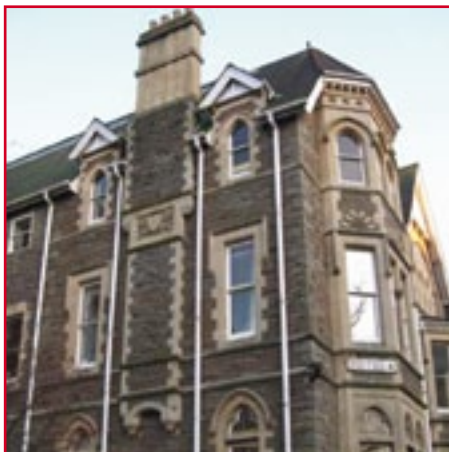
Park Place – the corbelled chimney stack and windows add interest to the side elevation.

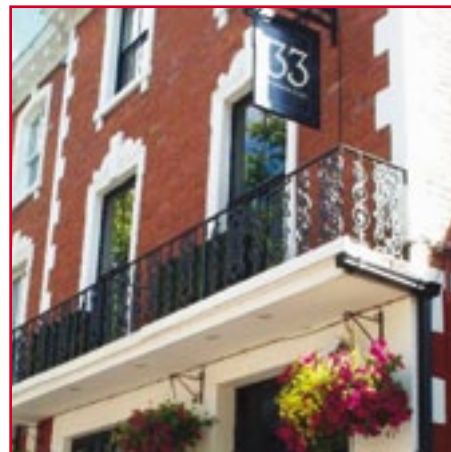
Some of the buildings in Windsor Place retain their iron railed balconies.

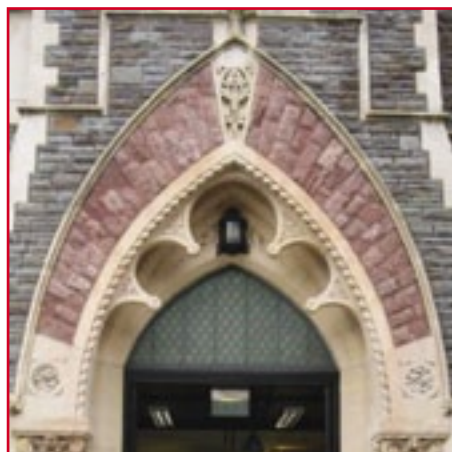
Pink Radyr stone is used as part of the detailing around the main door – City United Reformed Church

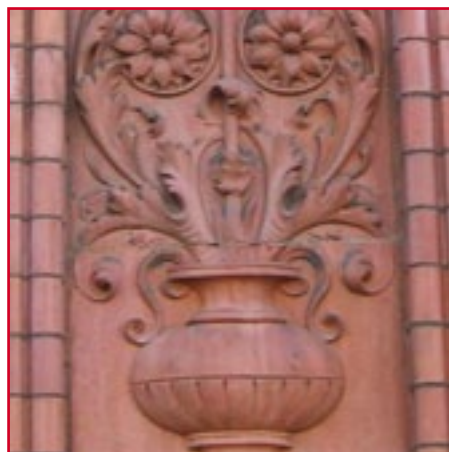
A terracotta moulding of a plant motif ornamenting a pilaster on the South Wales Institute of Engineers.

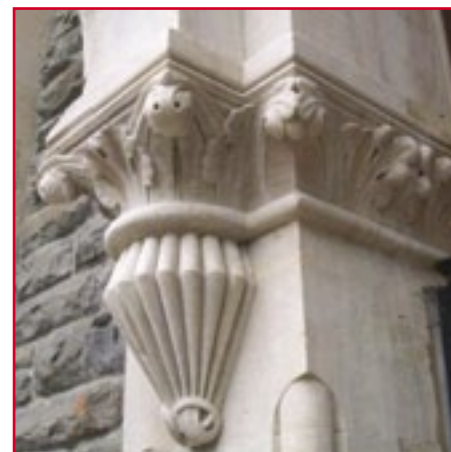
Bath stone pilaster topped by an ornately carved capital and corbel - doorway at 3 Park Place.

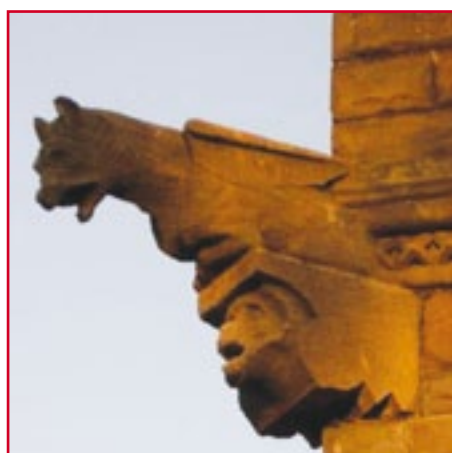
A gargoyle carved from stone juts out from the corner of Park House

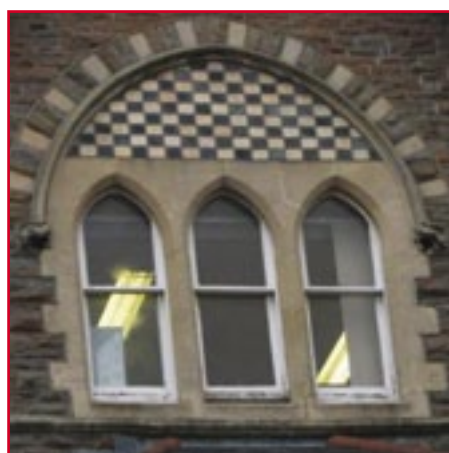
Tiles create chequer board detailing above an upper floor window – 11 Park Place.

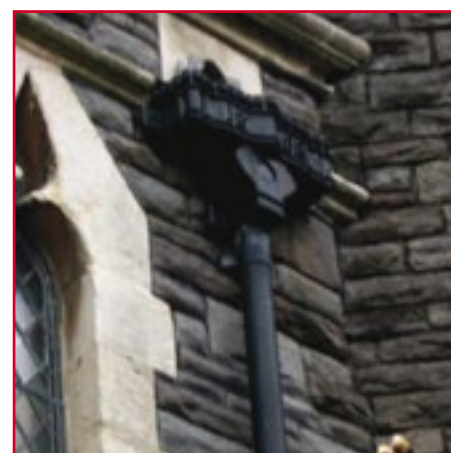
Cast iron rainwater head and down pipe – City United Reformed Church.

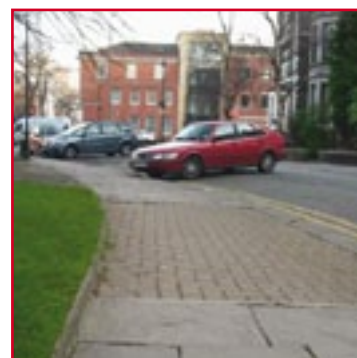
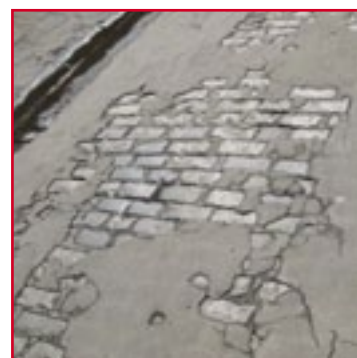
- Inappropriate block paviour insert, St Andrews Crescent.
- Poor quality patching, Park Lane.
- Lime Trees at Windsor Place.
- Lime Trees and lawn at St Andrews Crescent.

The original paving to the outer pavement at St Andrews Crescent has been lost, as various properties have removed their front boundary walls to allow easy access for parking. Replacement paving is of varying quality, materials, design and approaches, resulting in a piecemeal and poorly considered surface treatment to the Crescent.

Access to car parking on front forecourts around St Andrews Crescent has led to problems with broken and cracked slabs and oil deposits on street paving.

Throughout the area, there has been a tendency for low quality materials to be used, including poorly executed 'patching' when repair works or amendments are carried out. The overall effect detracts from the visual quality and image of the area.

Resurfaced roads are predominantly black top tarmac, with parking delineation indicated by painted lines. Rear lane areas are in a particularly poor condition, many comprising cobbled surfaces either covered or patched with tarmac.

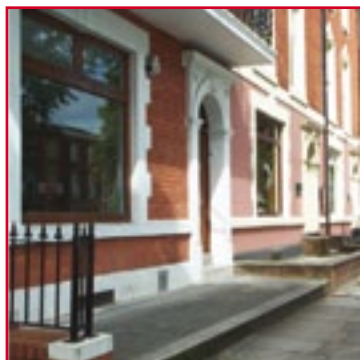
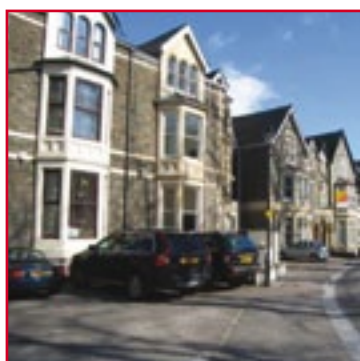
- Loss of boundary railings at Windsor Place.
- Forecourt parking at St Andrews Crescent.
- Discrete signage.

The oval defined by the front boundaries at St Andrews Crescent has deteriorated through the loss and alteration of front boundary walls. Boundary walls and railings at Windsor Place have also been lost.

- Public on-street parking at Windsor Place and St Andrews Crescent has had a negative impact on the character of the Conservation Area, both visually and through conflict between motor vehicles and pedestrians, as well as through damage to street trees.

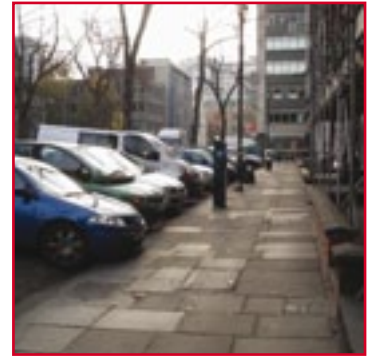
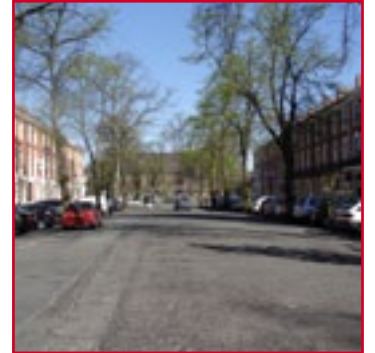
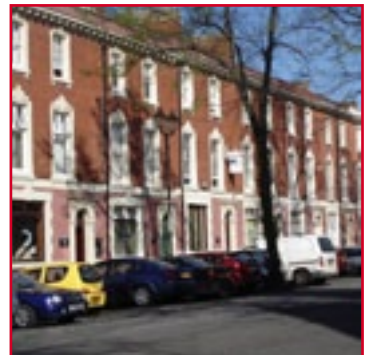
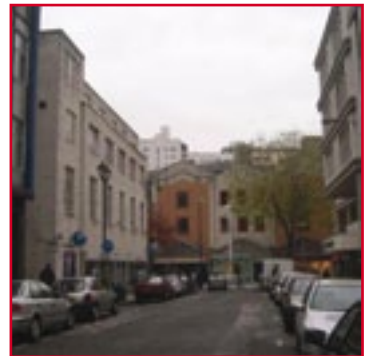
- Inconsistent use of paving materials.
- Wide expanse of tarmac at Windsor Place.
- On street parking throughout the area.
- Poor legibility between Queen Street and Windsor Place.

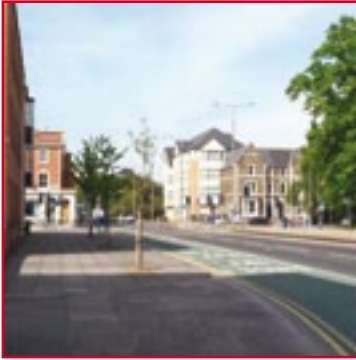
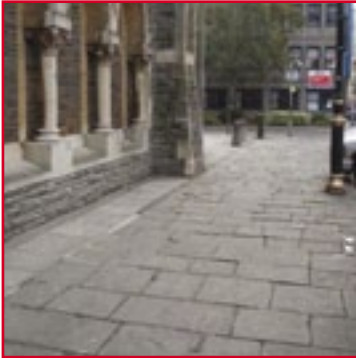
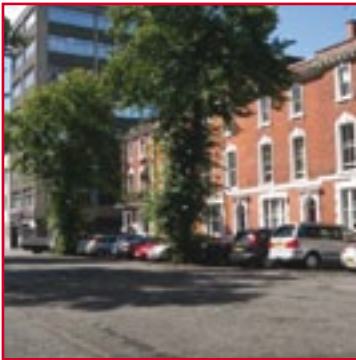
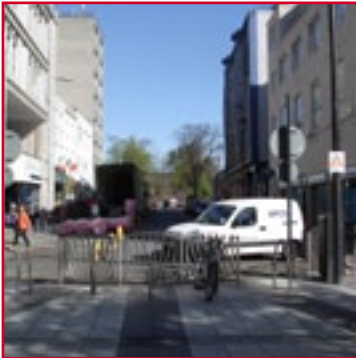
- Stuttgarter Strasse separates Windsor Place from St Andrews Crescent.
- Original pennant paving.
- Mature street trees.
- View into Windsor Place from Queen St.

- Seek to retain and enhance the historic character of Windsor Place including: reinstating pennant paving, continuing the programme for street tree maintenance and, where necessary, replacement of trees, creating high quality forecourt boundary treatments and reducing the impact of vehicles using the area.
- Seek to enhance the public realm at the junction of Windsor Place and Queen Street to improve pedestrian priority, enhance views and aid legibility.

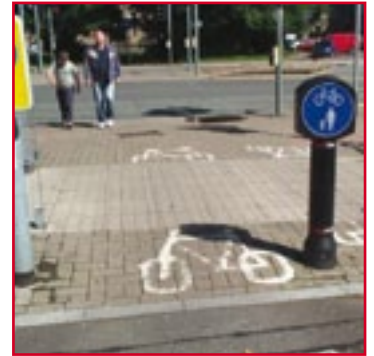
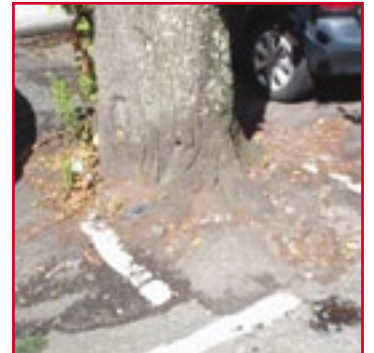
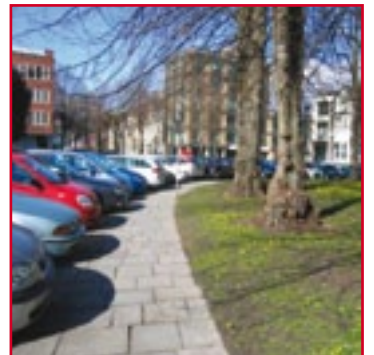
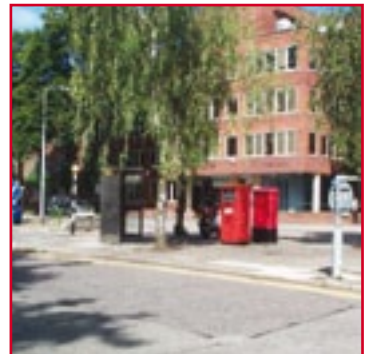
- Pedestrian crossing island at Windsor Place.
- Lack of protection around mature street trees.
- On street parking around St Andrews Crescent.
- Array of street furniture.

- Street furniture is found throughout the Conservation Area, particularly in Queen Street where it is located in many clusters along its length, including at junctions with side streets and at either end of Queen Street. The siting and amount of furniture can impede pedestrian flow and can act as a visual barrier.

- The majority of the Conservation Area is pedestrianised, however, in areas where vehicles are permitted (side streets), it is noted there is often parking on pavements and parking / waiting in turning heads and on double yellow lines. This can give rise to conflicts between users and restrict traffic circulation.

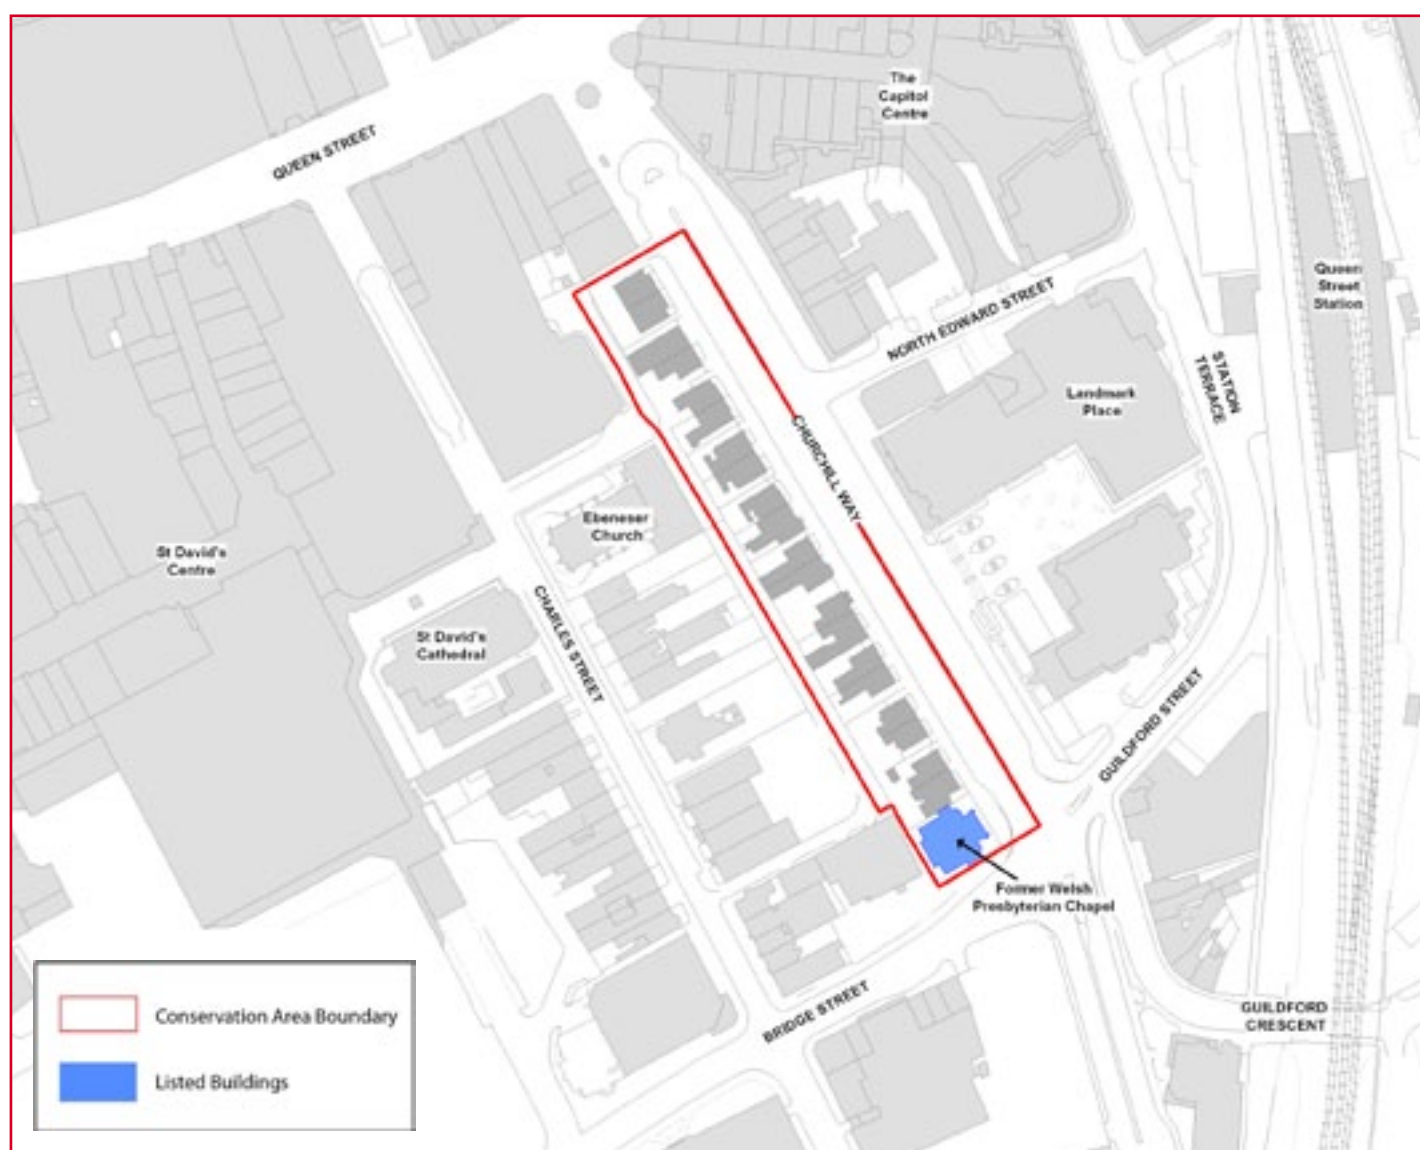
Map1: Churchill Way Conservation Area Boundary, designated 1991

The assessment of the Conservation Area confirmed that the area still has a special character. Whilst development continues to be a constant presence in Churchill Way, it was considered that overall buildings of special historic and architectural value have been protected. There is no scope to extend the boundary to the east where a very different scale has developed over the last decade. A fragment of the historic terrace adjoining the listed Masonic building at Guildford Crescent endures. However the terrace is remote from the group forming the focus of the Conservation Area and has been the subject of cumulative small scale change. No extension to include it was therefore recommended.

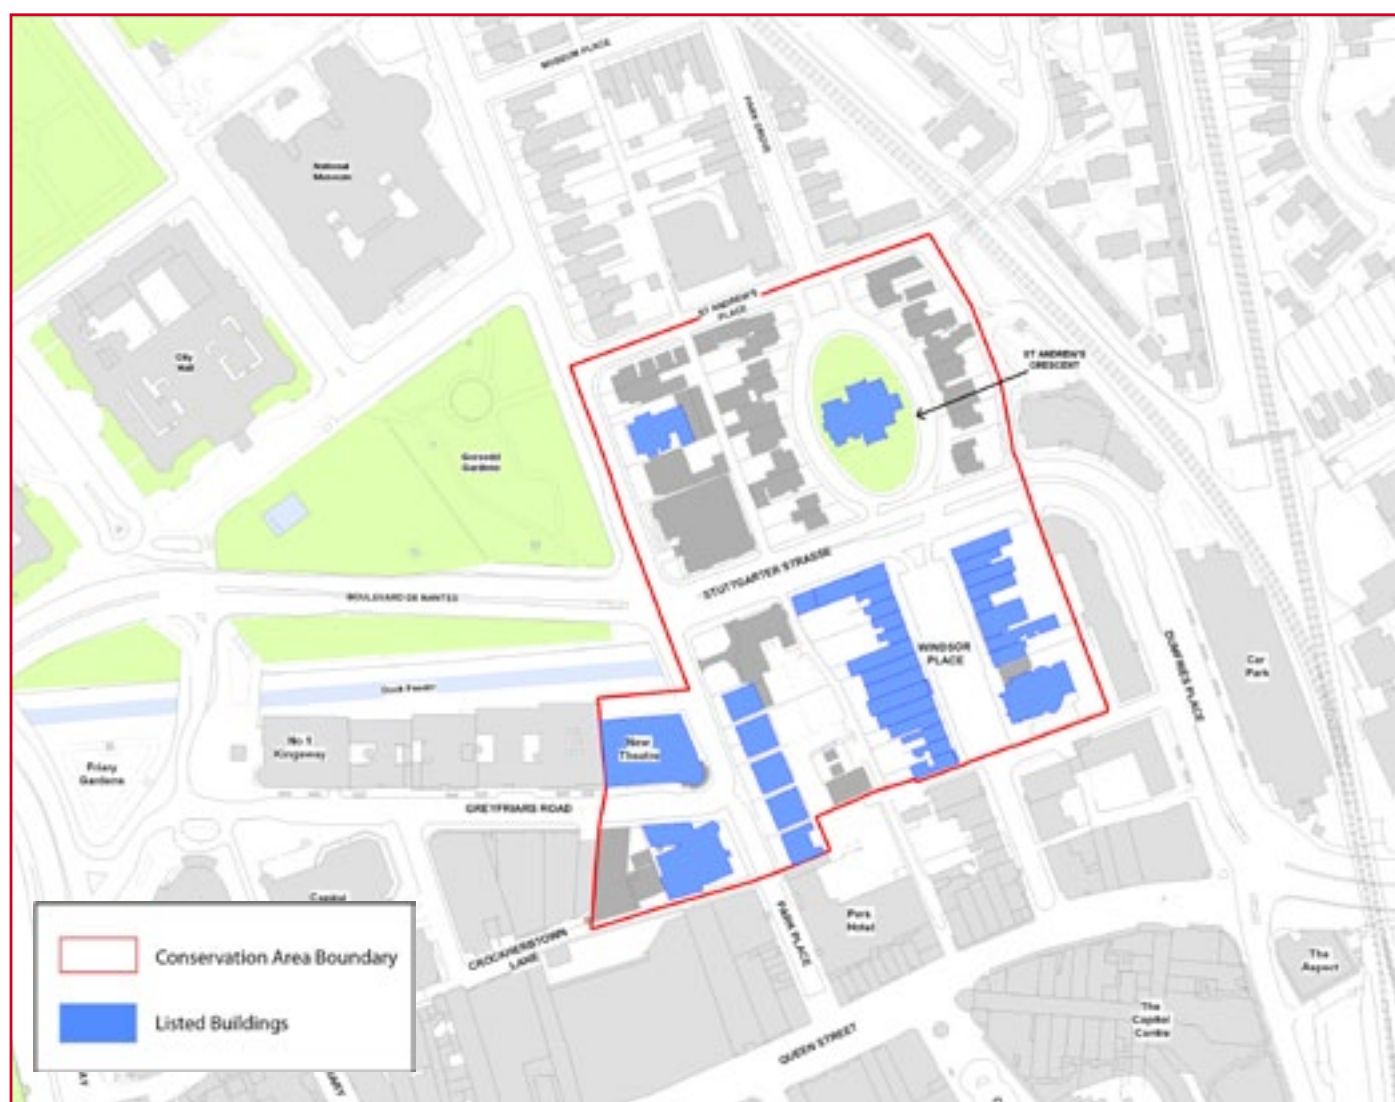
## Map 1: Windsor Place Conservation Area Boundary, designated 1975

The assessment of the Conservation Area and its immediate surroundings confirmed that the area still has a special character. Overall, buildings of special historic and architectural value have been protected and, in the main, designation has also afforded protection to non-listed buildings as well as the public realm. No amendments to the Conservation Area boundary were therefore proposed.
