2 *Beaches and Dunes*

OVERVIEW

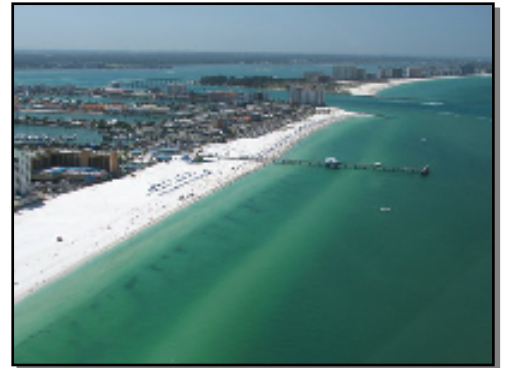
Clearwater Beach Island is 3.1 miles long and averages 1,200 feet in width and is accessible from the mainland by a causeway. Highly developed as a resort and residential area, its bayside had been extended into Clearwater Bay by extensive dredge, fill and finger canal construction. Most of the beaches consist of fine grained sand. From 1873 to 1950, the shoreline receded an average of 121 feet overall, and from 1950 to 1979 it advanced an average of 175 feet overall. Some reaches have not changed positions or have receded. Some of the shoreline advance is due to local corrective action. Over the past century, there has been a relatively wide and stable beach on the south of the island; considerable erosion and a minimal beach in the central portion; and a wide and accreting beach on the northern end.

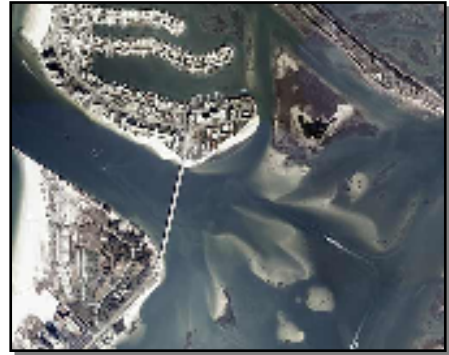
Clearwater Pass

Inlets have ebb and flood tide deltas or sand bars which are major sediment storage areas for the coastal system. Major storms such as hurricanes flush out the inlet and the sand is transported laterally where it is used to absorb the storm energy in the beach zone.

southern tip of Sand Key, Treasure Island, and Long Key. There is one significant jetty in Pinellas County found on the south side of Clearwater Pass. Jetties are long structures that are intended to keep sand from flowing into a channel, and they trap sand in the same manner as a groin or terminal structure. This interruption of the flow of sand may direct sediment offshore and out of the beach zone. These structures keep sand from flowing to the next beach, causing erosion at downdrift locations. Areas in Pinellas County with groins and jetties have also been the sites of beach renourishment programs, in which sand is dredged from channels or offshore sites and placed on the beaches.

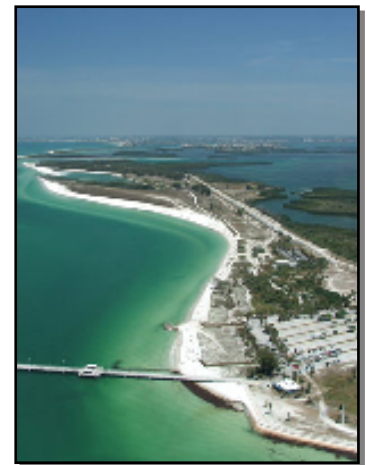
Mullet Key is a V-shaped island about 1,000 to 2,000 feet wide that has a 2.5 mile north-south segment and a 3 mile east-west segment extending into Tampa Bay. The key contains Fort DeSoto Park. The beaches are of predominantly fine grained sand with a shell hash. In the early 1970s, severe erosion occurred in the central portion of the north shoreline.

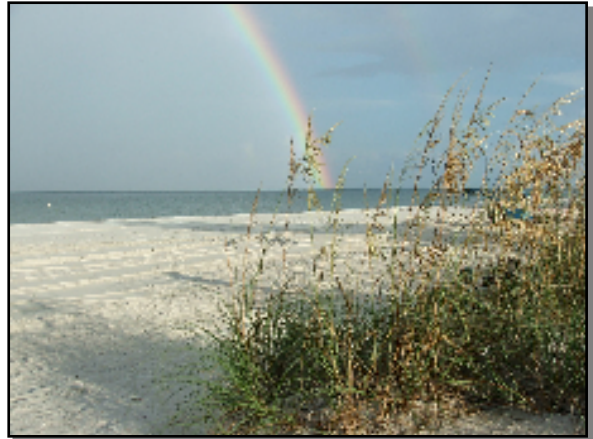
Dunes on Treasure Island

Natural dune systems used to extend throughout the length of Pinellas County's barrier islands. However, the primary dunes, which under natural conditions provide sand to the beaches, have been covered or destroyed along much of Pinellas County's barrier islands, and natural primary dunes of significance are found only on Caladesi Island, north Clearwater Beach Island, and portions of Treasure Island, Long Key and Mullet Key. Secondary dune systems can be found only on Caladesi Island and northern Clearwater Beach Island. Artificial dunes have been created on Clearwater Beach Island, on the northern portion of Sand Key, throughout Treasure Island, on the southern tip of Long Key, and in the Madeira Beach portion of Sand Key. The creation of additional artificial dunes on the barrier islands is planned in the near future.

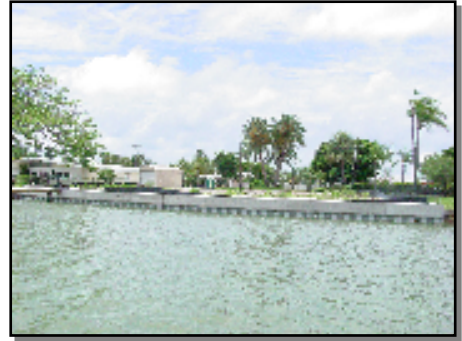
Seawall along an altered shoreline

Seawalls are another type of coastal protection structure. They can be large, massive structures designed to withstand storm wave impact loads, generally designed for a 20- to 50-year frequency storm event or greater. Many of the seawalls in Pinellas County have been placed seaward of buildings that were built upon the first, or primary, dune. Bulkheads are another type of coastal protection wall and were built primarily to protect exposed structures or to retain upland fill. They are generally designed for moderate to heavy wave activity. Seawalls and bulkheads deflect wave energy; however, they may accelerate beach erosion and steepen the offshore profile.

Placing seawalls and bulkheads in front of exposed structures constructed upon the primary dunes prevents the exchange of sand between dunes and beach. This results in the inability of the beach to supply new sand to the dunes and prohibits the dunes from nourishing the beach with sand during storms. Wave and current energy concentrates at the ends of coastal protection structures and causes erosion at these points.

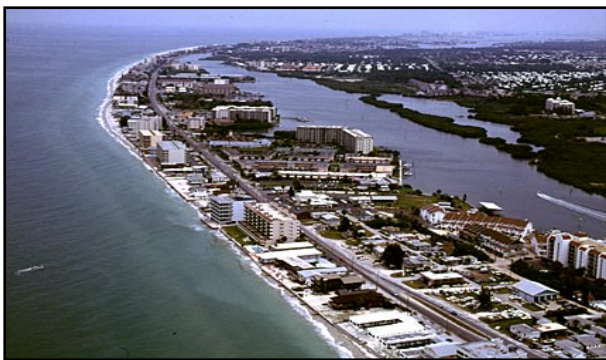
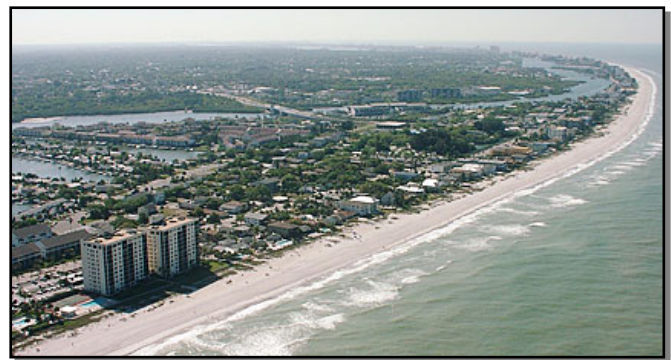
Sand Key before and after beach nourishment in the early 1990s

The initial nourishment of this project was accomplished in phases. In 1988, Sand Key Phase I placed 380,000 cubic yards of sand along 1.5 miles of shoreline at North Redington Beach and Redington Shores. In 1990, Sand Key Phase II nourished approximately three miles of the Indian Rocks Beach shoreline with 1.3 million cubic yards of sediment. In 1992, Sand Key Phase III nourished 2.9 miles of Indian Shores with the placement of 850,000 cubic yards of beach sand.

The 1998/1999 Sand Key Phase IV Project included the initial nourishment of the southern part of the Clearwater section of the island and Belleair Beach, as well as renourishment of Indian Rocks Beach, Indian Shores, Redington Shores, and North Redington Beach. This project provided 2.6 million cubic yards of sediment to 8.7 miles of beach.

The 2005/2006 Sand Key Beach Renourishment project placed 1.8 million cubic yards of sand along the same 8.7 miles of beach.

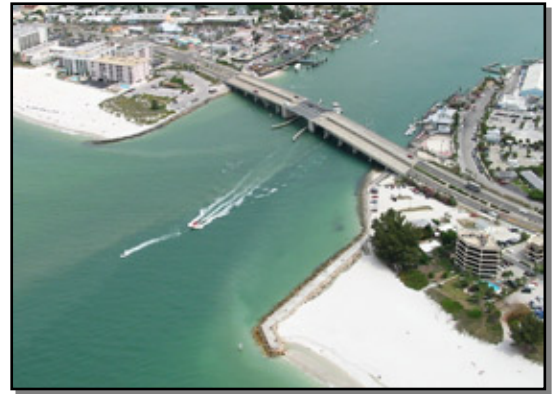
John's Pass

Since the inception of the federal project on Treasure Island, the southern half of the island (Sunset Beach) has been renourished through federal periodic renourishment efforts eight times, in 1971, 1972, 1976, 1983, 1996, 2000, 2004, and 2006. An emergency fill project placed 550,000 cubic yards of fill in 1986 due to damage done by Hurricane Elena. Fill was also placed on the northern end of the island (Sunshine Beach) in 1980, 1982, and 1991 as maintenance dredging disposal areas. An ECL (erosion control line) was established along the northern end of the island, and this segment is now a part of the periodic federal renourishment program. It was renourished in 2000 and 2006. A terminal structure (jetty) was constructed on the north end of Treasure Island, adjacent to John's Pass, in 2000.

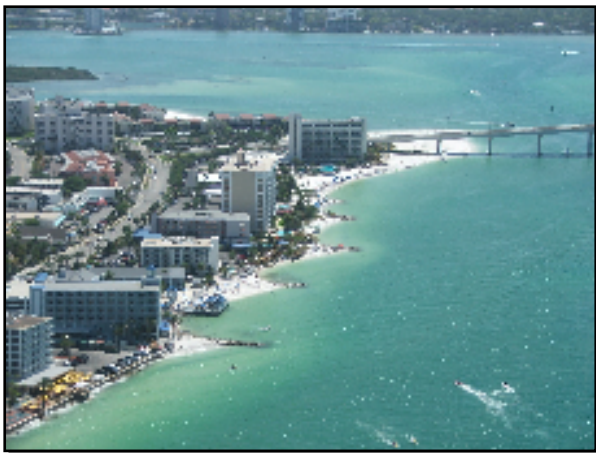
Groins on Clearwater Beach Island

Pinellas County's barrier island coastline has been subjected to severe erosion in several locations. As was described earlier, both hard and soft shore protection (structures and nourishment) have been implemented to protect the shoreline. Groins have been constructed on Clearwater Beach Island, Sand Key, Treasure Island, Long Key and Mullet Key. Groins are built on straight stretches of beach away from channels and inlets, and are intended to trap sand in the longshore current. Terminal structures are found at the end of islands near channels or inlets. These structures trap sand on

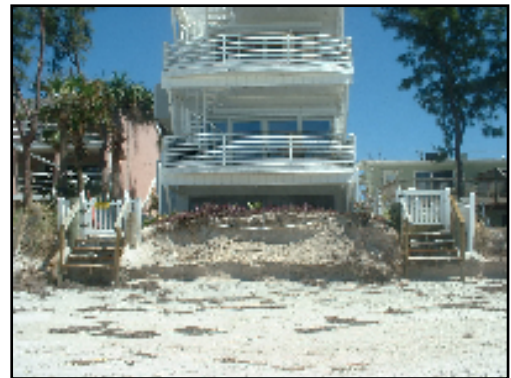
Dunes helped protect this home during the 2004 hurricane season

In most cases, the most effective and efficient coastal protection is provided by a natural or artificial beach and dune system. During Hurricanes Elena and Juan, damage to structures where beaches existed was the least; whereas, in areas where beaches were narrow or nonexistent, the damage to bulkheads and buildings was often extreme. In areas where man-made dunes have been created, such as on Treasure Island, adequate storm protection was provided to properties behind those dunes during the referenced storms.

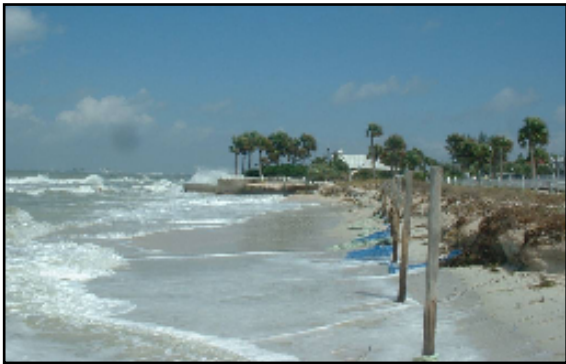
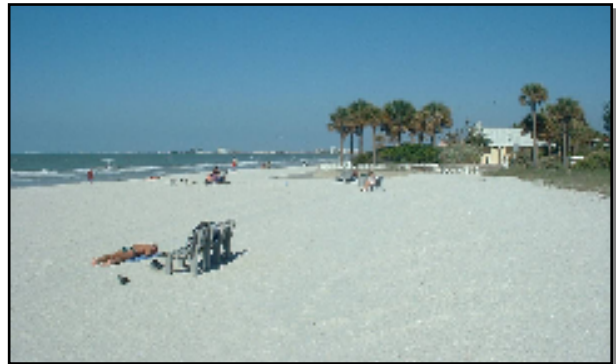
Pass-a-Grille Beach before and after nourishment in 2004 following Hurricane Jeanne

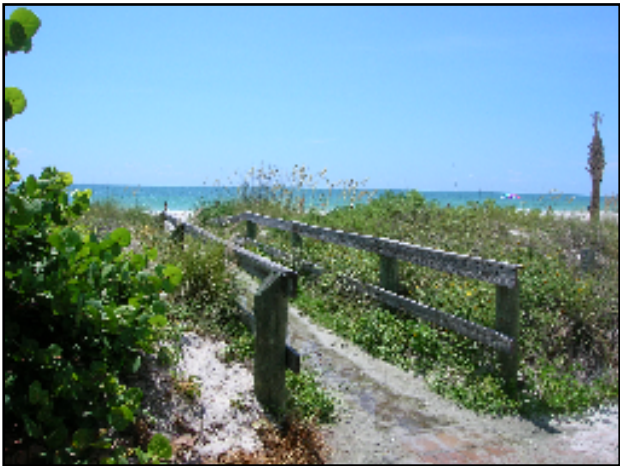
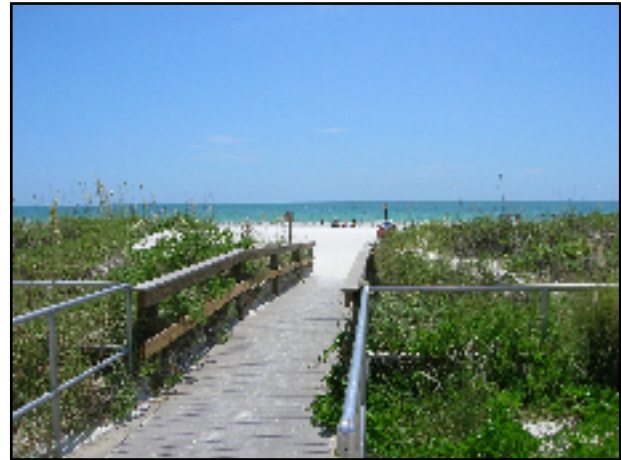
Dune walkovers help protect fragile vegetation from foot traffic.

Pinellas County has constructed in excess of 50 beach walkovers in the communities of Madeira Beach, Indian Shores, and Indian Rocks Beach, four dune walkovers in Treasure Island, and 20 dune walkovers and vehicle access structures along St. Pete Beach. The Coastal Management Program is updated annually through the County's Capital Improvement Program. Ongoing and future projects are listed in **Table 11**.
