STORM DATA EXCERPT FOR HURRICANE ANDREW - AUGUST 1992

NATIONAL OCEANIC AND
ATMOSPHERIC ADMINISTRATION

Damage Survey of Hurricane Andrew in South Florida by Ted Fujita

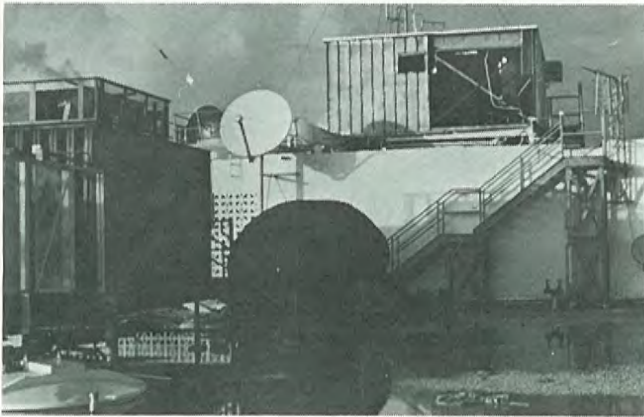
Above: A view of some of the wind damage to NHC's communications equipment atop the IRE Financial Building. The radar dome of the WSR-57 weather radar was blown off the highest structure seen at the center right of the photograph. *(Photo courtesy: Roger Edwards)*

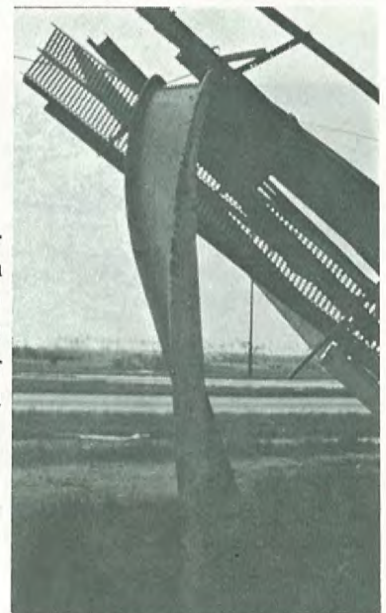
Right: An 18-inch wide structural I-beam bent and twisted in the Naranja community. (Photo courtesy: Ralph Clark) **Left:** Another royal palm tree near Homestead was pierced by a wind driven sheet of plywood. (Photo courtesy: NHC)

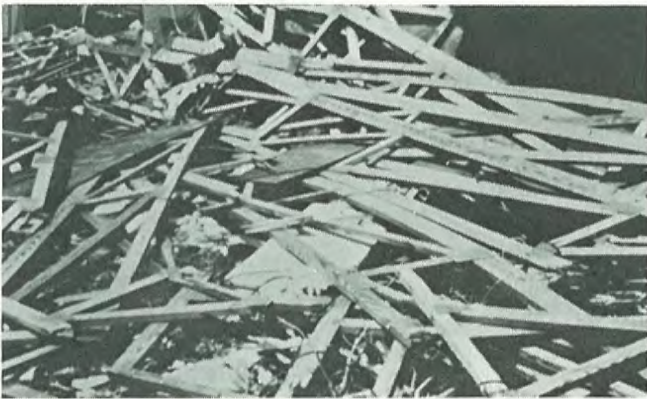
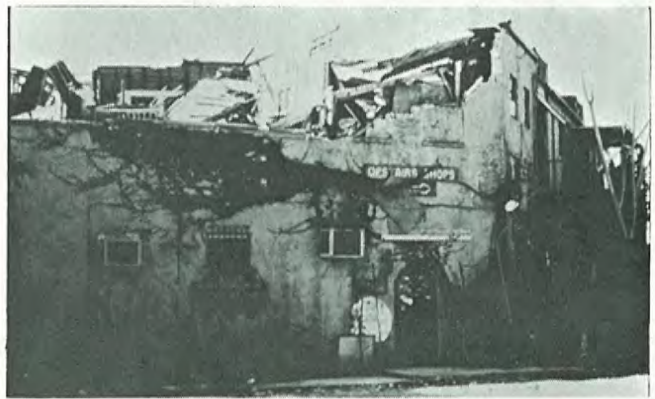
Above(left): Many roof trusses failed during the hurricane force winds. **Above(right):** These rustic shops were part of Gauley Square, a shopping area located north of Homestead. Both new and old buildings suffered significant damage. *(Photo courtesy: NHC)*

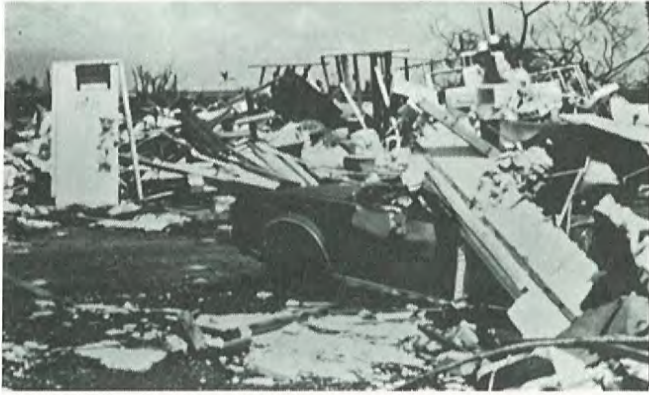
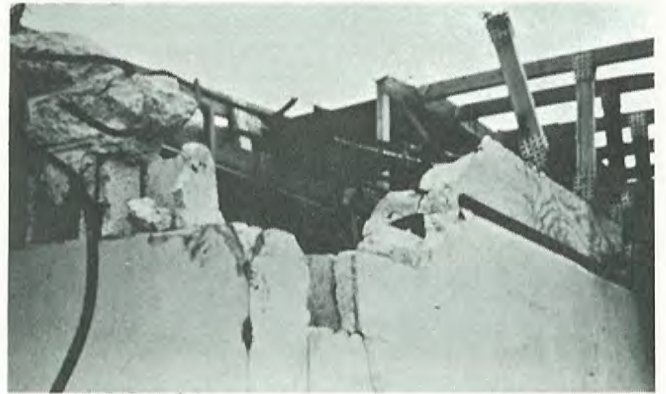
Above(left): Naranja Lakes homes were primarily concrete block and stucco (or CBS) construction. The force of Andrew's wind was strong enough to lift concrete tie beams and propel them into nearby structures. **Above(right):** This home in Naranja Lakes shows inadequate tie beam construction. Note that there were no vertical ties to the foundation. Many homes in Naranja Lakes lacked any vertical tie columns. *(Photo courtesy: NHC)*

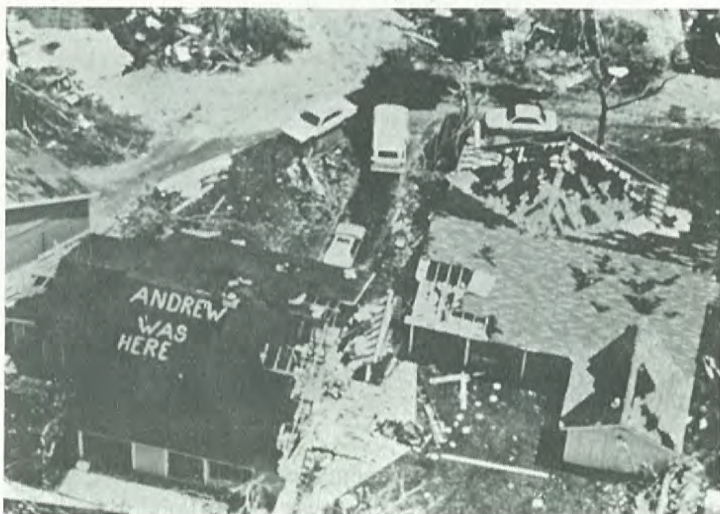
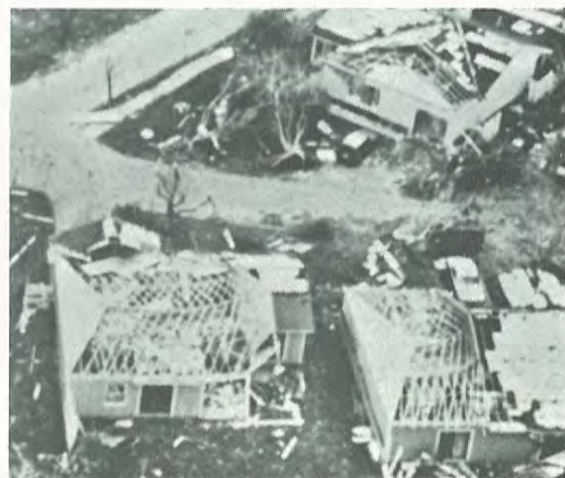
Above(left): Despite the devastation, some residents of Country Walk exhibited a sense of humor. **Above(right):** The roof structure of many homes in Country Walk development failed because of unsupported gables. (Photo courtesy: NHC)

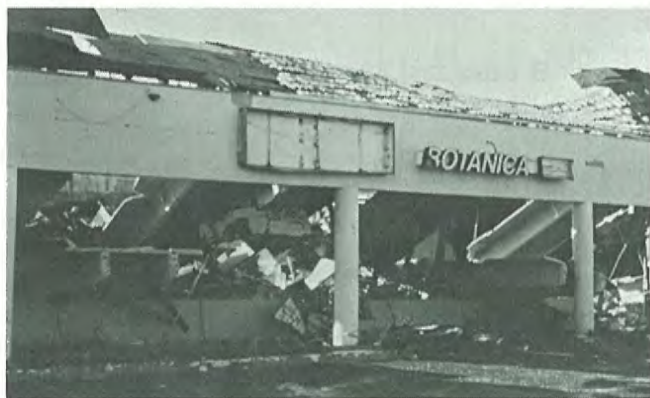
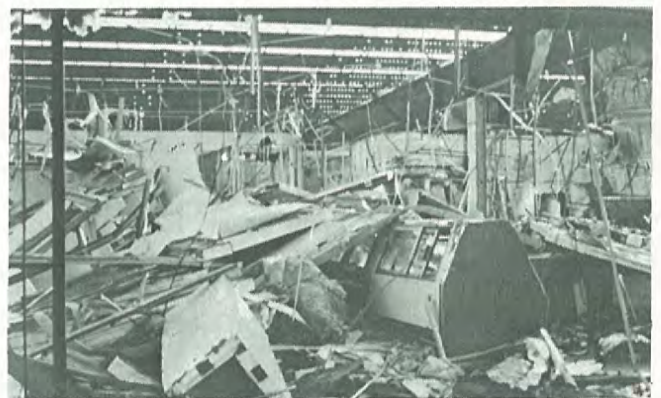
Above(left): Front view of the east (windward) face of a strip shopping center on the north side of Quail Roost Drive, near the Florida Turnpike. Winds flowing in through the broken plate glass windows, pushed the walls outward a sufficient distance to allow the pre-cast concrete roof to fall into the store. **Above(right):** View of the rubble inside a "Food Stop" convenience store, at the same shopping center. *(Photo courtesy: Roger Edwards)*

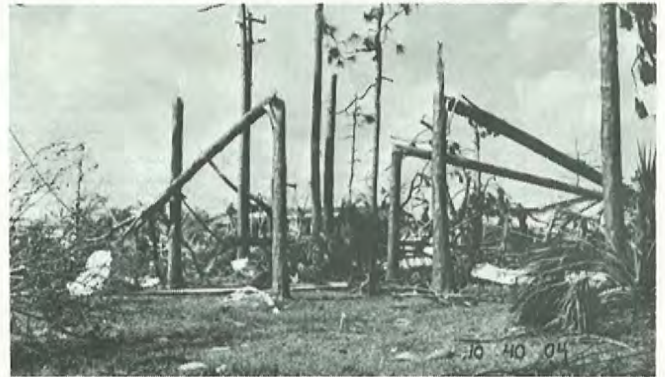
Typical damage of pine trees caused by the first and second winds. Numerous Australian pines were blown down by the first wind. Fujita photo 1040 EDT 9/9/92

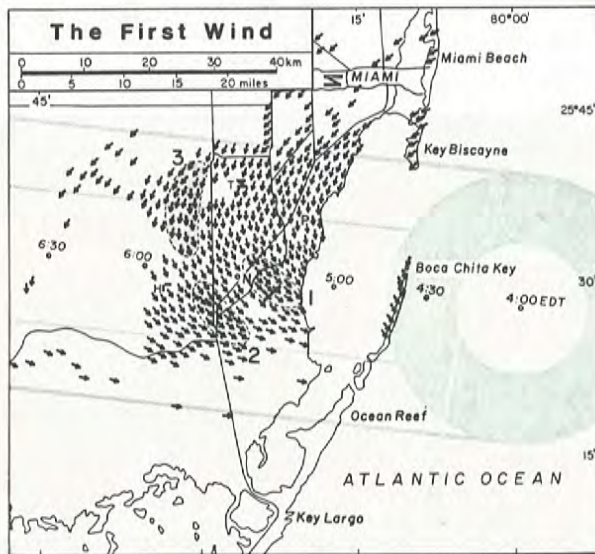
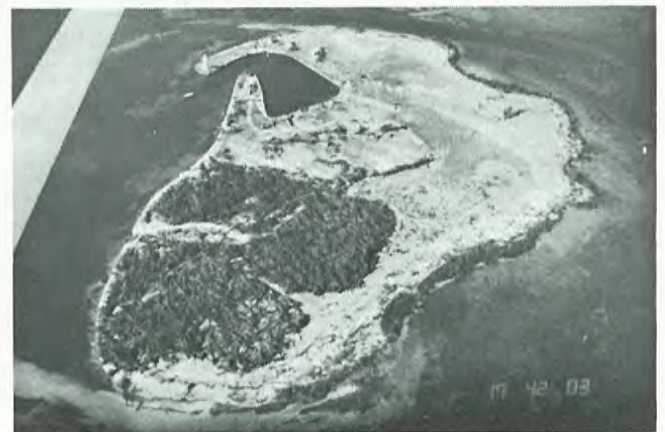
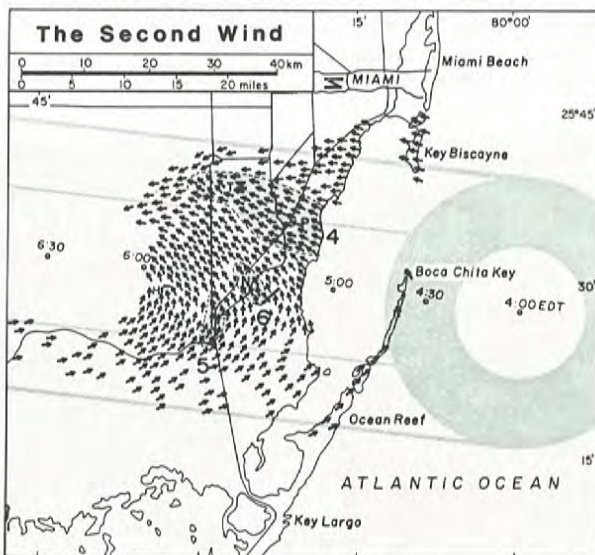
Above: Direction of the first damaging wind occurring during the approach phase of Andrew. Below: Damage by the second wind, during the receding phase.

Above: Boca Chita Key, 2 to 3 miles north of the eye center, received the first storm fury. Fujita photo 1742 EDT 9/7/92. Below: Damage map showing the average direction of the first wind from 10° and the second wind from 125°.

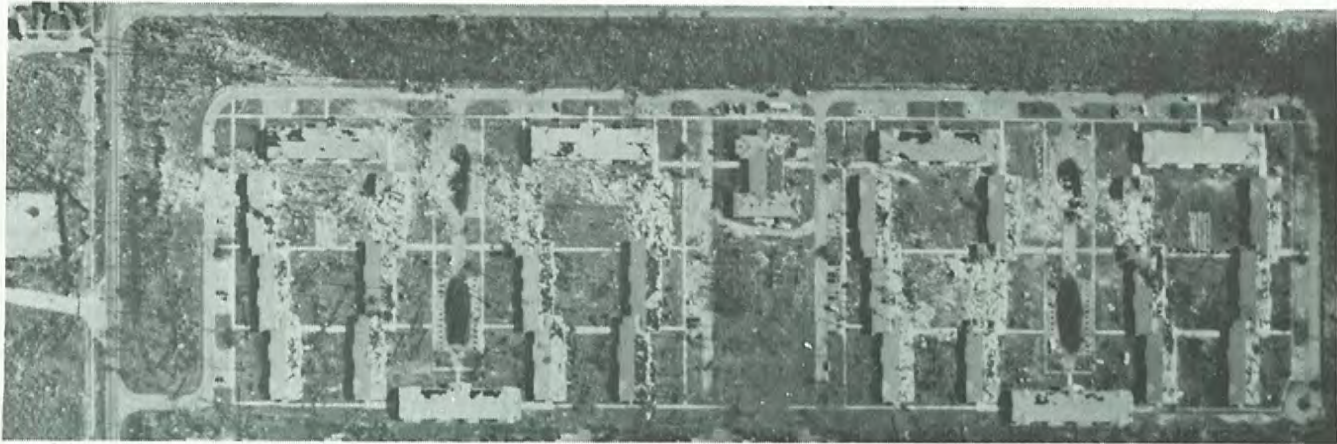
Mini-swirl Damage at Pine Woods Villa Southeast of 188 St and 87 Av SW

Above: Structural and tree damages at the Villa located inside the Tamiami Swath. Although trees were damaged by both first and second winds, the first wind did not cause structural damage, suggesting that the first wind was weaker than the second wind in the Tamiami Swath. The second wind caused the f1 damage to the east-side roofs while west-side roofs were not damaged (f0).
Below: An enlarged view of a 9"X9" vertical photo taken by Continental Aerial Survey on 8/27/92.

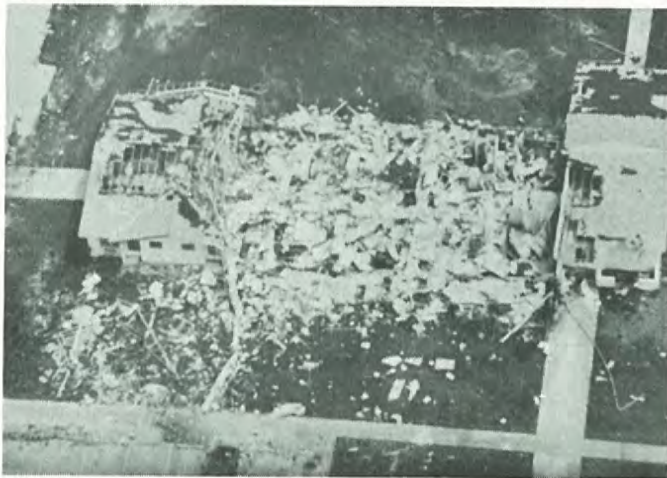
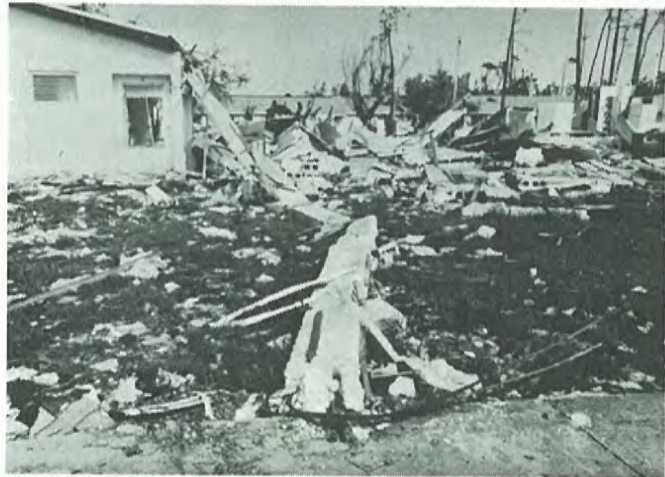
Left: Aerial photo of a tie-beam (see map) blown off toward the west. Fujita photo 1245 EDT 9/14/92.
Right: Ground view of the tie-beam reinforced with one-inch steel rods. Fujita photo 1649 EDT 9/15/92.

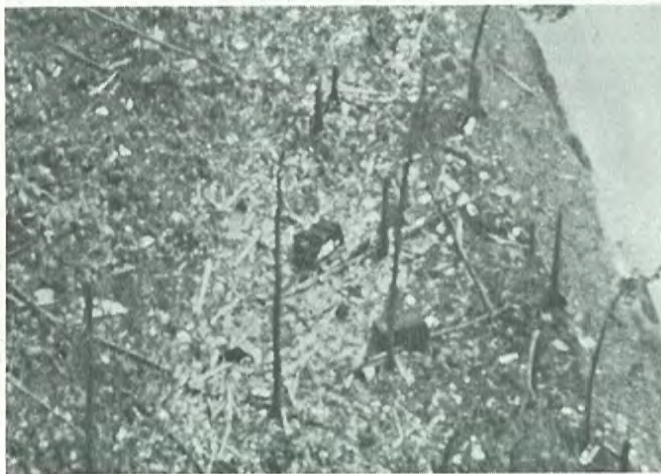
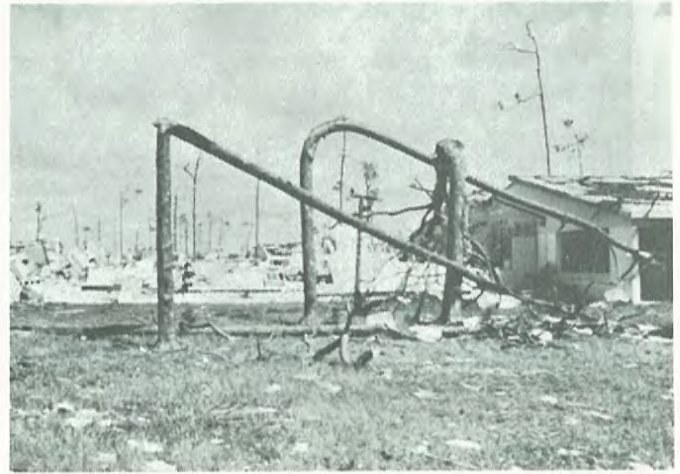
Left: A dumpster found inside the high-speed debris (see map). Some trees in this photo were blown down by both first and second winds. Fujita photo 1234 EDT 9/14/92. **Right:** Bi-directional tree damage seen near the dumpster site. Fujita photo 1109 EDT 9/9/92.

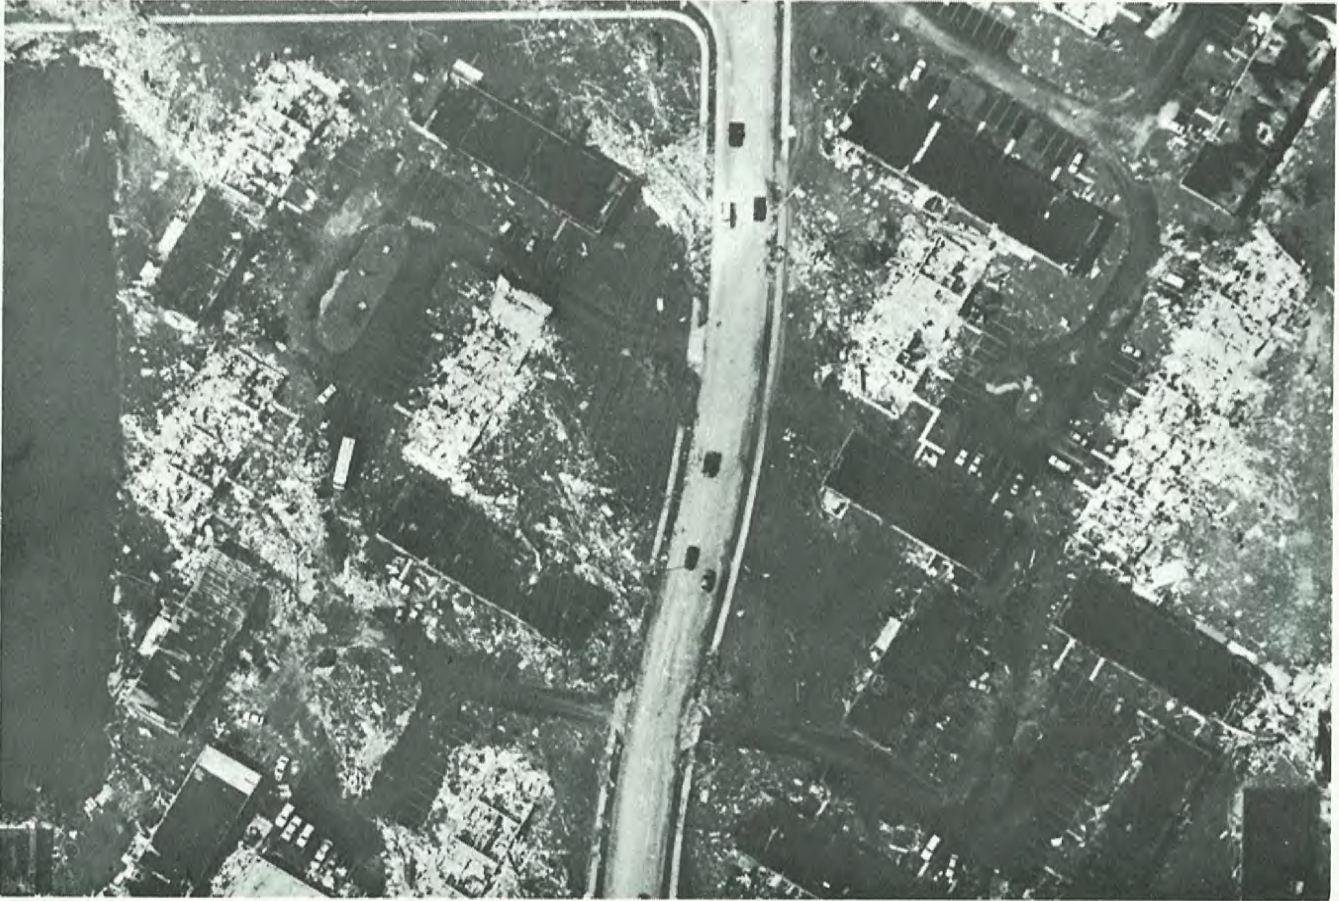
Condos at Naranja Lakes in Wind-parallel and Perpendicular Directions

Center of Andrew's eye passed directly over Naranja Lakes, resulting in a 180° shift of the first wind from NNW into the second wind from SSE. Many buildings oriented WSW-ENE (wind-perpendicular) direction received the f3 damage while those in the NNW-SSE (wind-parallel) direction were spared. Enlargement of a Continental Aerial Survey photo taken on 8/26/92.

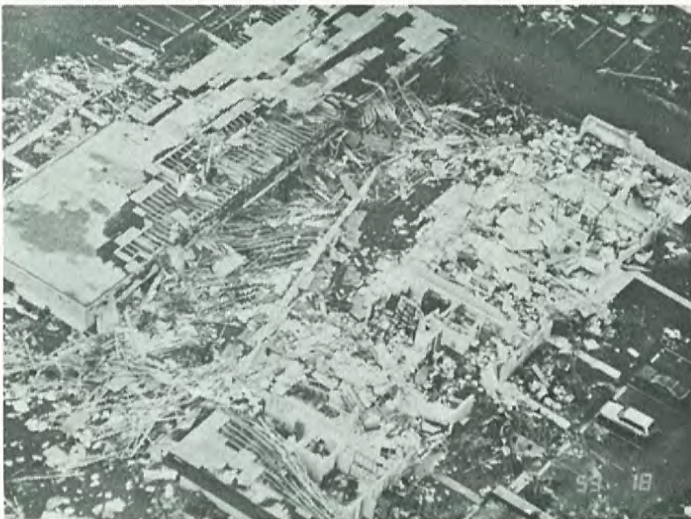
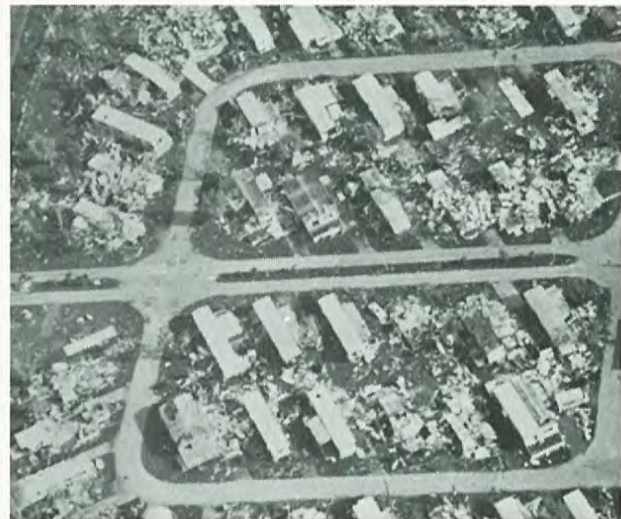
Left: A Naranja Lakes condo oriented in the wind-perpendicular (broadside) direction. The roof was lifted into a vertical position and dropped upside-down after a 180° rotation. Connected and broken tie-beams weighing one ton per 20 ft are visible on the downwind side. Fujita photo 1253 EDT 9/14/92. **Right:** Mobile homes at Naranja Lake oriented by luck in the wind-parallel (streamline) direction. Fujita photo 0906 EDT 9/8/92.

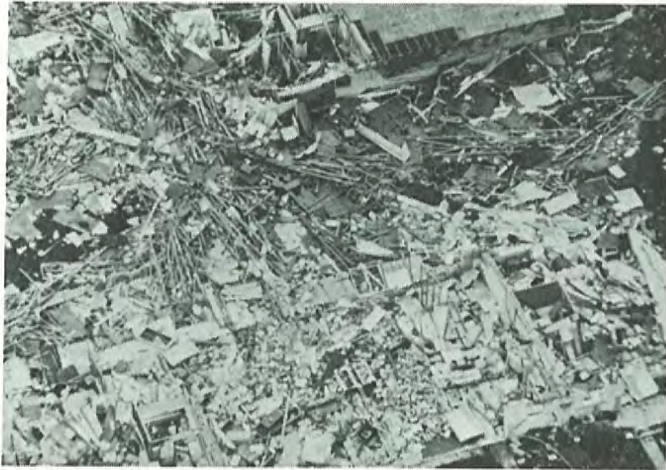
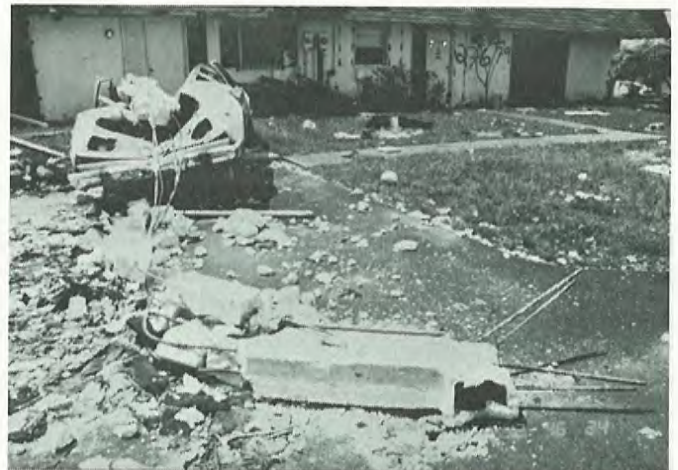
Left: An f3 damage of Naranja Lakes condo caused by a mini-swirl that formed inside the second wind. Fujita photo 1253 EDT 9/14/92. **Right:** Pieces of a connected tie-beam which flew 150 feet (45m) from a Naranja Lakes condo in the second wind. Fujita photo 1246 EDT 9/10/92.
