AIRCRAFT ACCIDENT INVESTIGATION REPORT

Japan Air Lines Co., Ltd.
Boeing 747 SR-100, JA8119
Gunma Prefecture, Japan
August 12, 1985

Aircraft Accident Investigation Commission
Ministry of Transport

June 19, 1987

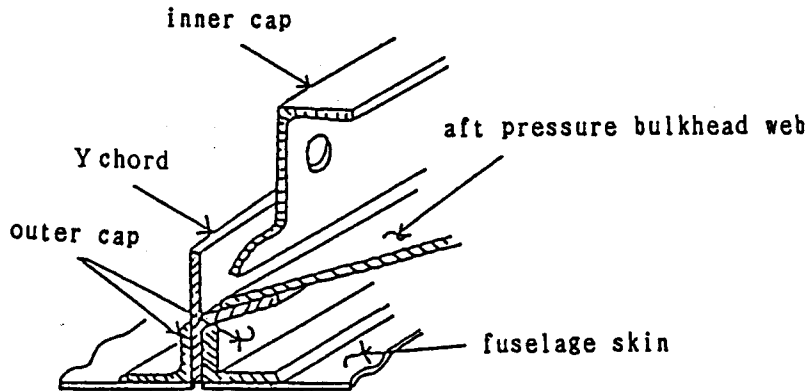
Figure-1 Cross Section of Joint of Y Chord and Fuselage

(3) In BS2360, the ringform chord of a Y-section (hereinafter referred to as "Y" chord, see Figure-1) retained on the whole its original circular form, although partly bent.

(4) A major part of the inner cap (a ringform angle of L-section having lightening holes) attached inside of, and along the Y chord was fractured and separated from the Y chord, and the rivets connecting the inner cap with Y chord were sheared off by forces at right angles to their shanks.

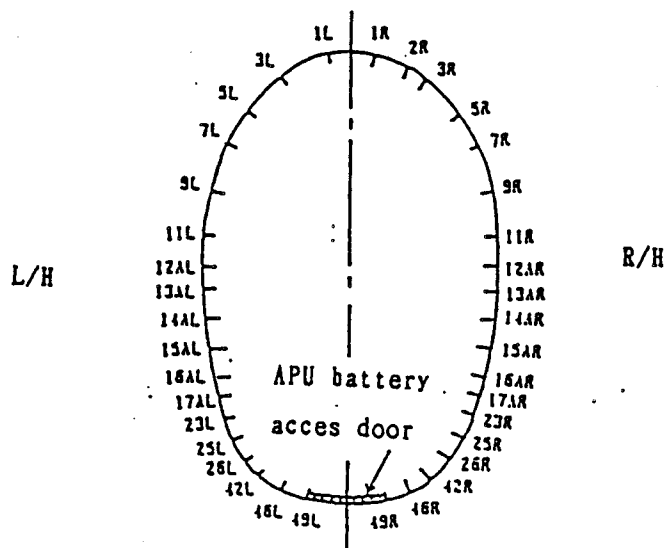
Figure-2 Cross Section of BS2658 where APU Fire Wall is attached (as viewed from the rear)

(5) Fractures along the circumference of BS2658 (where APU fire wall is attached) were as follows:

(a) Between fuselage stringer 1L (hereinafter stringers are represented by abbreviation only, where L indicates left side, and R right side) and 1R, the forward angle, doubler, and forward fuselage skin were all fractured on fastener row ① (see Photo-33).

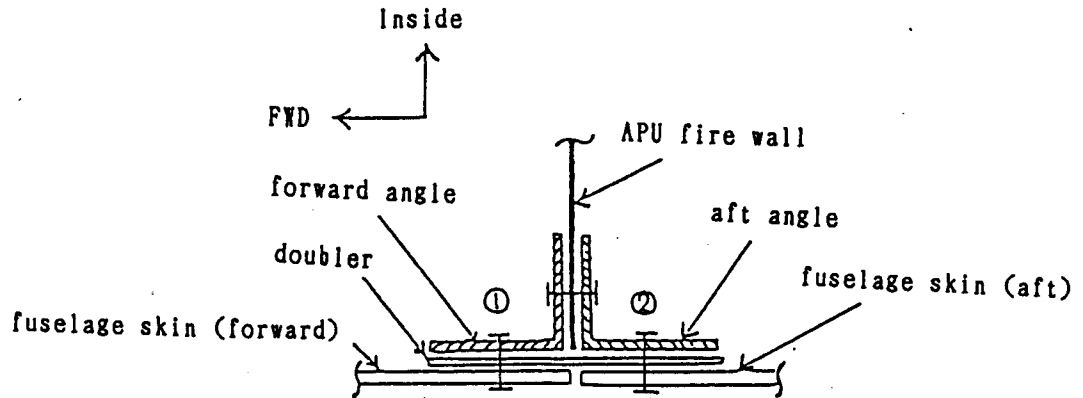
Figure-3 Cross Section of Joint of APU Fire Wall and Fuselage

(c) The portion Near 9R remained, the cross section shown in Figure-3 being kept unchanged. From 11R through 15AR a fracture was found on fastener row ②, only the doubler remaining in the rear. The doubler was fractured on fastener row ② by tension (see Photo-35).

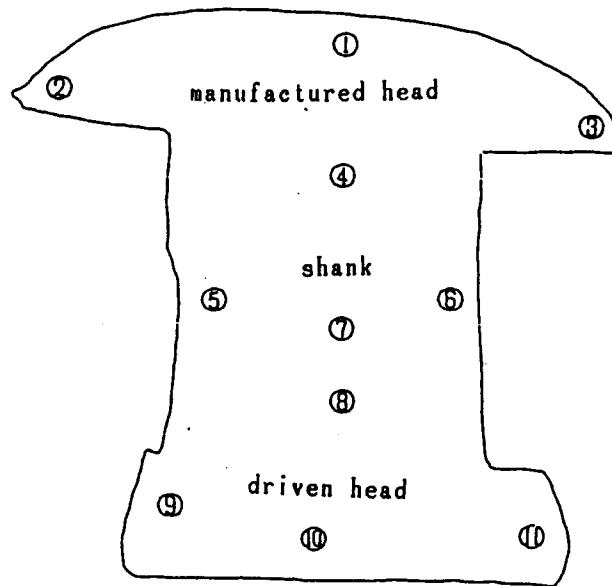
Figure-5 Hardness Distribution of L18 Stiffener in No.29 Rivet
BACR15BB-D Aluminum Alloy 2017-T3

Measured Points	Micro Vickers Hardness
	HV(500g)
①	144
②	134
③	142
④	154
⑤	137
⑥	156
⑦	149
⑧	154
⑨	166
⑩	179
⑪	170

Based on the results of the testing including the chemical analysis, microstructure inspection, and mechanical properties test above, it is verified that qualities of the structural materials used in the aft pressure bulkhead met specifications for materials of the aircraft manufacturer, and materials standards.

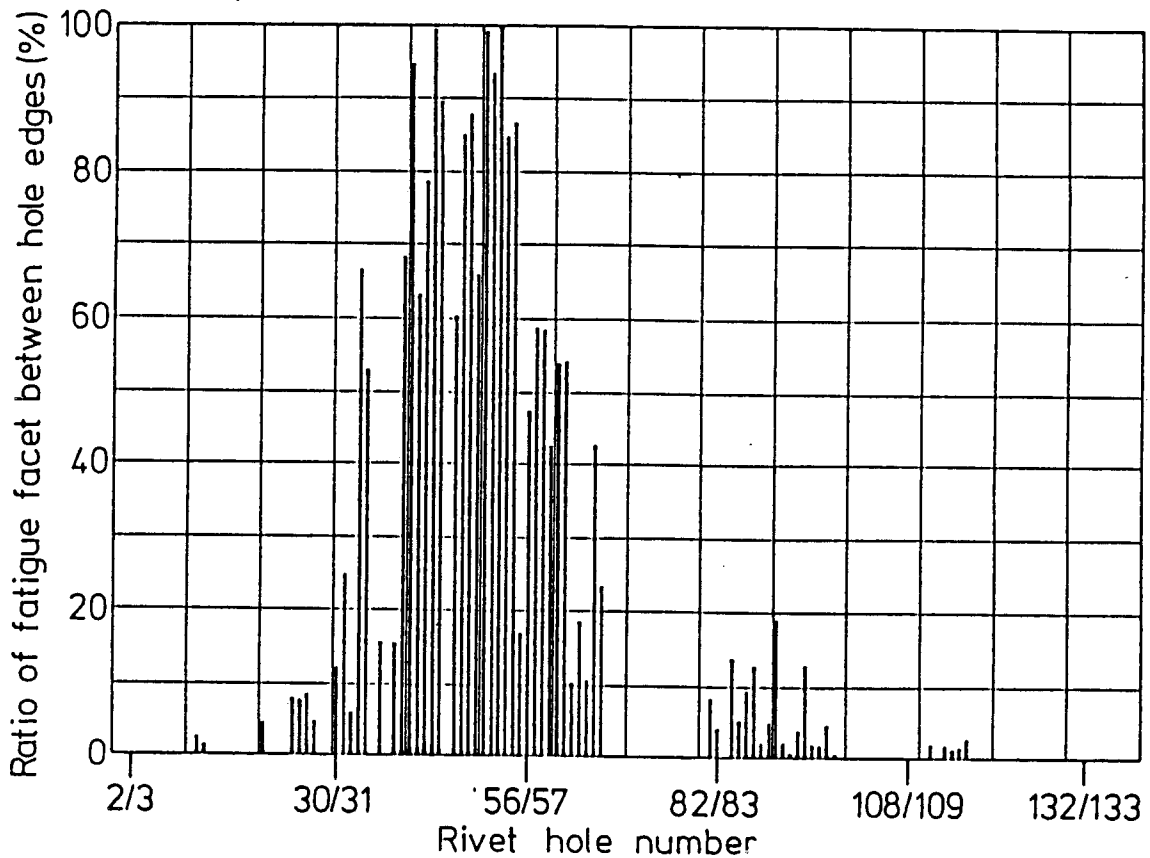
Figure-7 Distribution of Fatigue Failure Ratios between Hole Edges

Ratios of fatigue failure between the hole edges, when shown in a bar chart, are varying along stiffener L18 as in Figure-7 below.

(i) A number of fatigue cracks were under progress on rivet hole edges of L18 splice of the aft pressure bulkhead of the accident aircraft as shown in Table-4 and Figure-7. It is estimated that some of these fatigue cracks had reached as much as 10 mm in length at the time of No.11 C maintenance in December 1984.

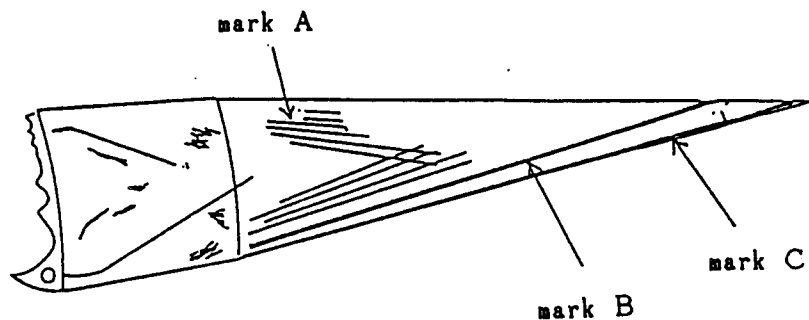
Figure-9 Stripped Contact Marks on Upper Surface of Lower Rudder

2.16.3.1 On the upper surface of the lower rudder, there were found striped contact marks which would have been caused by contact with gum seal installed on the under surface of the upper rudder. The state of the contact marks are shown in Figure-9.

2.16.3.4 An investigation made on several aircraft of the same type in current operation revealed the same marks on them as the mark "A" as shown in Figure-9. Therefore, the mark "A" is estimated to have been caused during the maintenance work.

2.16.3.5 Marks "B" and "C" in Figure-9 are estimated to be marks caused by adhesion of the gum seal installed under the surface of the upper rudder strongly compressed between the two rudders. Such severe compression to the gum seal does not occur during operation. The adhesion may therefore be estimated to have resulted from severe compression applied to the gum seal by the upper rudder when it was torn off. It was, however, impossible to clarify the process by which marks B and C were caused, because a little was recovered of the wreckage of the rudder.

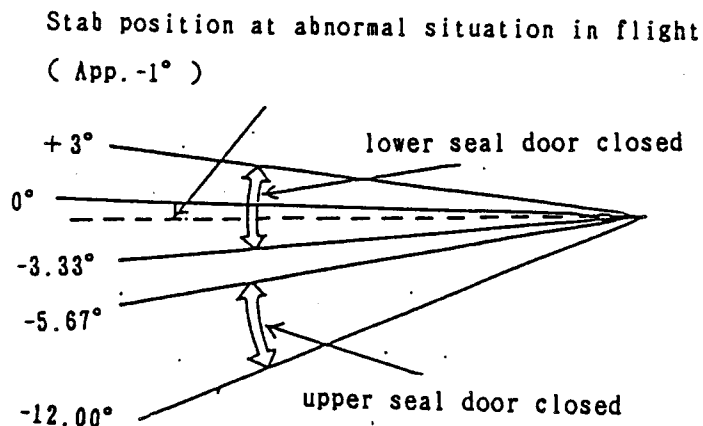
Figure-10 Relationship between Seal Door and Operative Angle of Horizontal Stabilizer

(4) Relationship between the position of the seal door and the operative angle of the horizontal stabilizer is shown in Figure-10.

Since the position of the horizontal stabilizer when the irregular sound occurred during flight over Sagami Bay is estimated to have been about -1° , it is estimated that the lower seal doors rose to seal the lower openings of the fuselage together with the sliding blade seals as shown in Figure-10 and Figure-11.

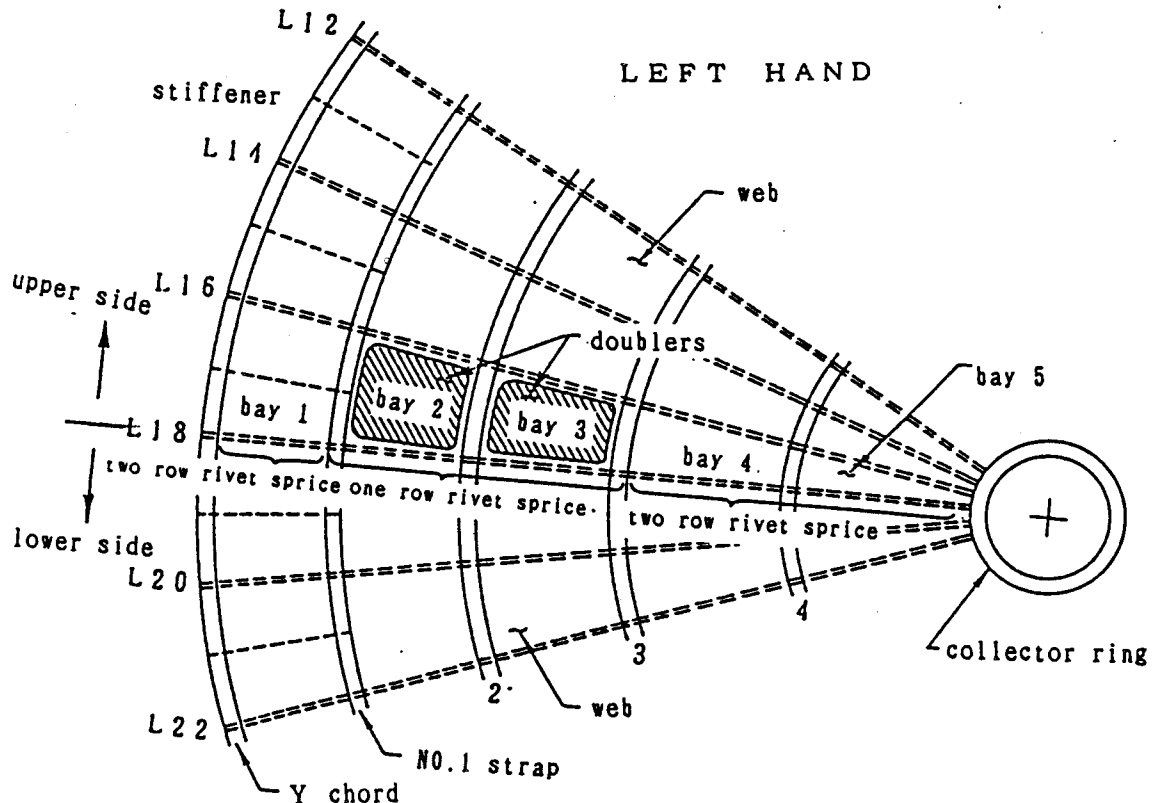
Figure-12 Vicinity of L18 Splice of the Aft Pressure Bulkhead

(2) The doublers applied to bay 2 and bay 3 of the accident aircraft as shown in Figure-12 have little effect on the stress distribution along L18 splice, and therefore have little effect on the propagation of fatigue cracks.

When L18 splice is broken into two portions, upper and lower, the stress of bay 5 connected with a collector ring increase. This indicates a possibility that the connection of the web and the ring is then ruptured towards a series of succeeding ruptures.

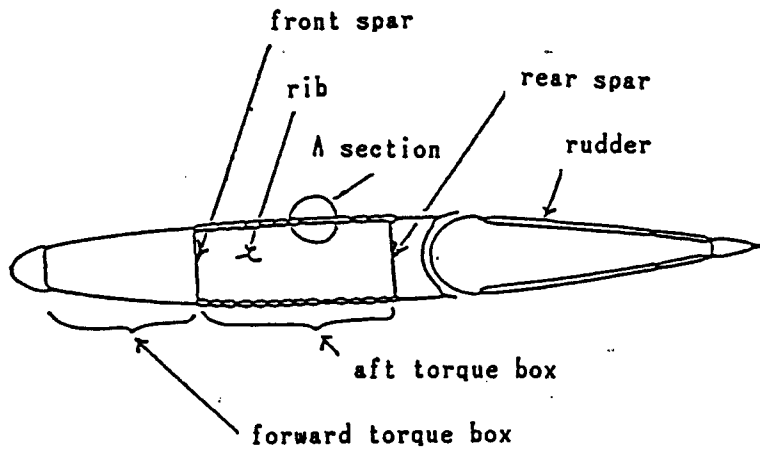
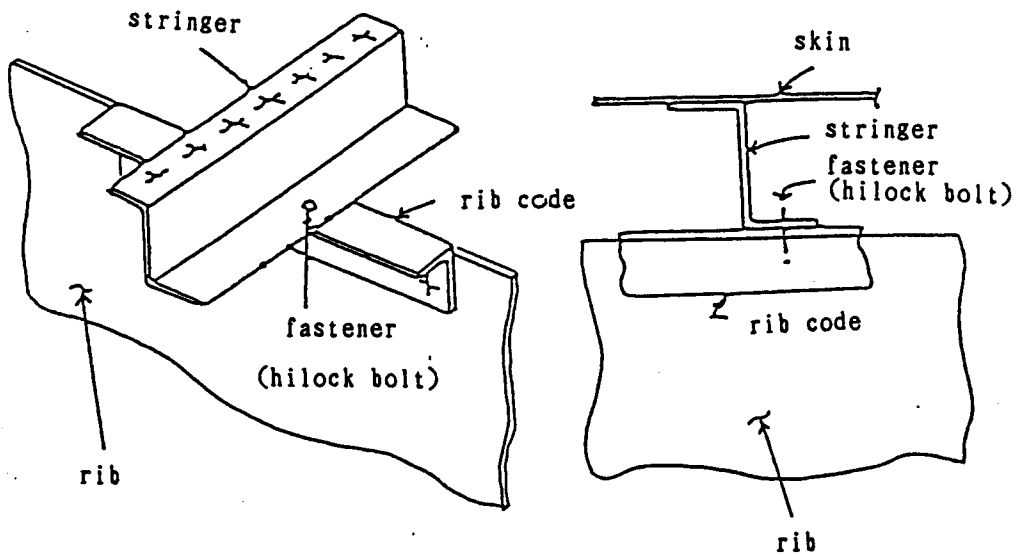
Figure-13 Fixture between Stringer and Rib Chord

The skin of aft torque box of the vertical fin, as shown in Figure-13, is connected to the rib through the stringers. The calculation indicated that when the internal pressure is applied to the vertical fin of such a structure,

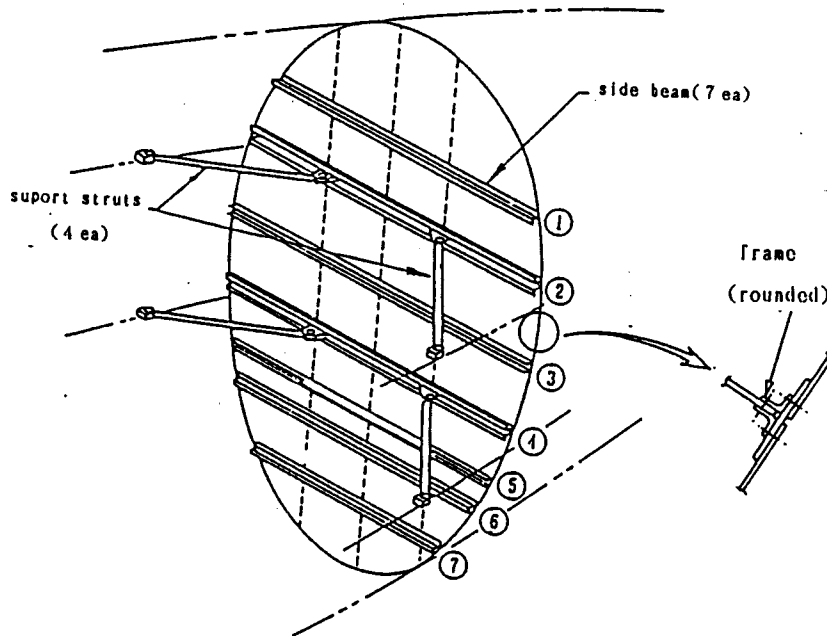
Figure-14 Outline of APU Firewall Structure .

- (5) The time required for the pressure to the APU firewall to reach about 4 psi is estimated to be extremely short, and therefore the rupture would have been momentary and impulsive. However, the actual process of destruction would have been more complicated than that estimated in the above calculation which based on static analysis.

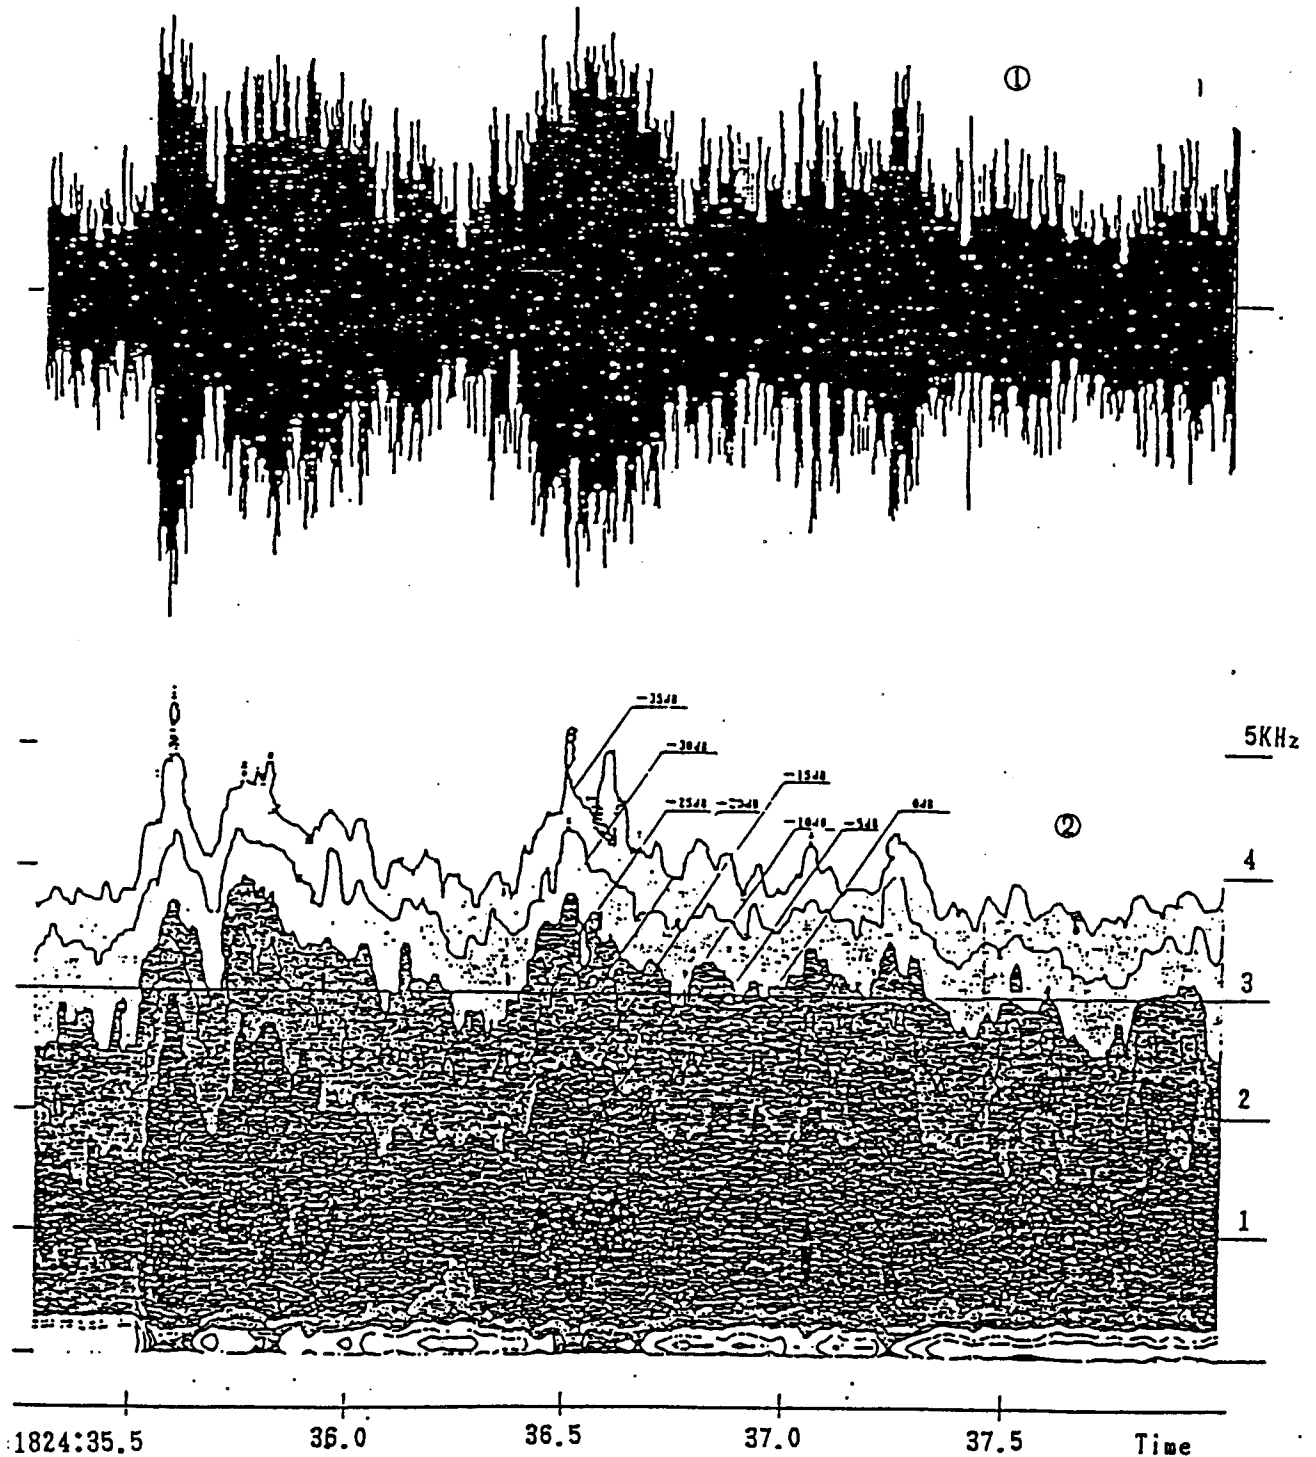
Figure-16 CVR Playback Wave and its Sound Spectrogram
CVR Playback Wave ① and its Sound Spectrogram ②

A sound like "bang" was heard from 1824:35.5-35.6 to 1824:37.0. The frequency analysis made on playback signals of CVR around this period indicated that the sound was composed of several groups. The played-back wave of CVR and its sound spectrogram are shown in Figure-16.

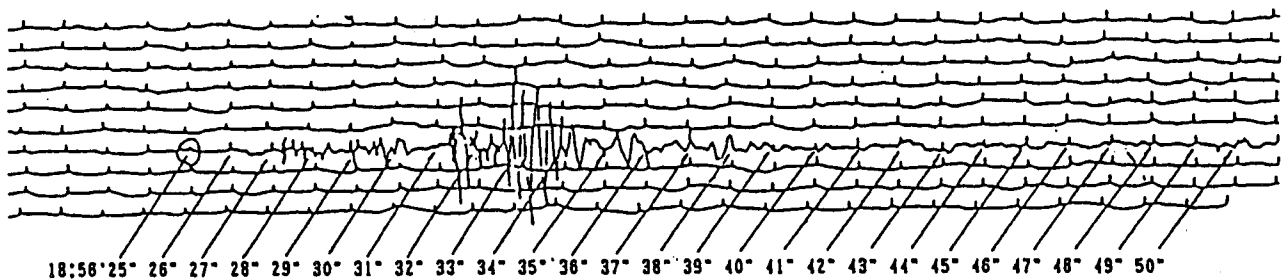
Figure-17 Recorded Seismic Shock Wave

A seismic shock wave regarded as related to the crash of the aircraft was recorded on a short-period seismometer installed in Shin-etsu Earthquake Observatory of Seismological Laboratory of Tokyo University, located at the point (elevation 1,430 meters, 35° 56' 25" N, 138° 40' 28" E) about 7 km (horizontal direct distance) SSE of the crash site of the aircraft. (see Figure-17)

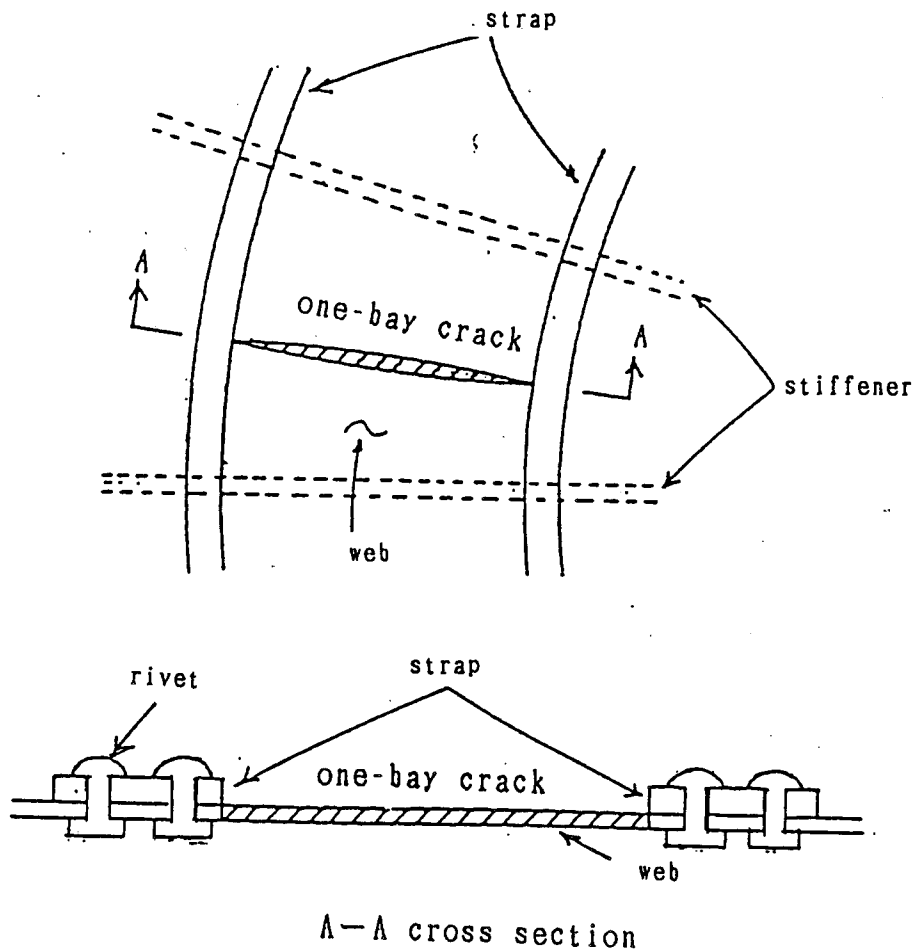
Figure-18 Failsafe Analysis of the Aft Pressure Bulkhead

In the design of the bulkhead of the aircraft, the residual strength is verified analytically with the condition that the bulkhead with one-bay crack shown in Figure-18 can withstand the expected maximum cabin pressure differential (the maximum operating pressure of the over pressure relief valve: 9.4 psi) considered as the fail-safe load.

It is conceivable that the premise of the one-bay fail-safe, that is, a crack was detected and repaired while it was staying within one bay, collapsed for the reasons that it was difficult to detect the fatigue cracks of the accident aircraft by visual inspection or by air leakage because the cracks were small and propagated along rivet holes at web overlaps.

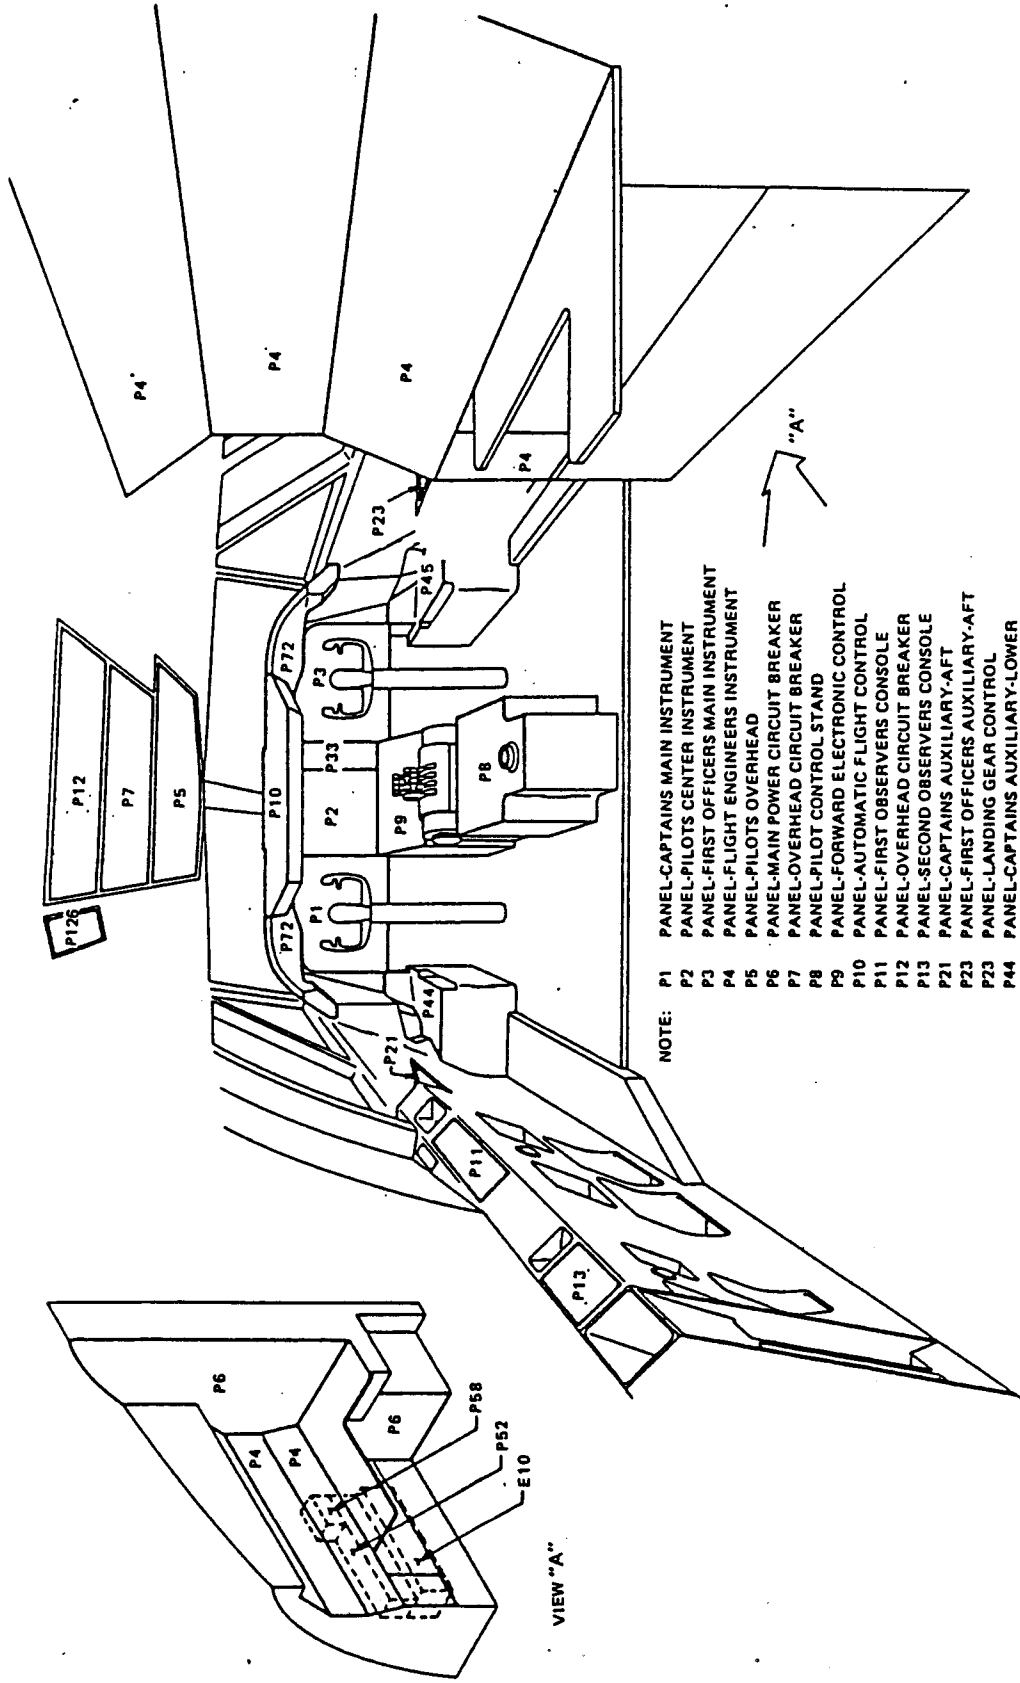
12 Flight compartment panels

It was very difficult to identify systems or to judge on their operational status, because the wiring, electric bulbs, switches and circuit breakers equipped to P2, P4, P5 and P6 were severely damaged or contaminated (see Attached Figure-12).

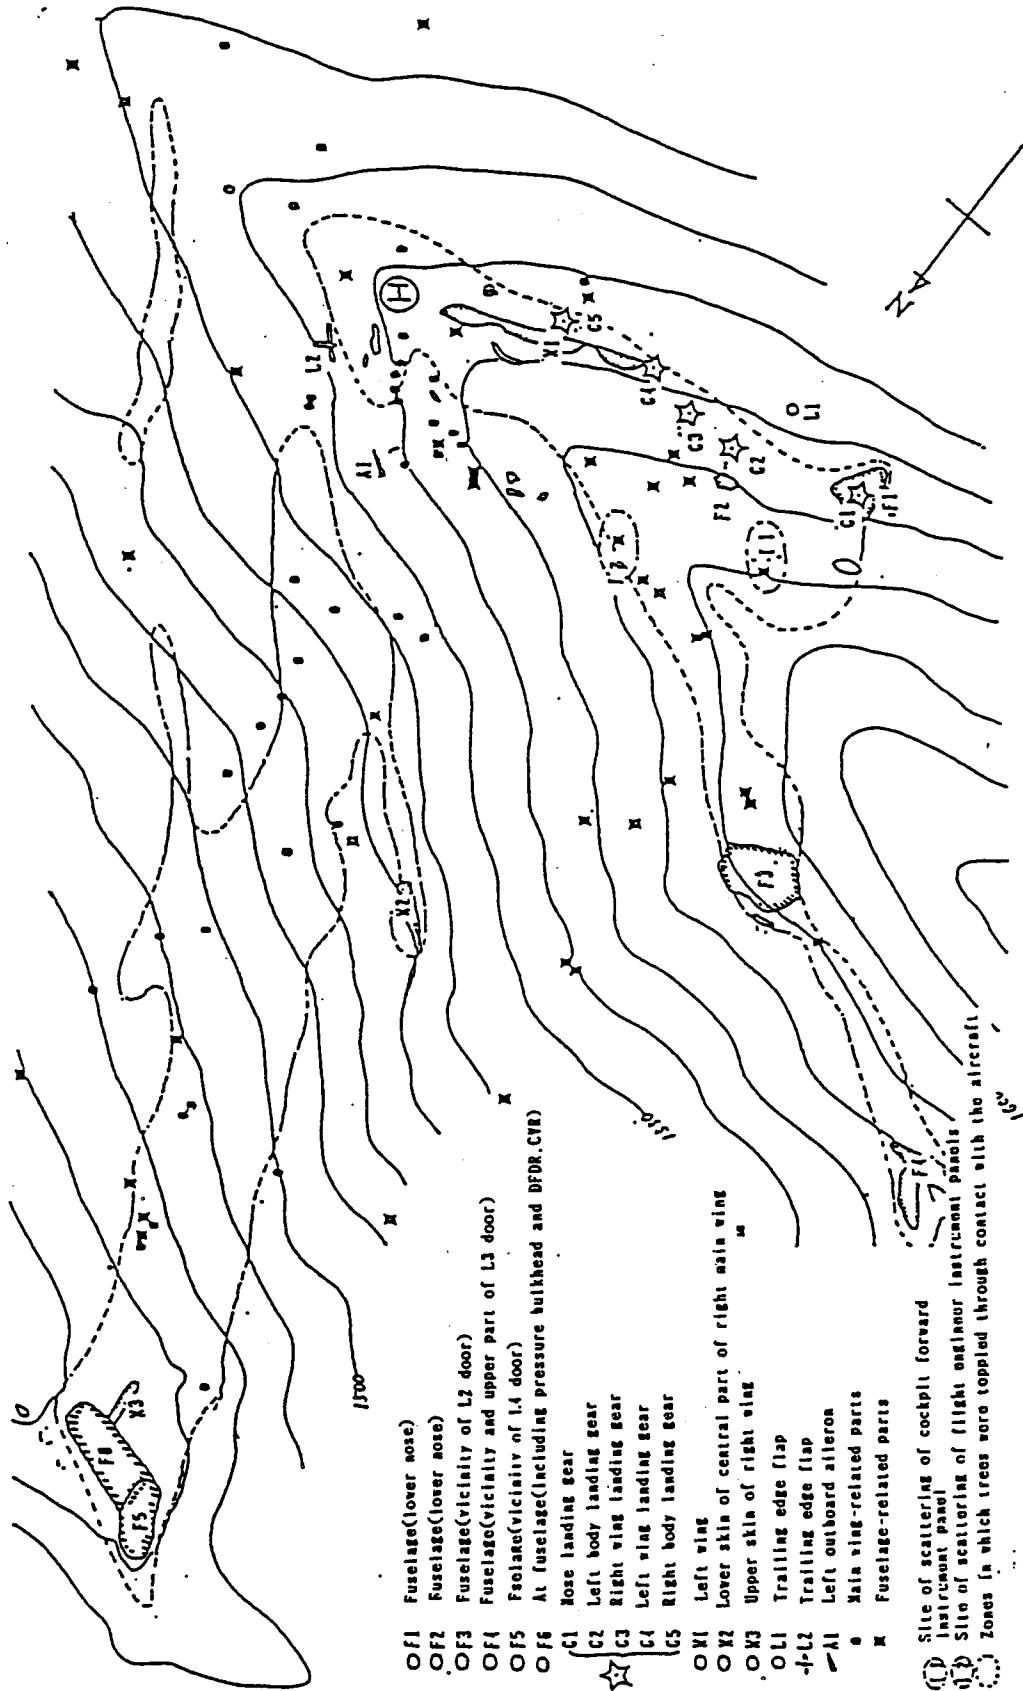
14 Distribution of wreckage - crash site

(1) Status at the crash point (see Attached Figure-14 and -15)

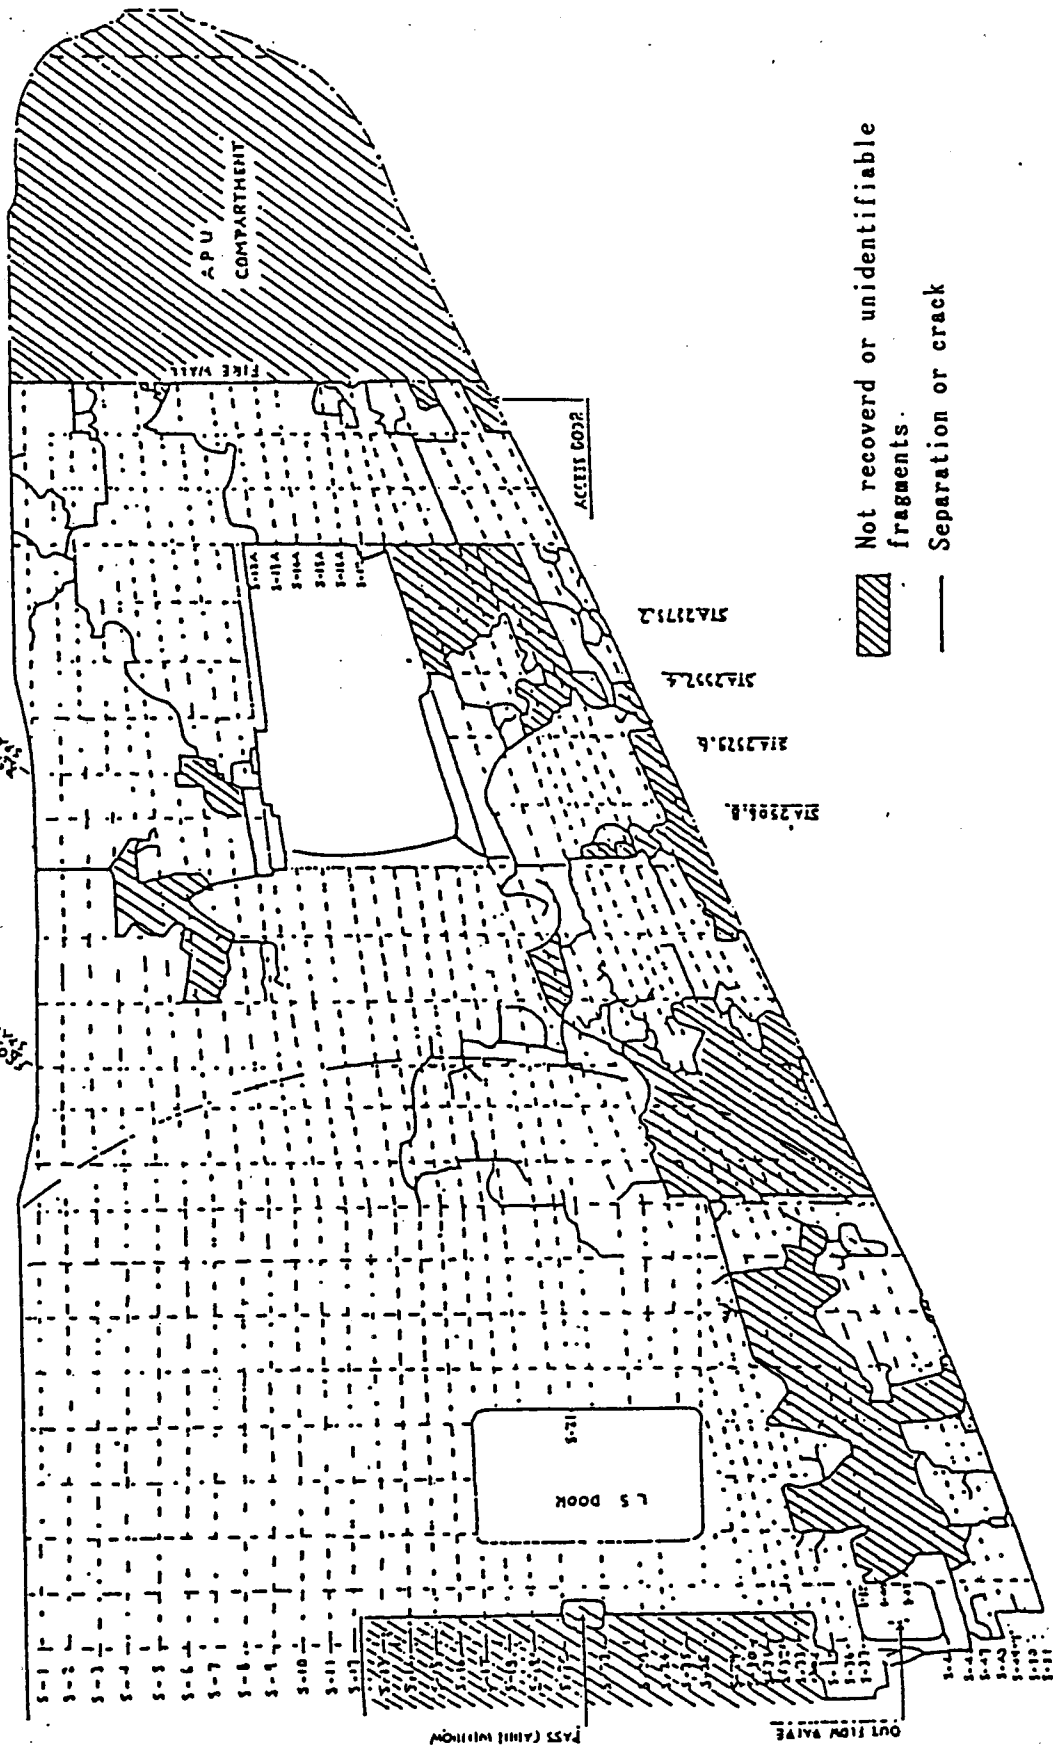
25 Damage to aft fuselage (left side)

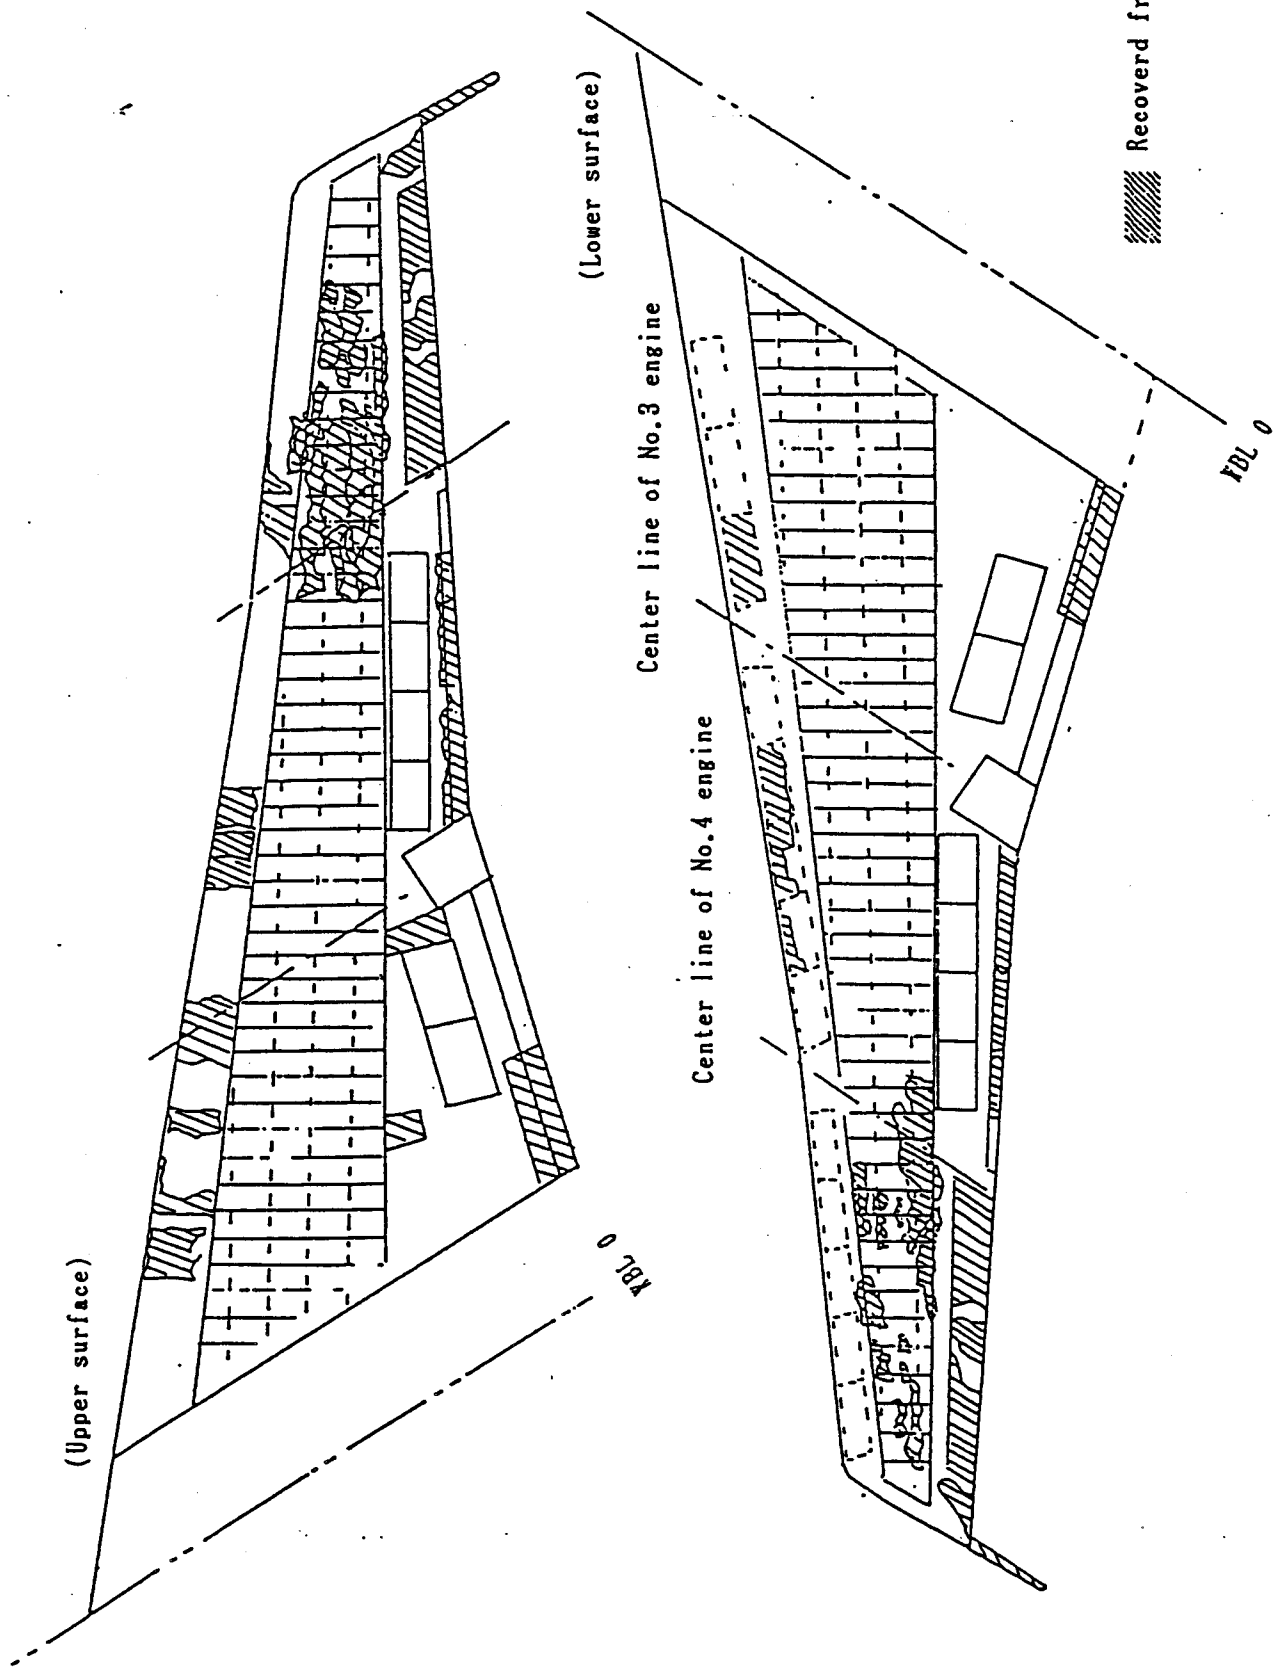
29 Right main wing recovered between single large tree and impact point

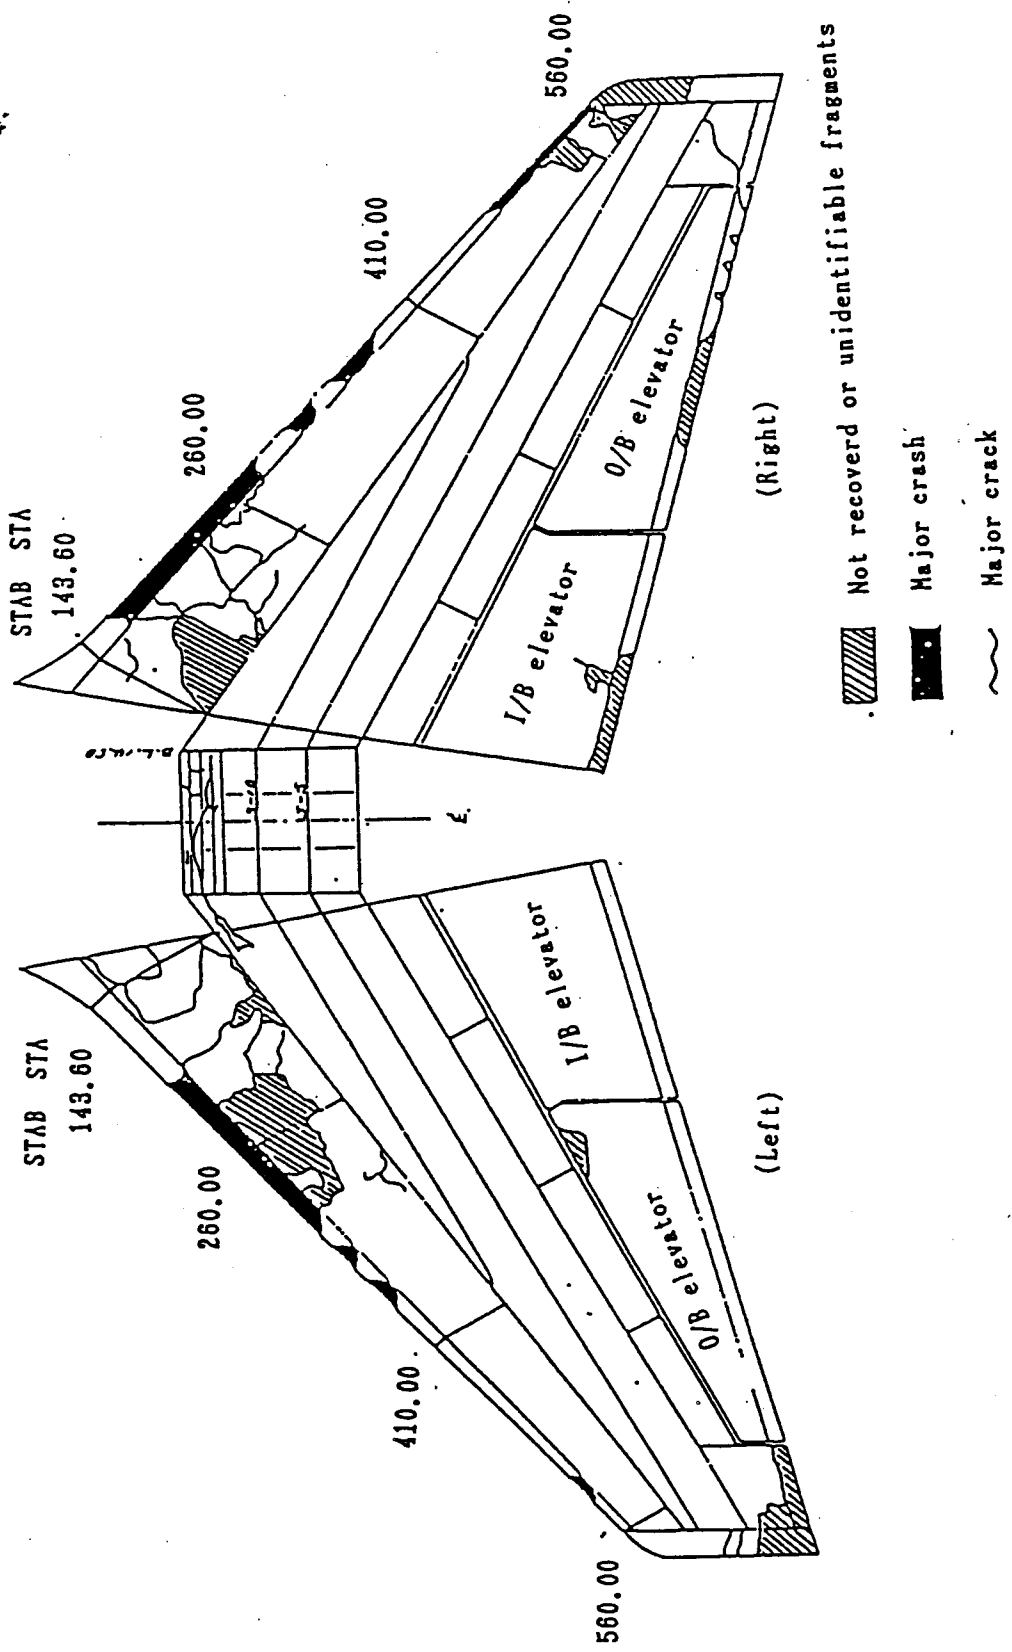
30 Damage to horizontal stabilizer (upper surface)

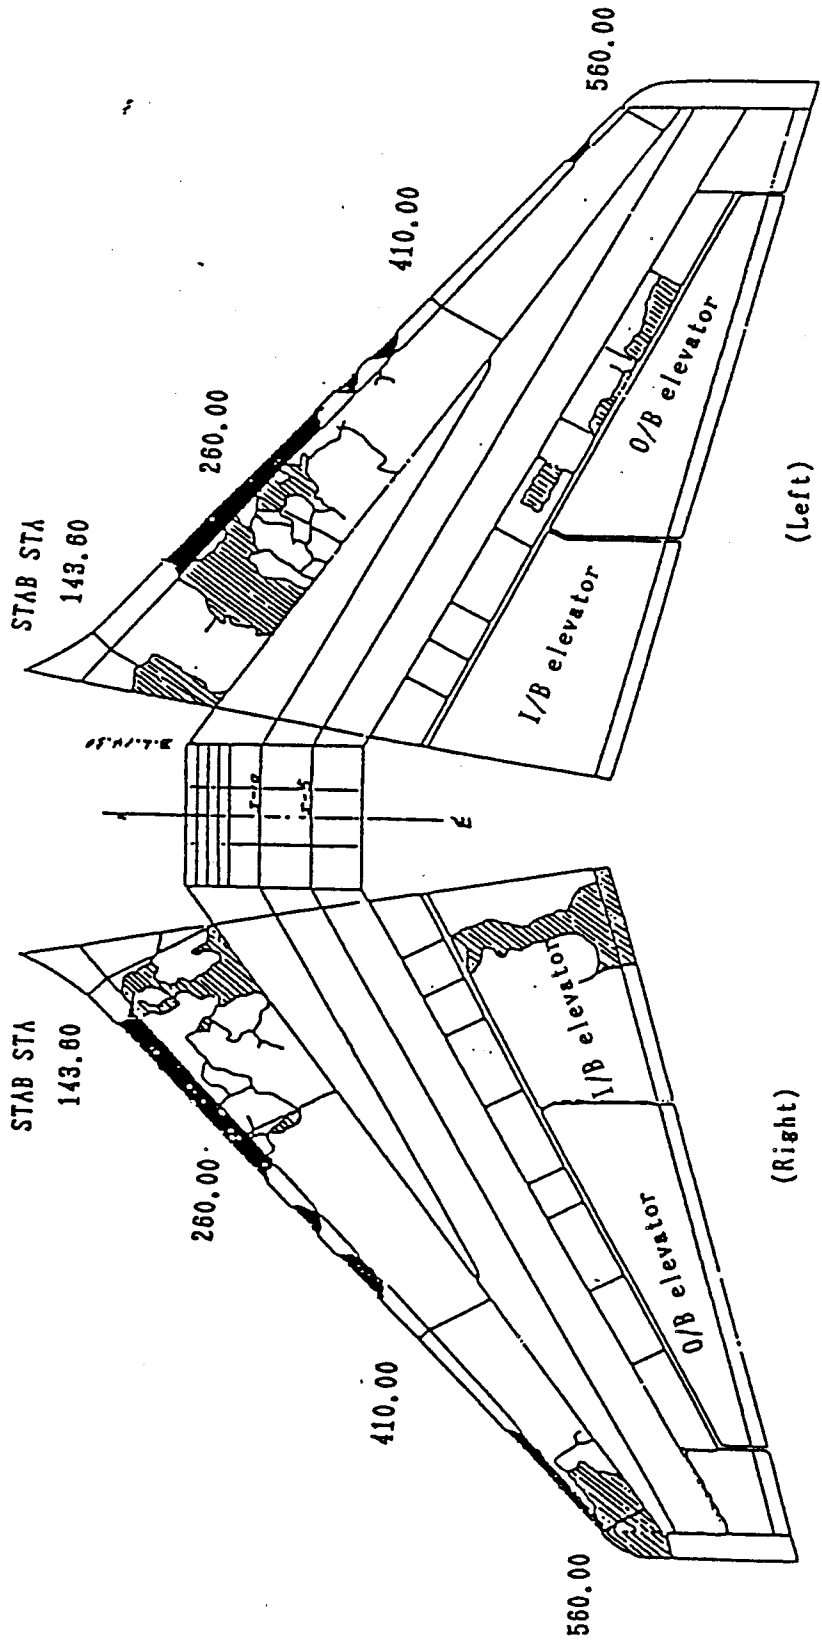
31 Damage to horizontal stabilizer (under surface)

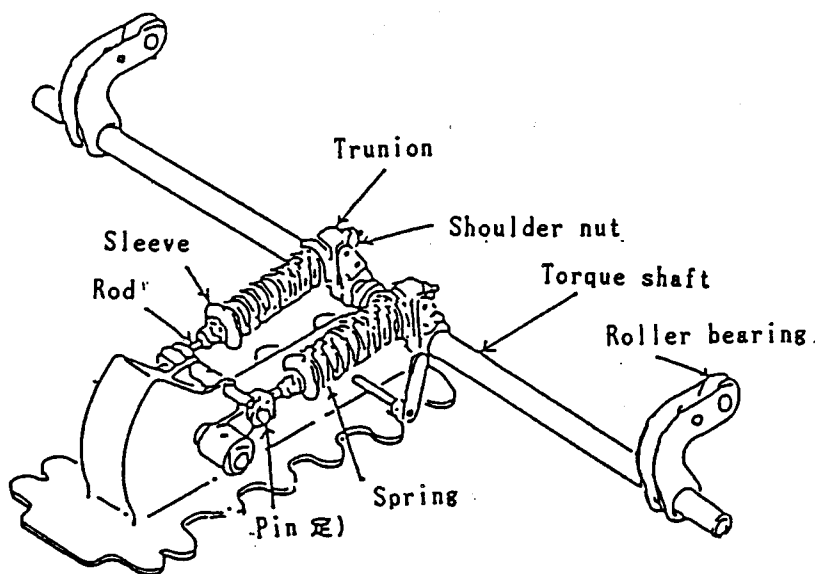
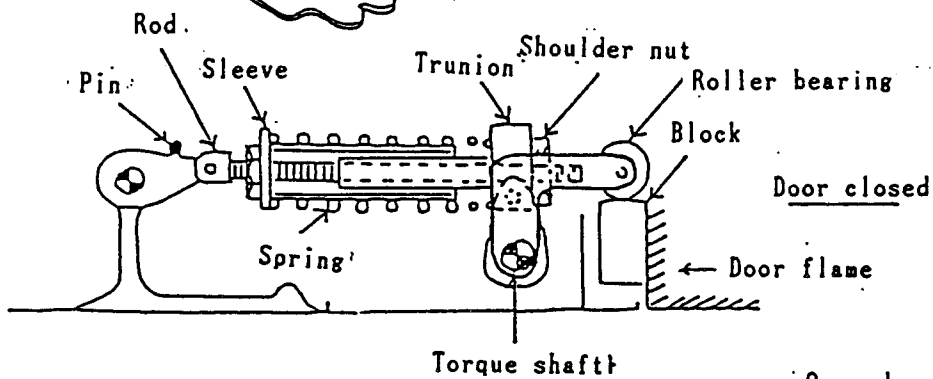
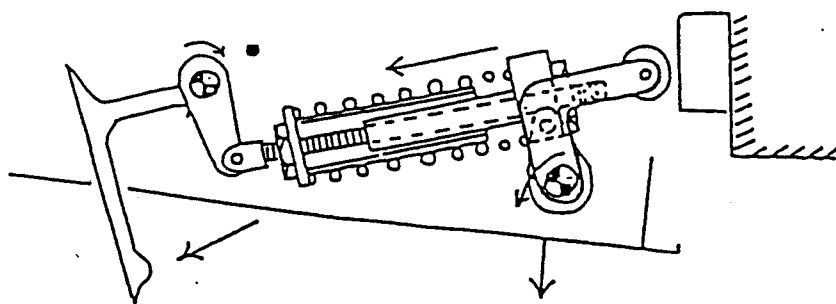
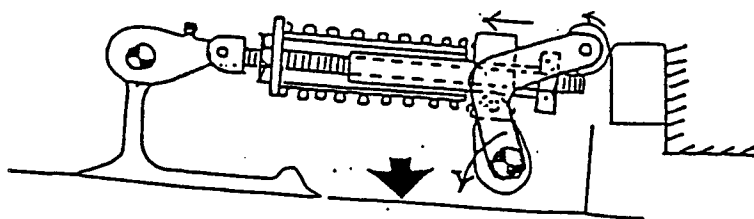
33 Latch mechanism of pressure relief door

Opened manually

Trunion don't slide on the Shoulder nut.

Opened without manually

Door will be opened without manually, the trunion slide on the shoulder nut against spring force
