AIRCRAFT ACCIDENT INVESTIGATION REPORT

Japan Air Lines Co., Ltd.
Boeing 747 SR-100, JA8119
Gunma Prefecture, Japan
August 12, 1985

Aircraft Accident Investigation Commission
Ministry of Transport

June 19, 1987

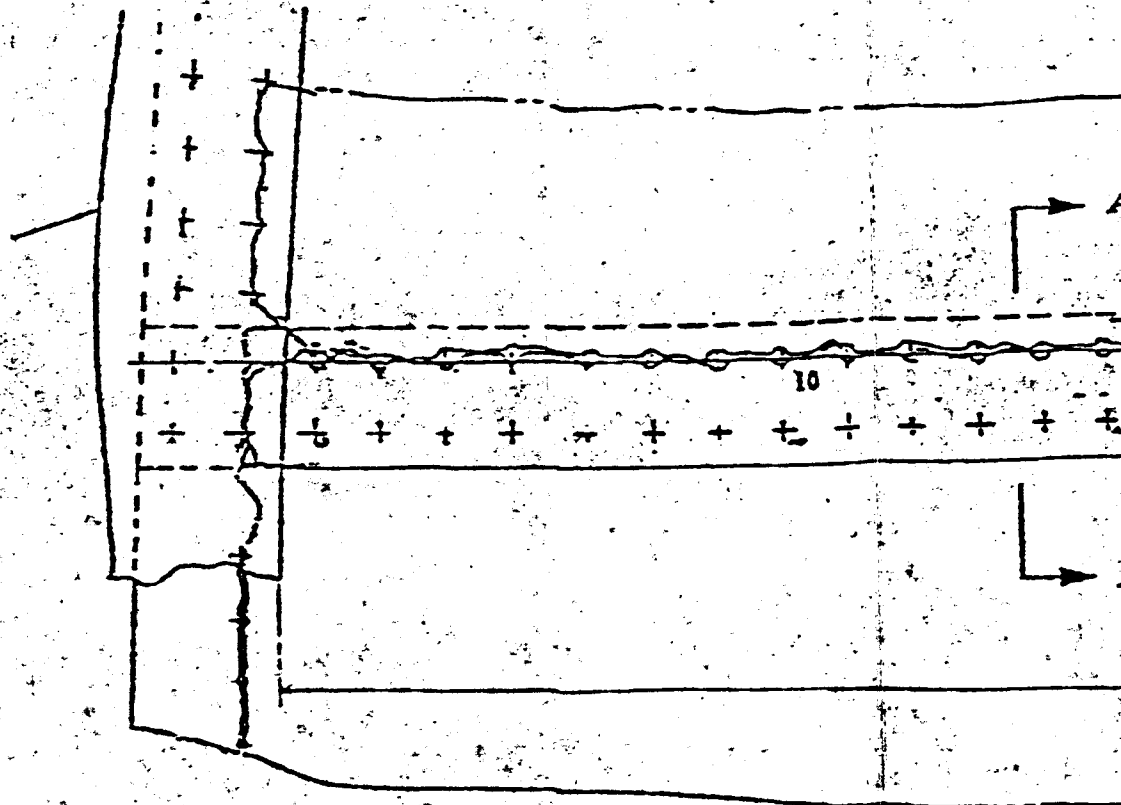
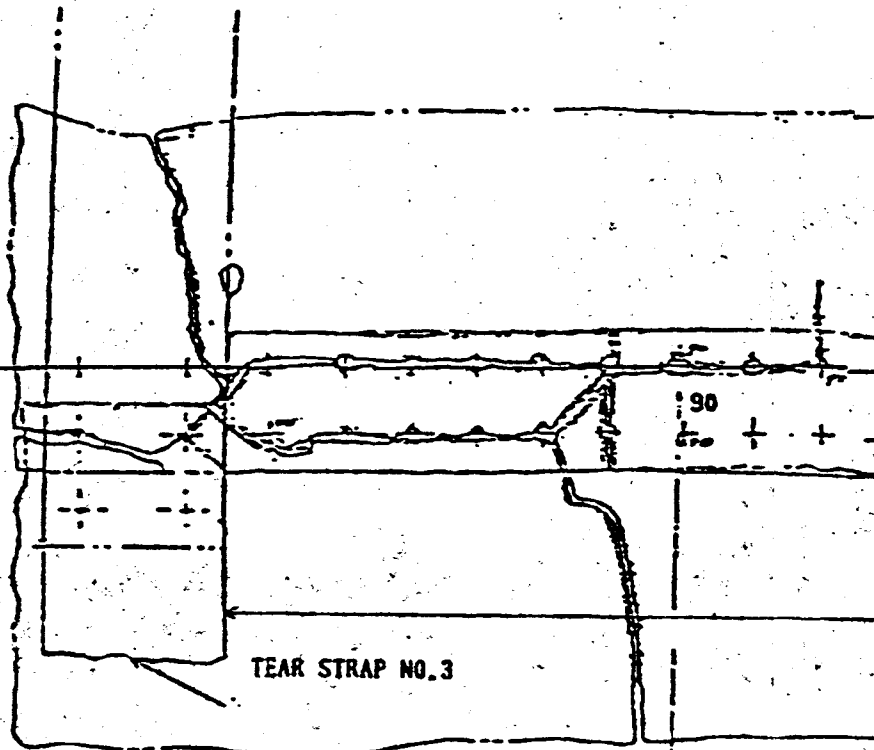
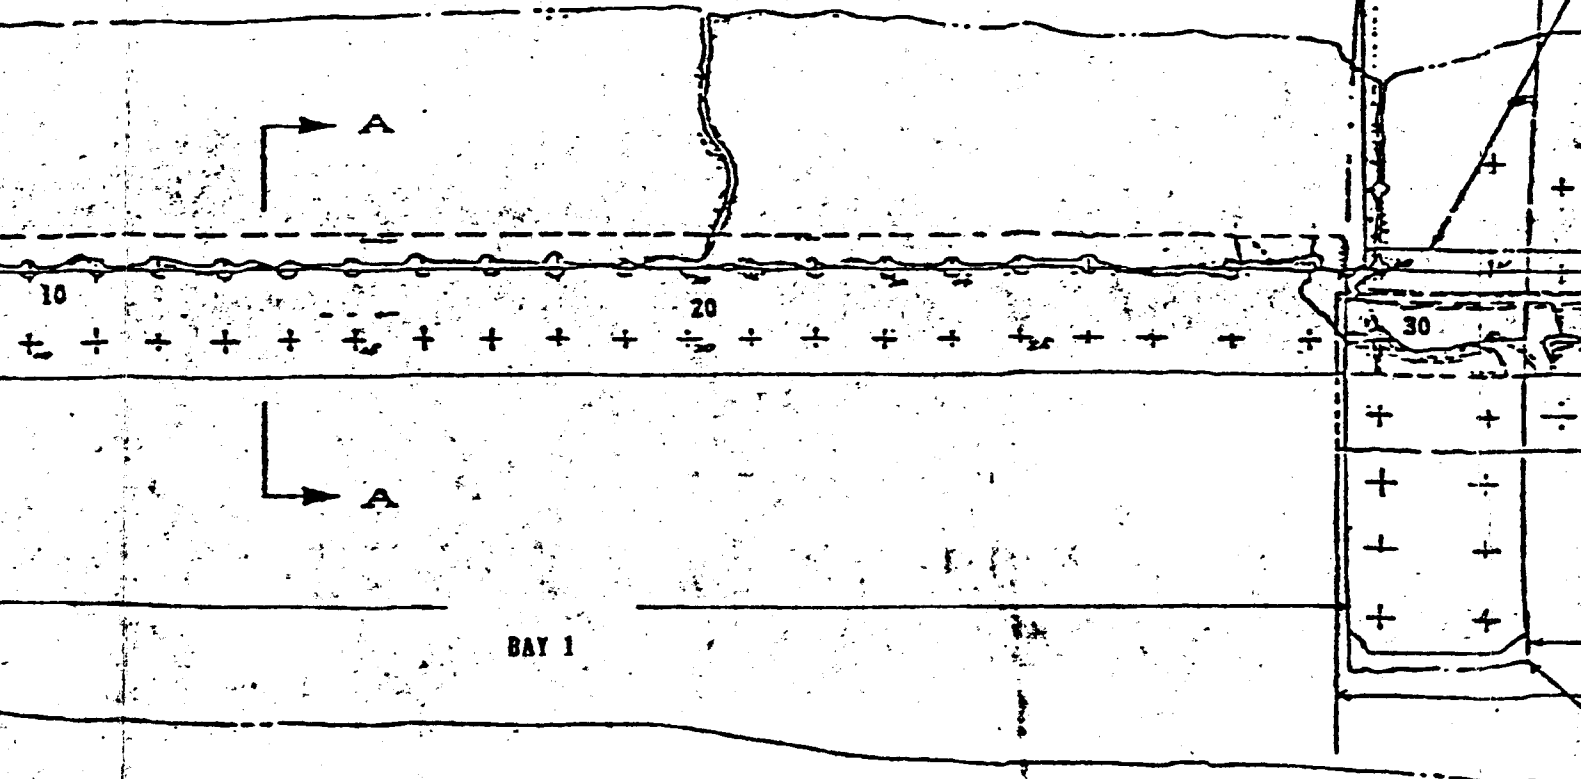
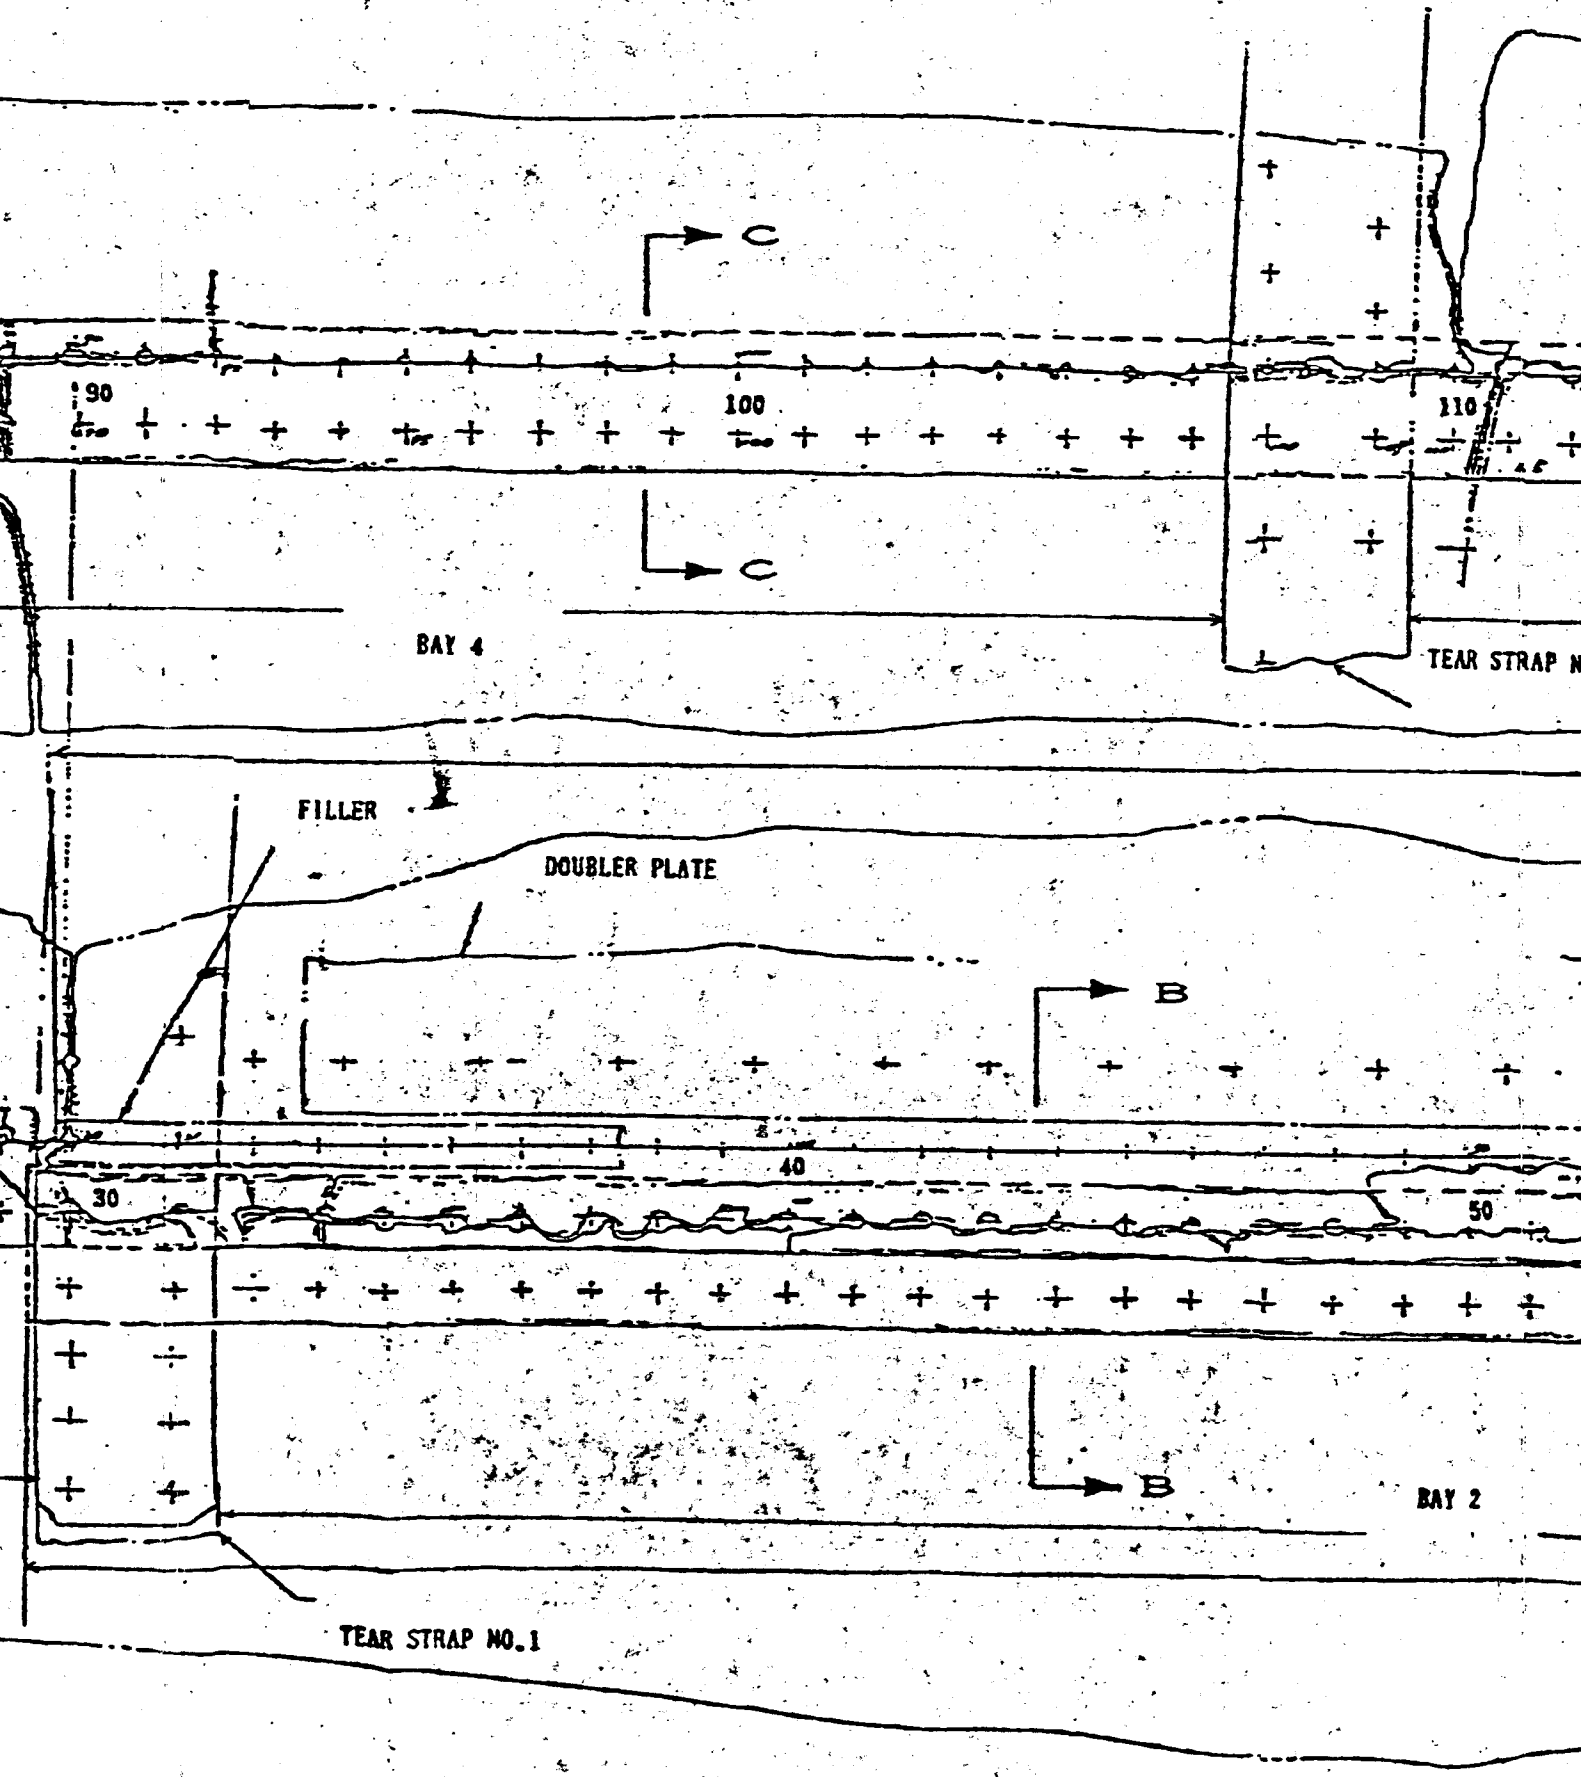
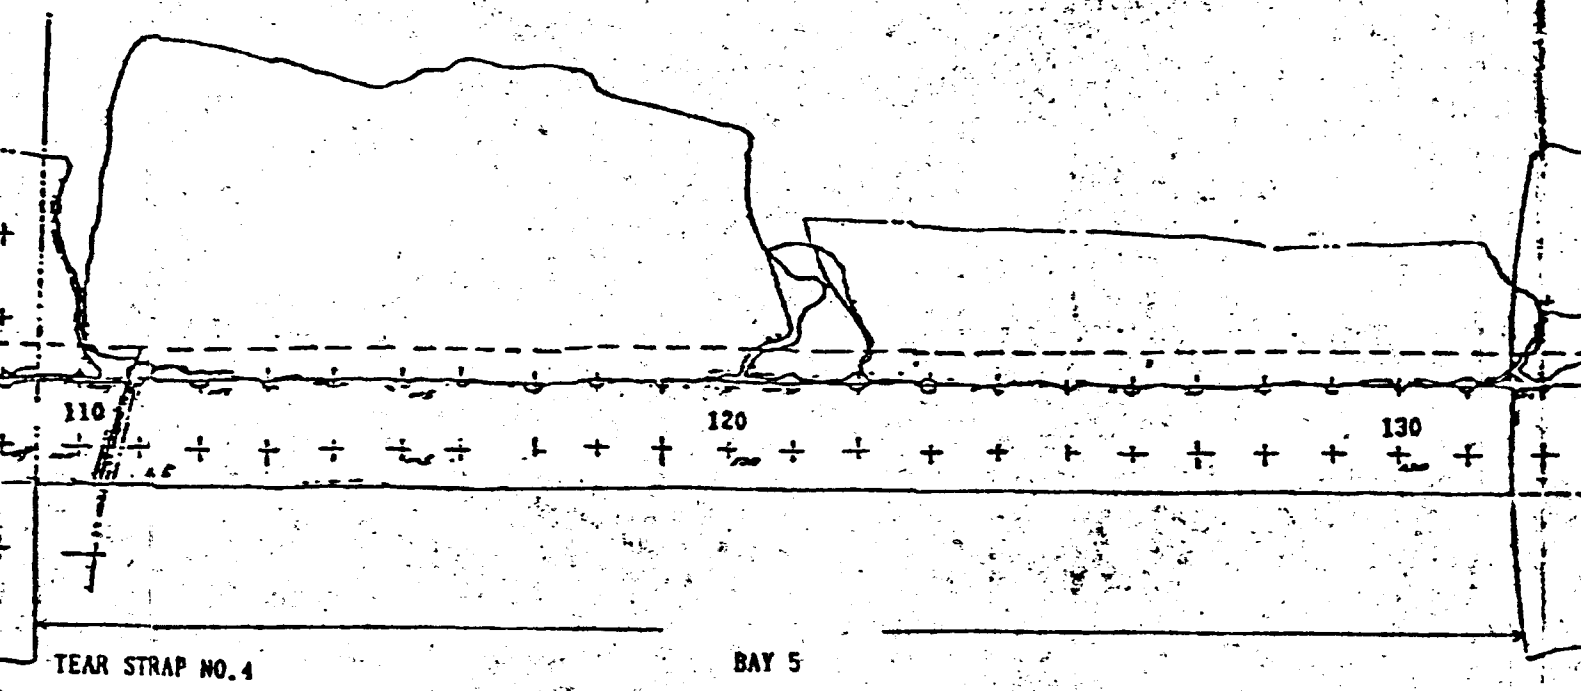
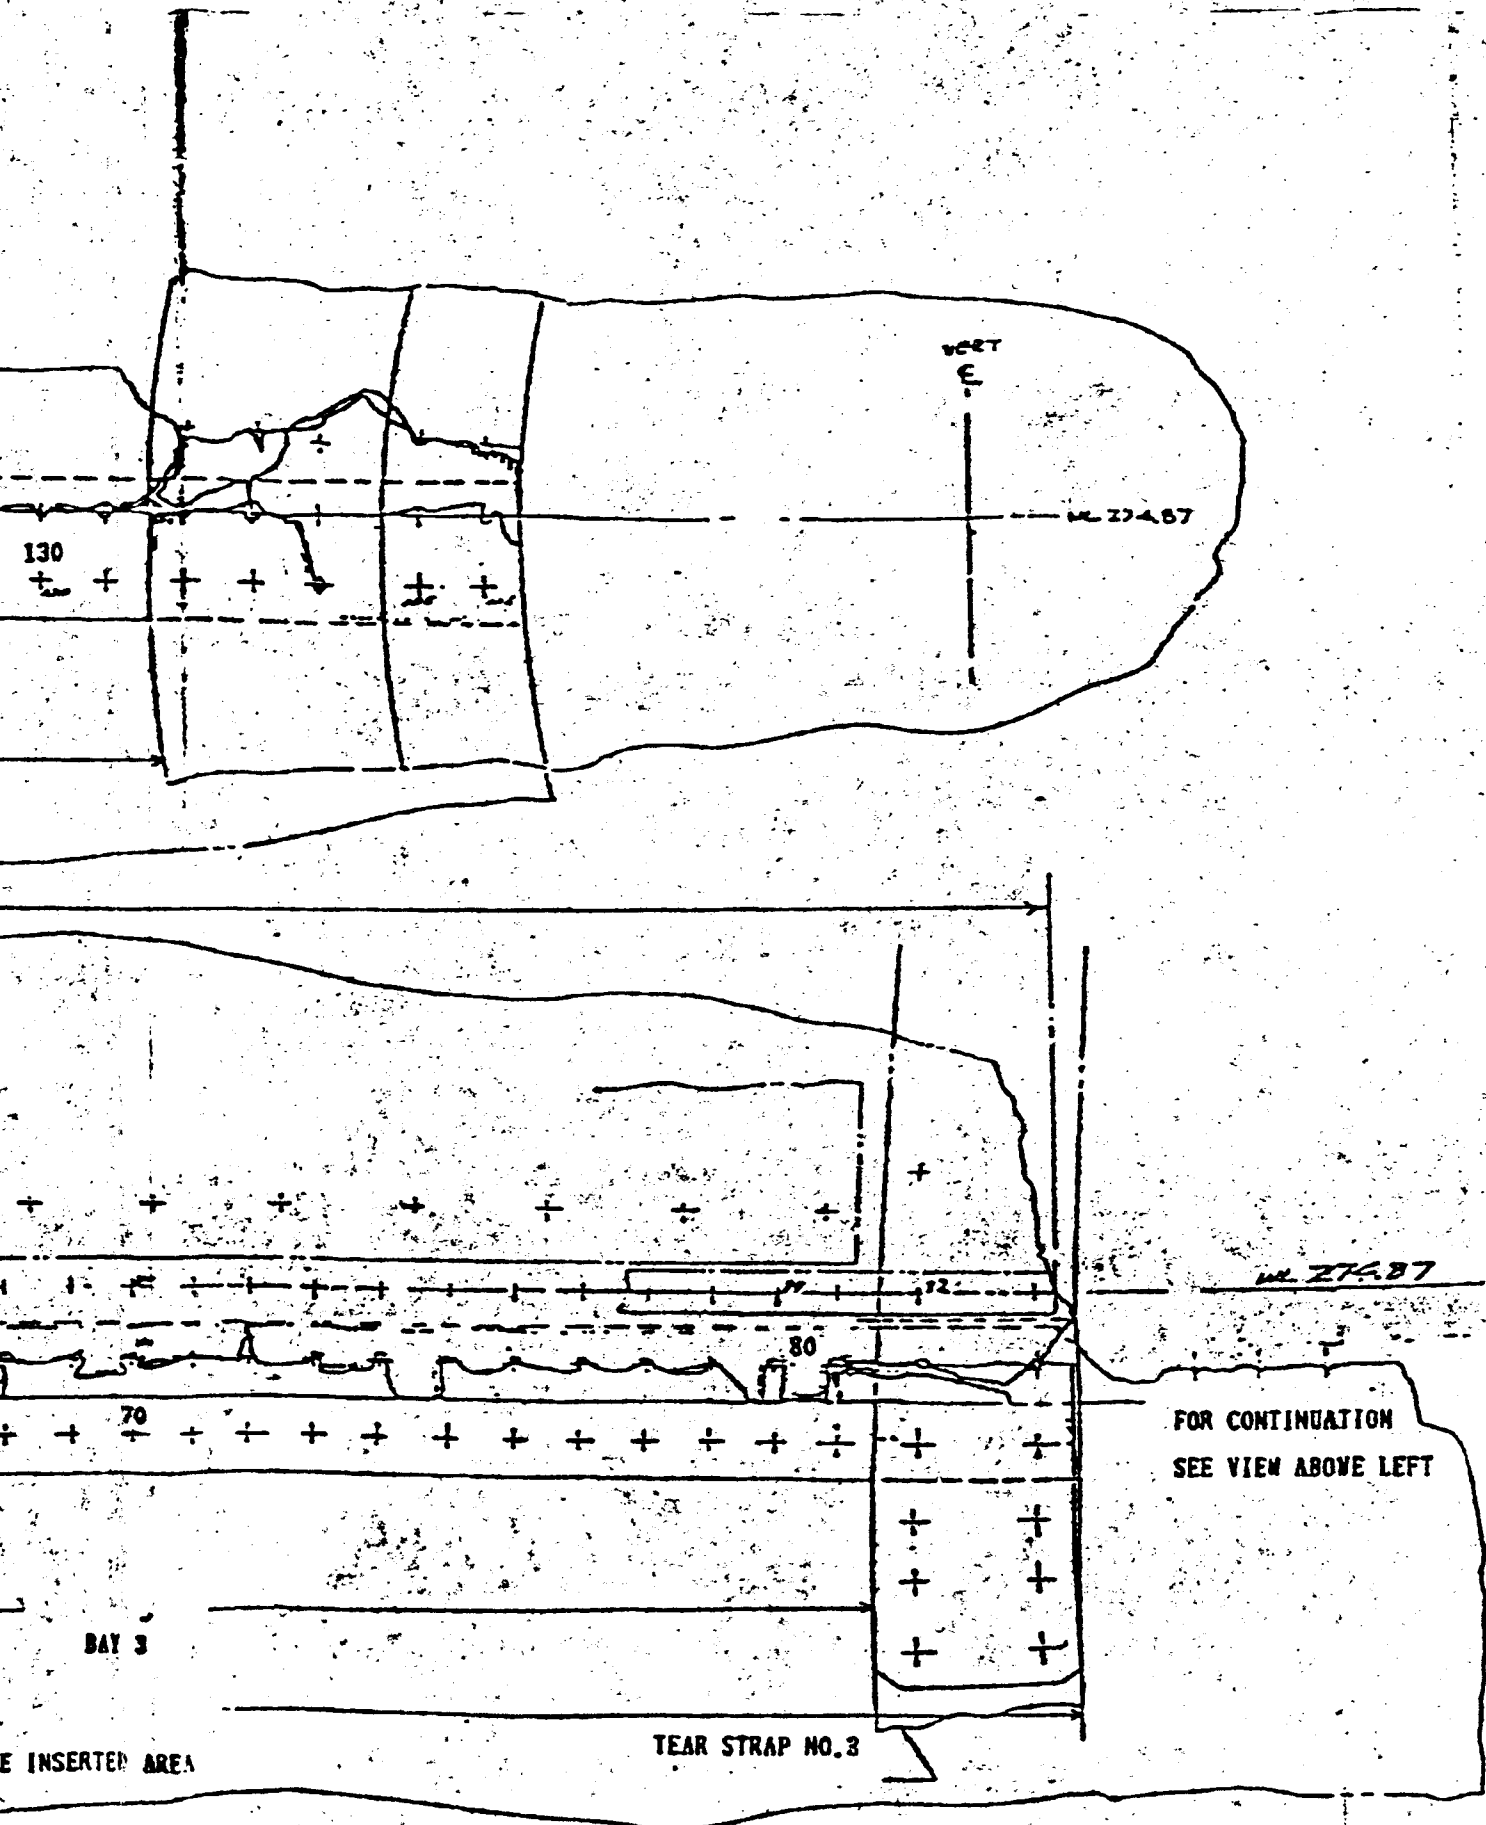
Figure-37 Fracture of webs along stiffener L18

Stiffener was failed at rivet #30 and #83.

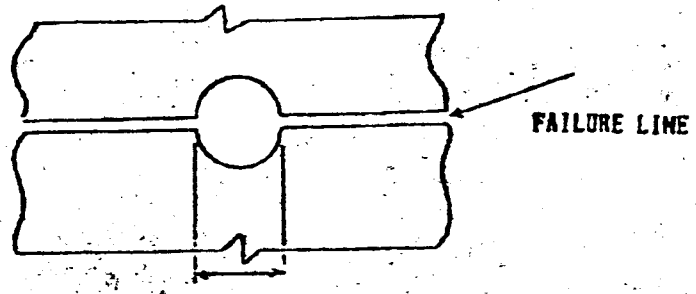
TYPICAL FRACTURE ASPECT

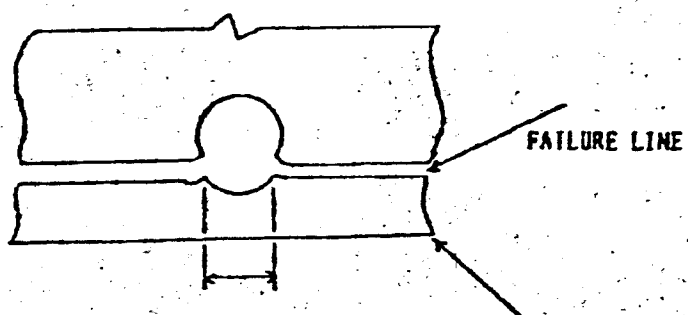
ASPECT OF FRACTURE NEAR EDGE OF PLATE

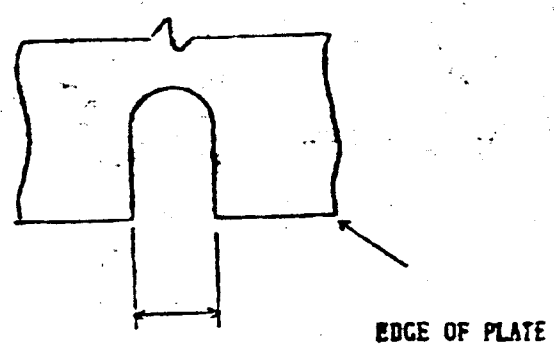
ASPECT OF SHEARING FRACTURE OF HOLE EDGE

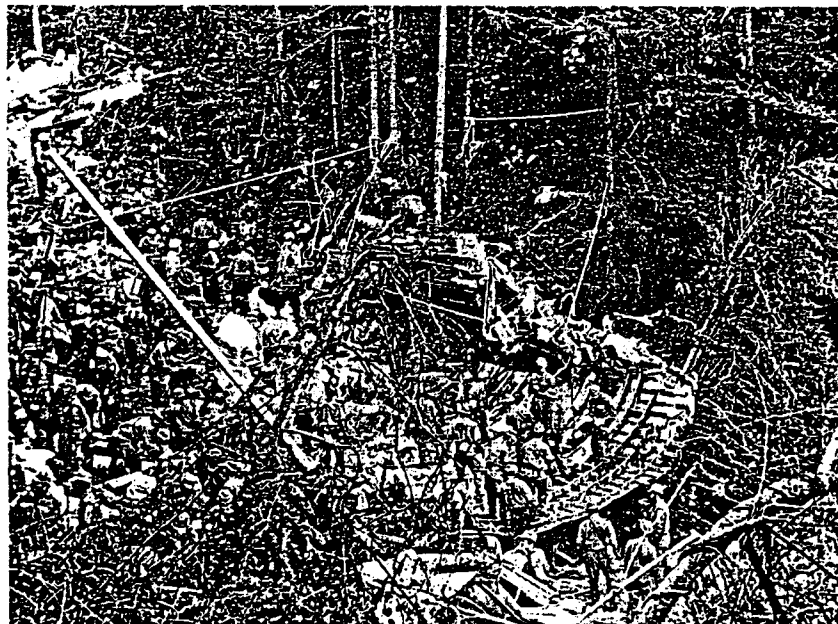
5 Debris of aft fuselage (2)

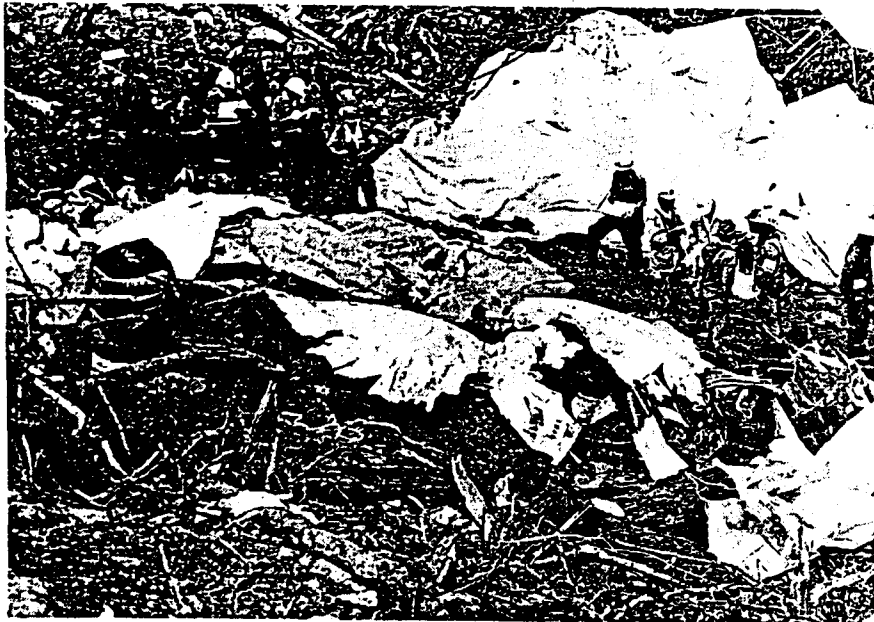
12 Recovered aft pressure bulkhead (1)

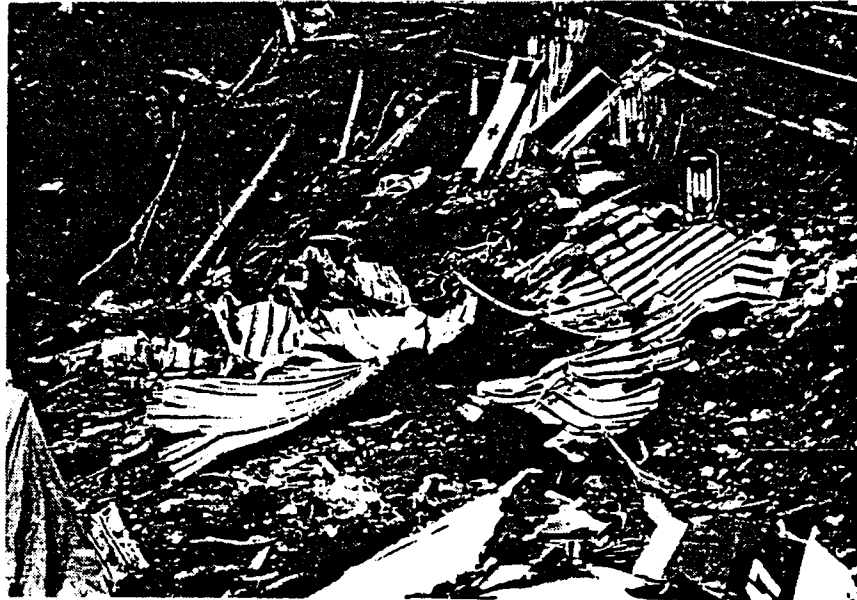
13 Recovered aft pressure bulkhead (2)

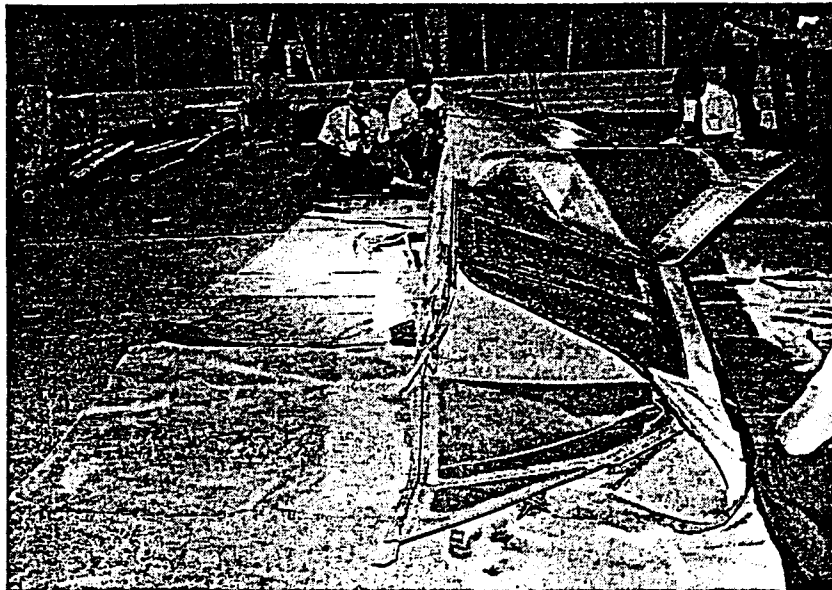
15 Part of vertical fin recovered from sea (1)

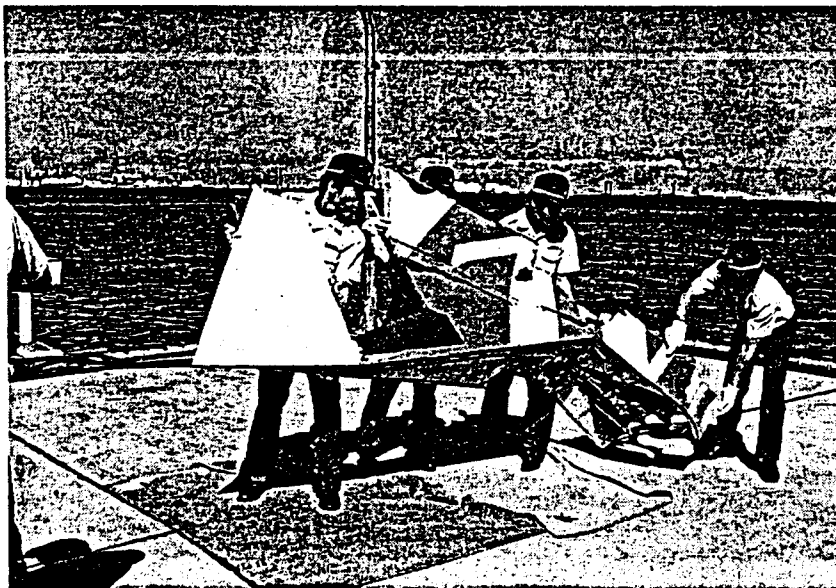
16 Part of vertical fin recovered from sea (2)

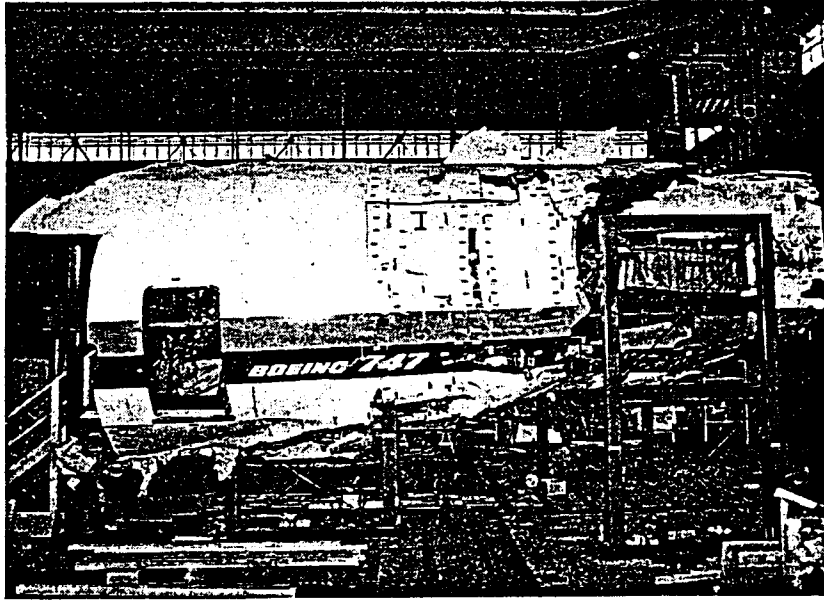
21 Reconstruction of aft fuselage (left side)

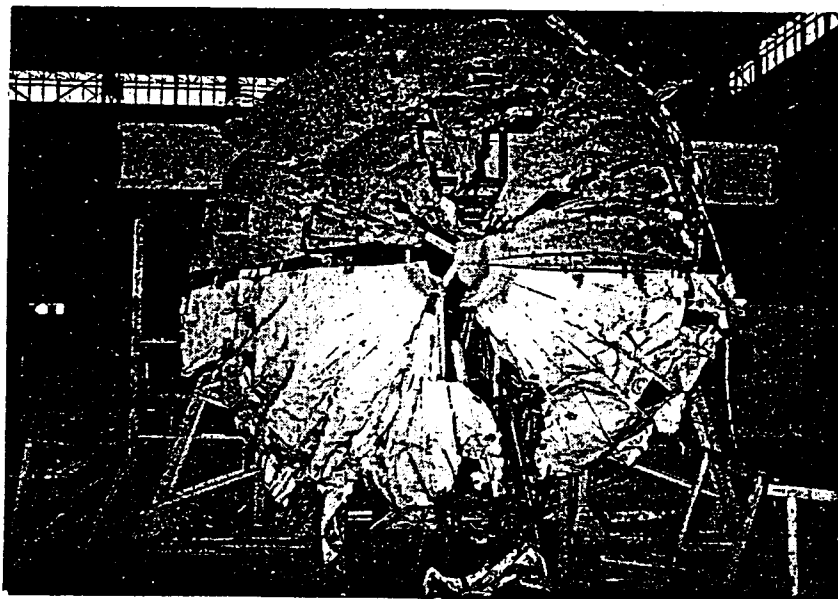
24 Reconstruction of aft pressure bulkhead

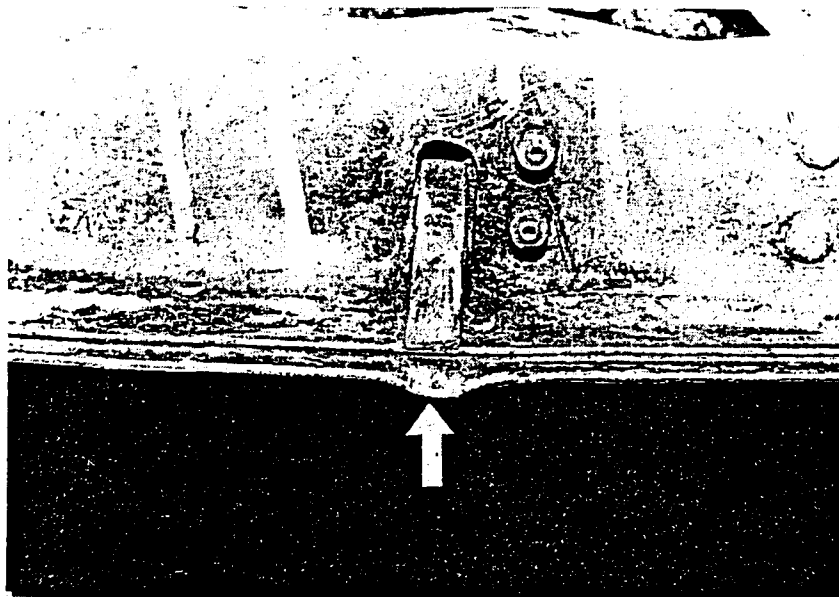
28 Deformation of skin at left door hinge
of pressure relief door

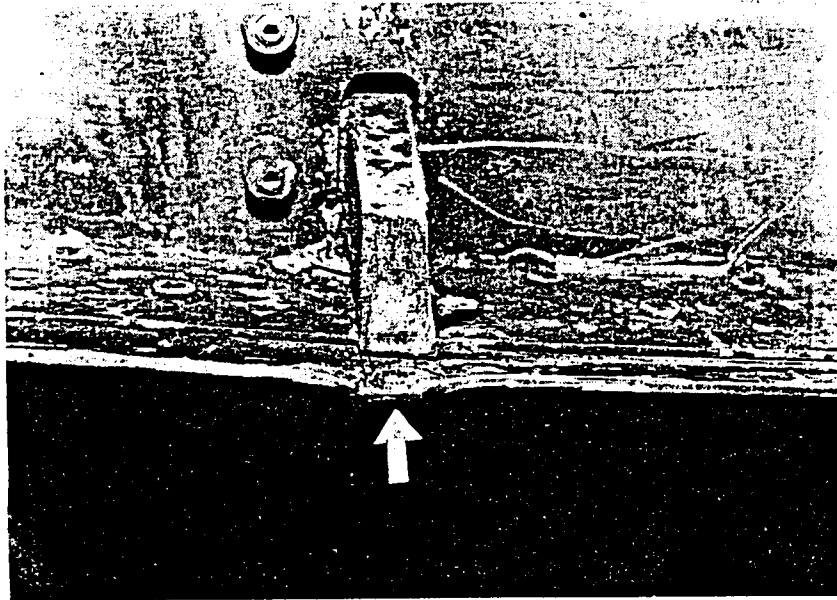
29 Deformation of skin at right door hinge
of pressure relief door

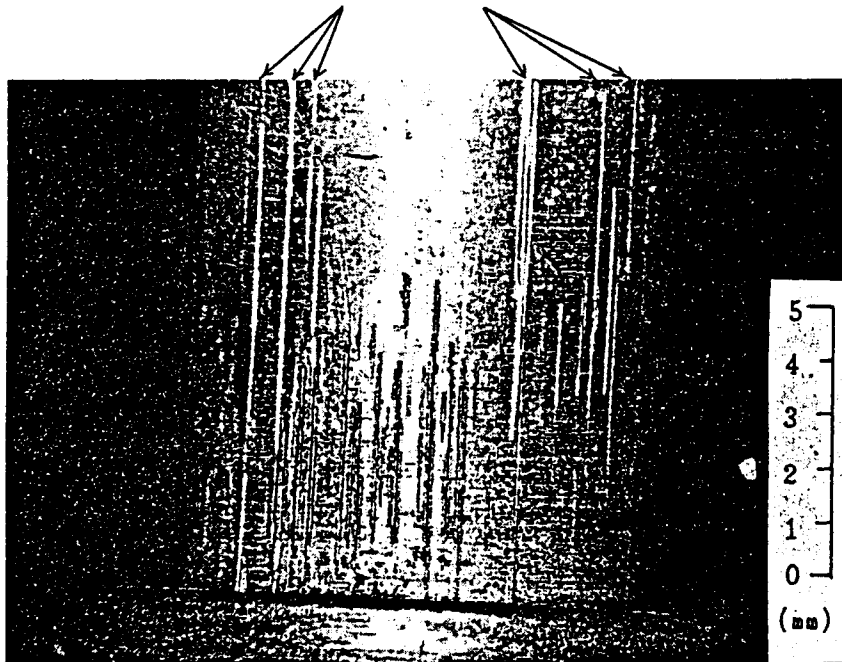
30 Abrasion on the shoulder nut of
the pressure relief door (left side)

これらの傷は、分解作業のため発生したものである。

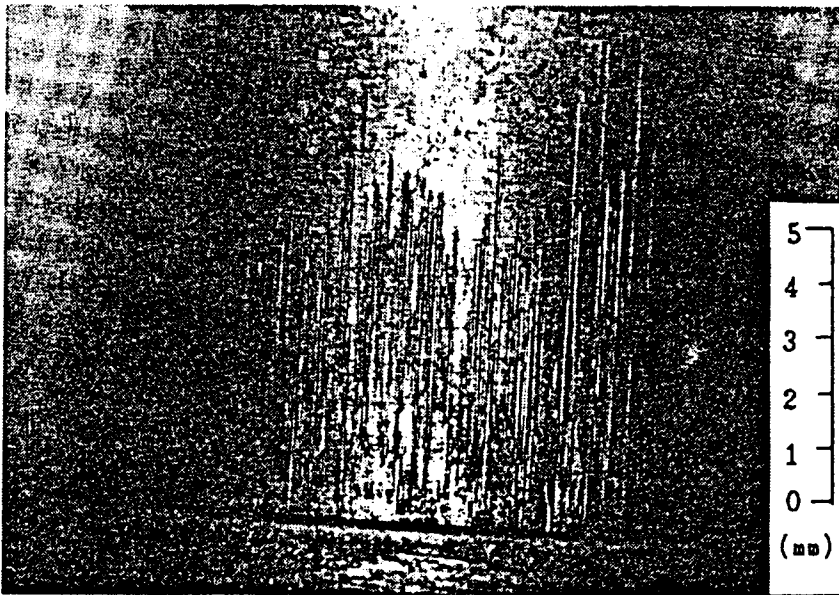
31 Abrasion on the shoulder nut of
the pressure relief door (right side)

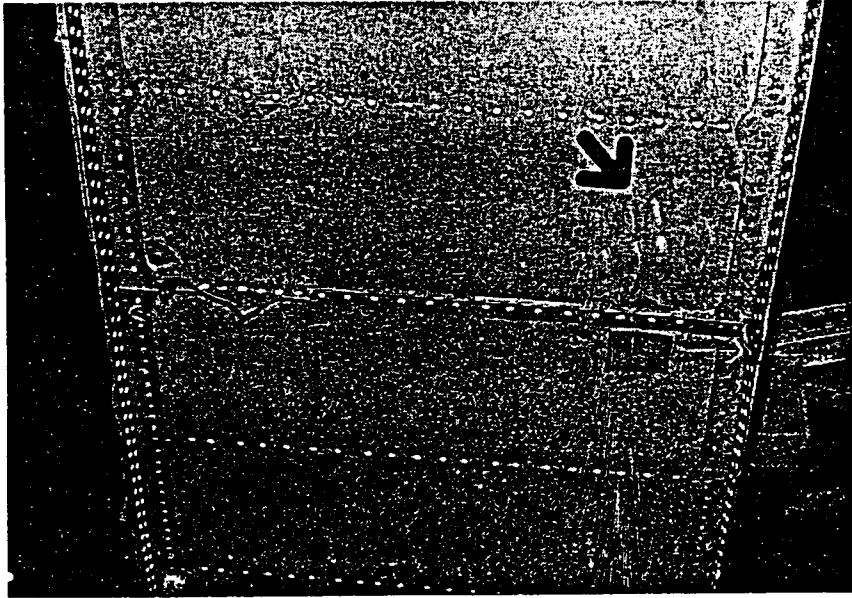
53 Scratches on vertical stabilizer front spar near FS445

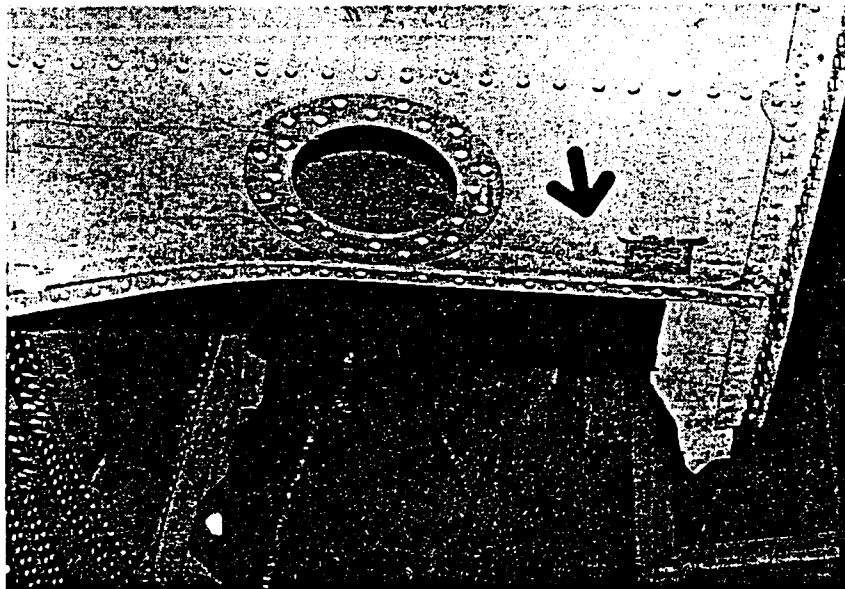
54 Scratches on vertical stabilizer front spar near FS420

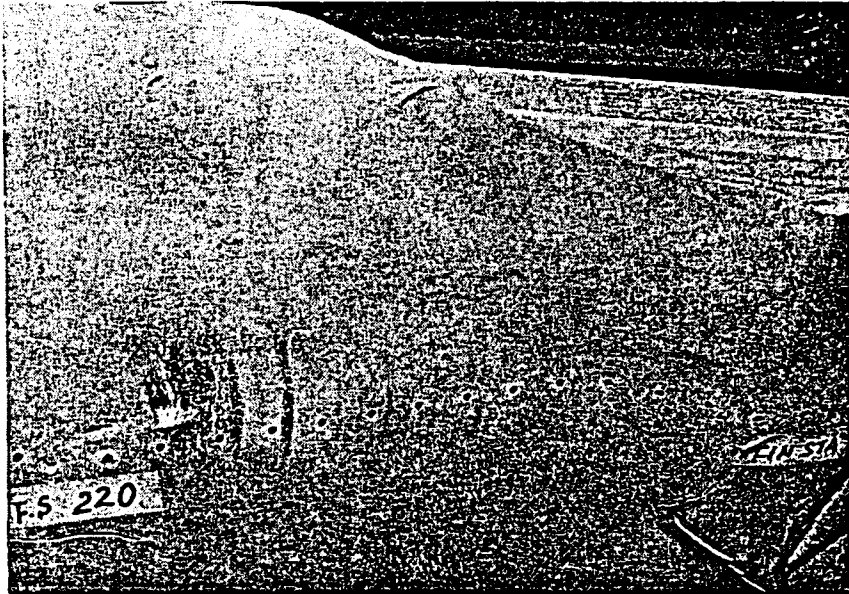
55 Scratches on vertical stabilizer front spar near FS220

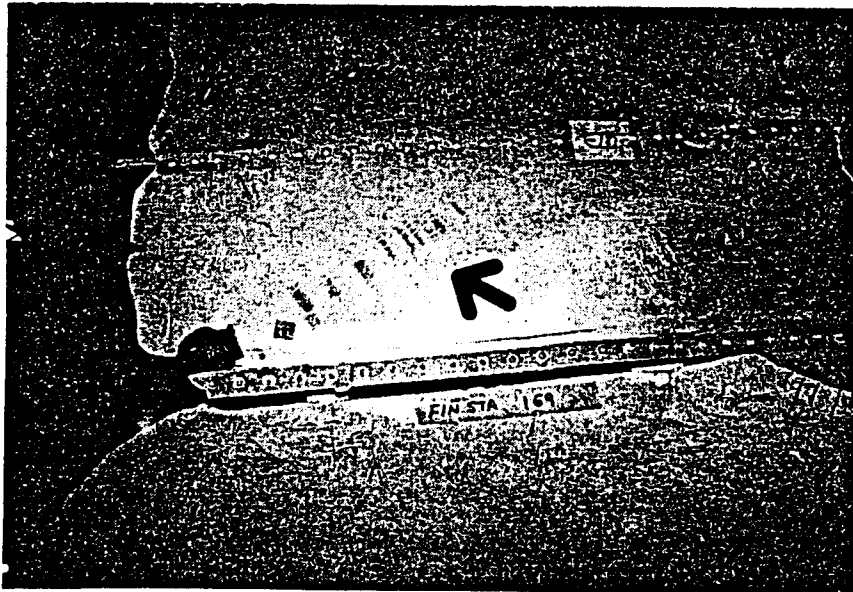
56 Scratches on vertical stabilizer front spar near FS169

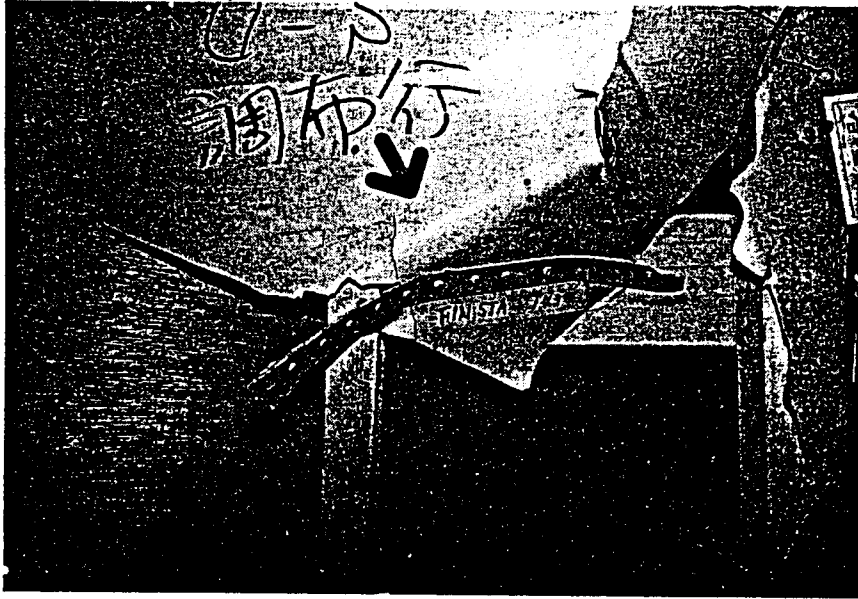
57 Scratches on vertical stabilizer front spar near FS143

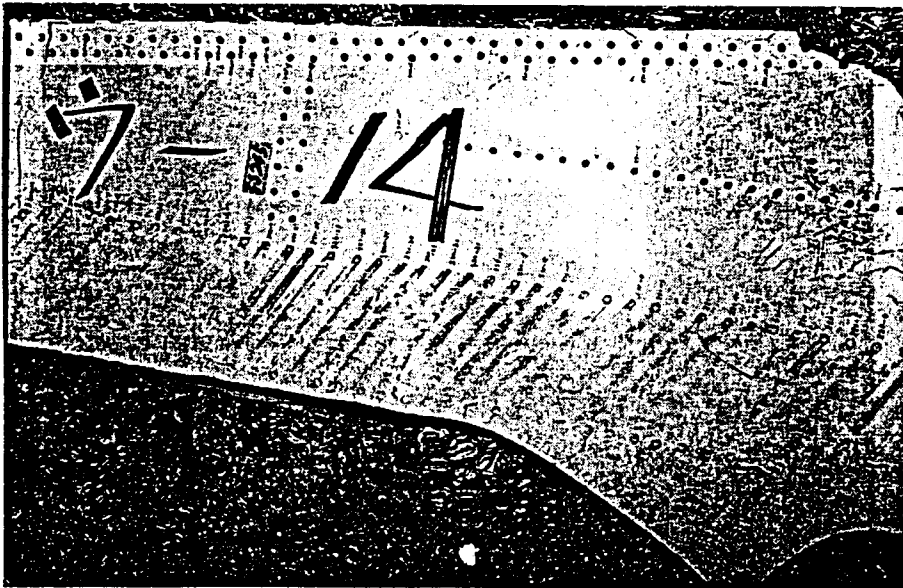
58 Black substance adhering to right side skin of vertical stabilizer (1)

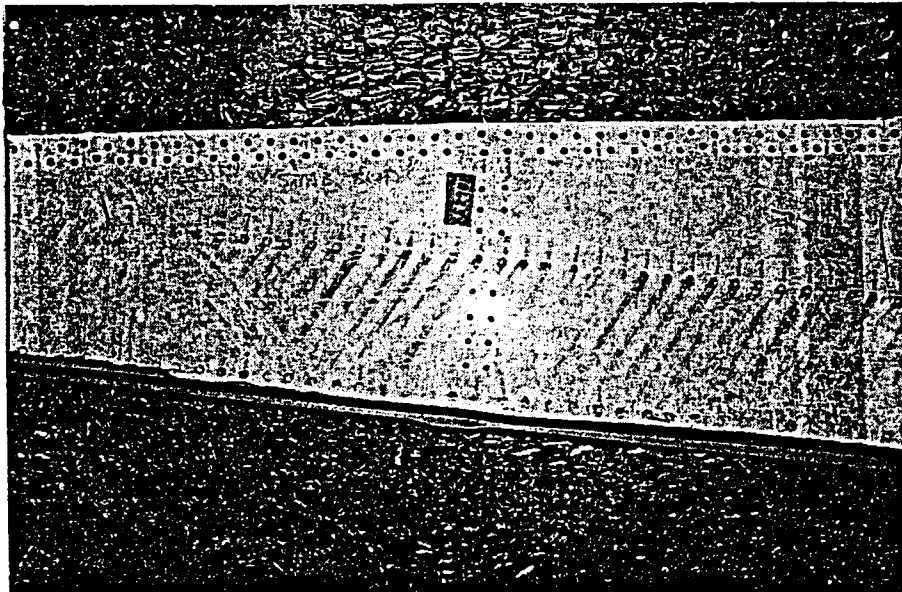
59 Black substance adhering to right side skin of vertical stabilizer (2)

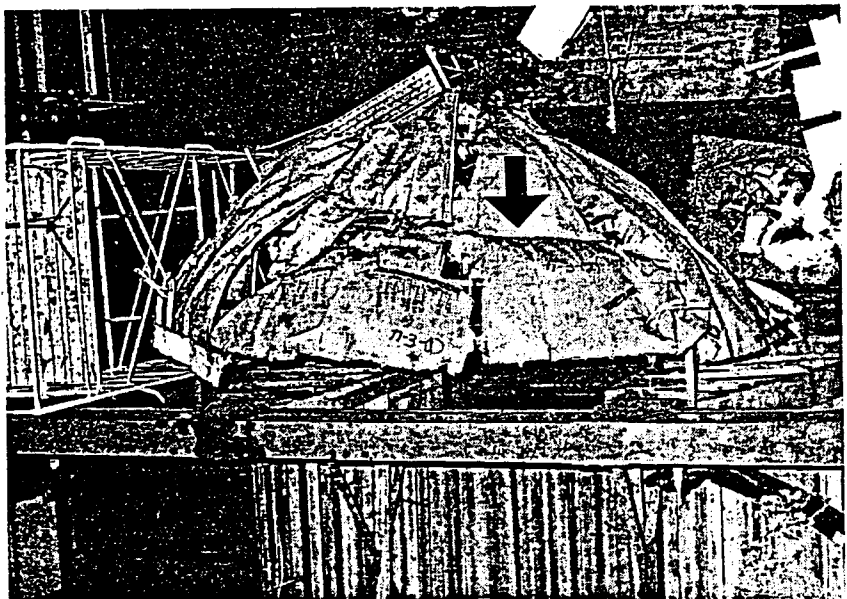
77 Buckling of aft pressure bulkhead (1)

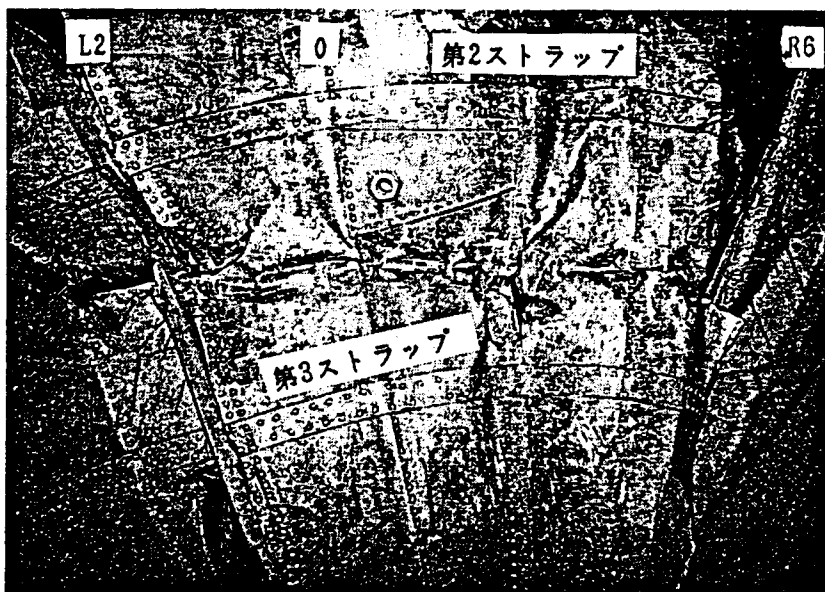
78 Buckling of aft pressure bulkhead (2)

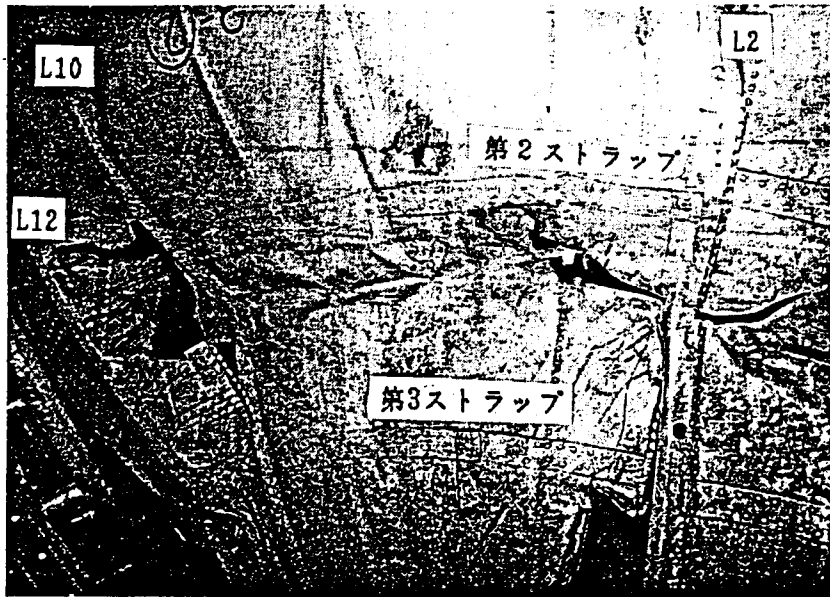
79 Buckling of aft pressure bulkhead (3)

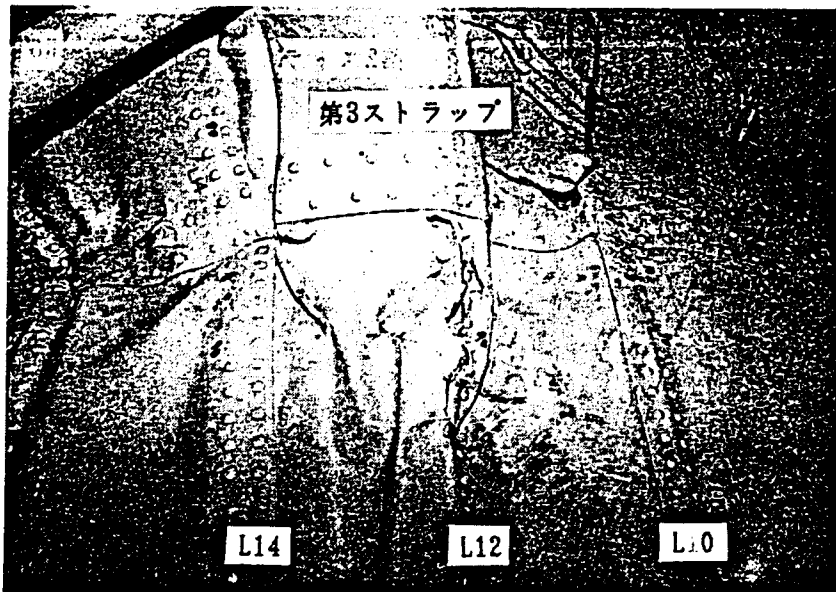
80 Buckling of aft pressure bulkhead (4)

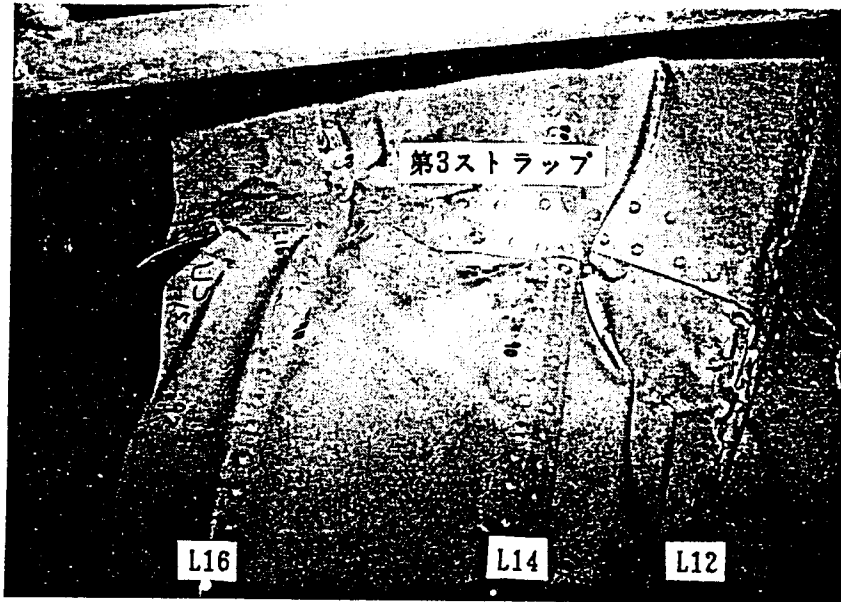
81 Buckling of aft pressure bulkhead (5)

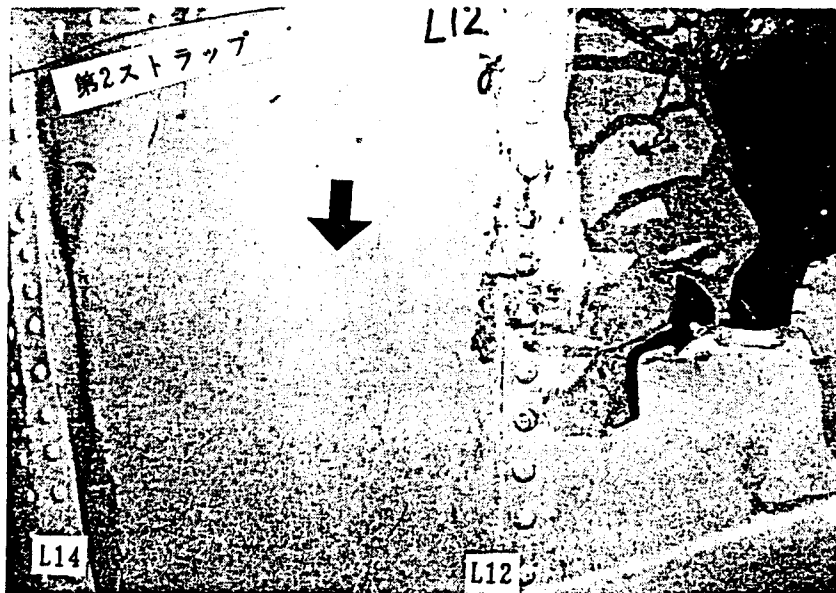
82 Buckling of aft pressure bulkhead (6)

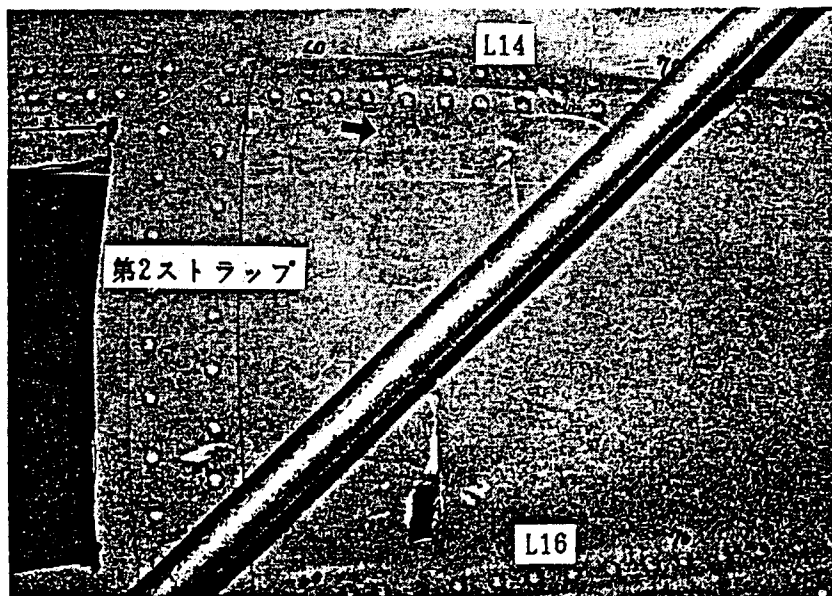
83 Buckling of aft pressure bulkhead (7)
