AIRCRAFT ACCIDENT INVESTIGATION REPORT

Japan Air Lines Co., Ltd.
Boeing 747 SR-100, JA8119
Gunma Prefecture, Japan
August 12, 1985

Aircraft Accident Investigation Commission
Ministry of Transport

June 19, 1987

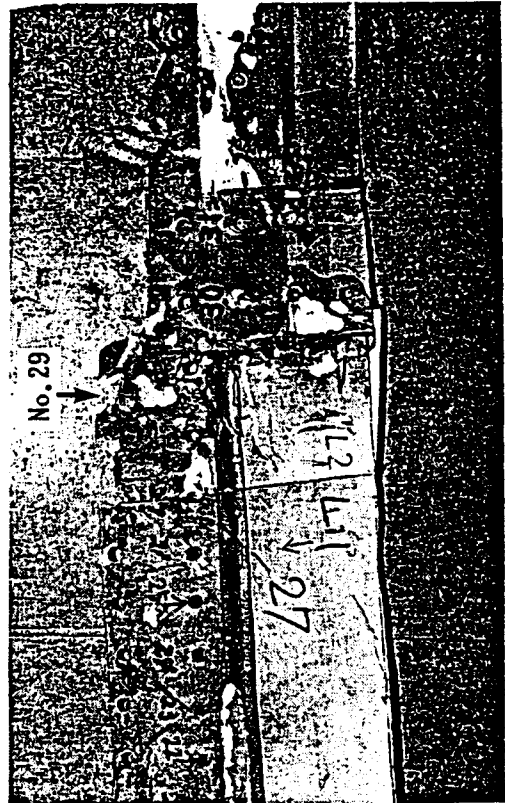
85 Aft pressure bulkhead L18 splice-edge distance in vicinity of rivet No. 29

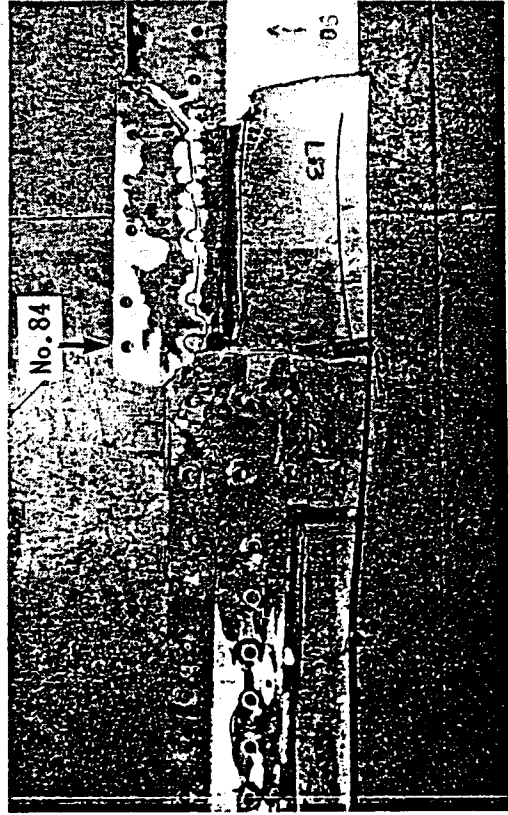
86 Aft pressure bulkhead L18 splice-edge distance in vicinity of rivet No. 84

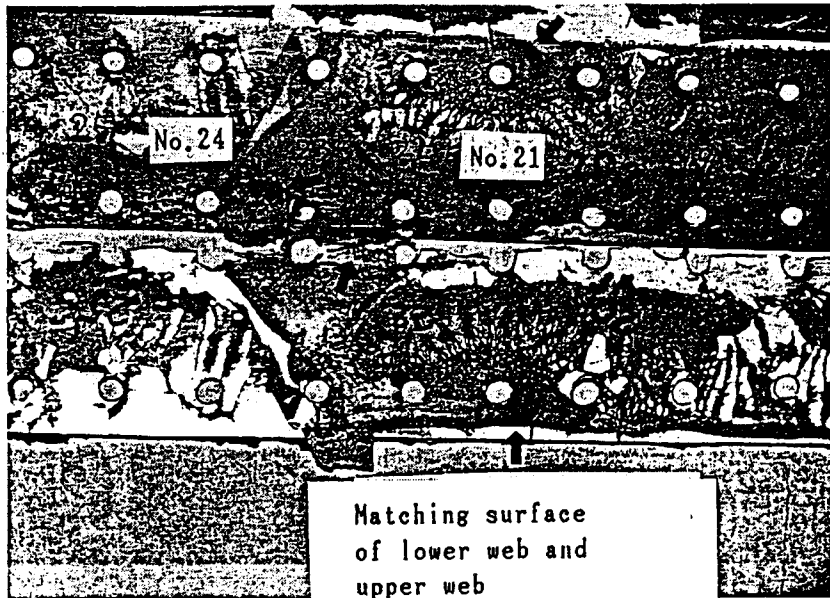
87 Aft pressure bulkhead L18 splice-adherence of tobacco
nicotine in vicinity of rivet No.21 to No.24

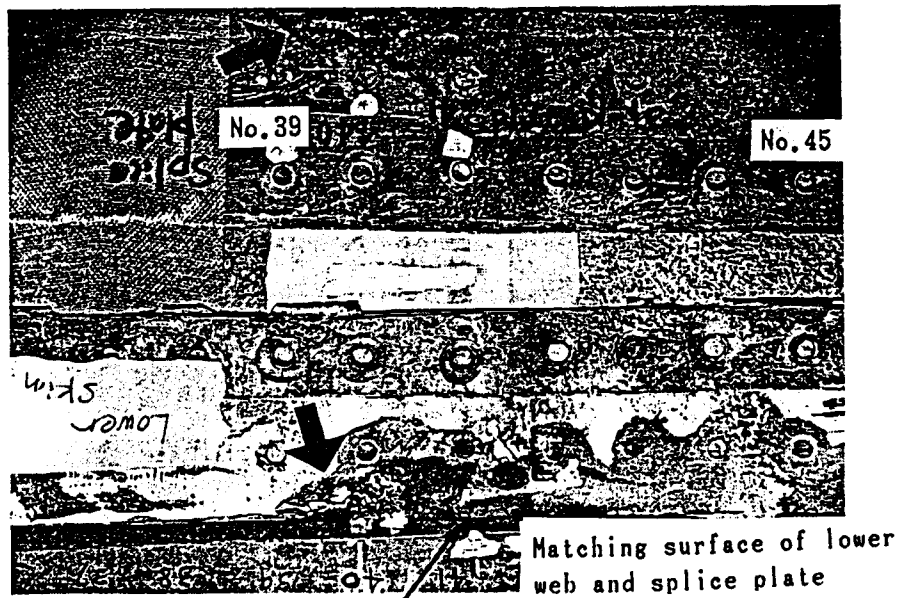
88 Aft pressure bulkhead L18 splice-adherence of tobacco
nicotine in vicinity of rivet No.39 to No.45

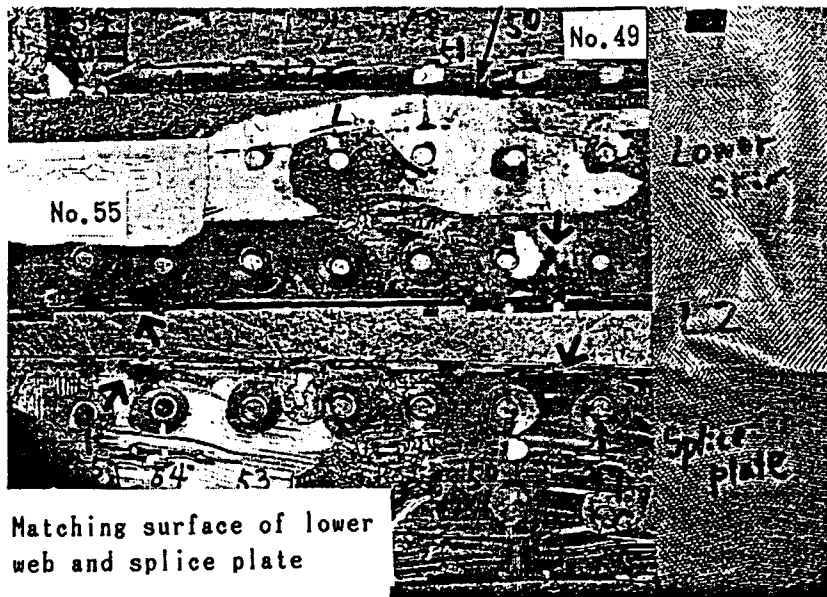
89 Aft pressure bulkhead L18 splice-adherence of tobacco
nicotine in vicinity of rivet No.49 to No.55

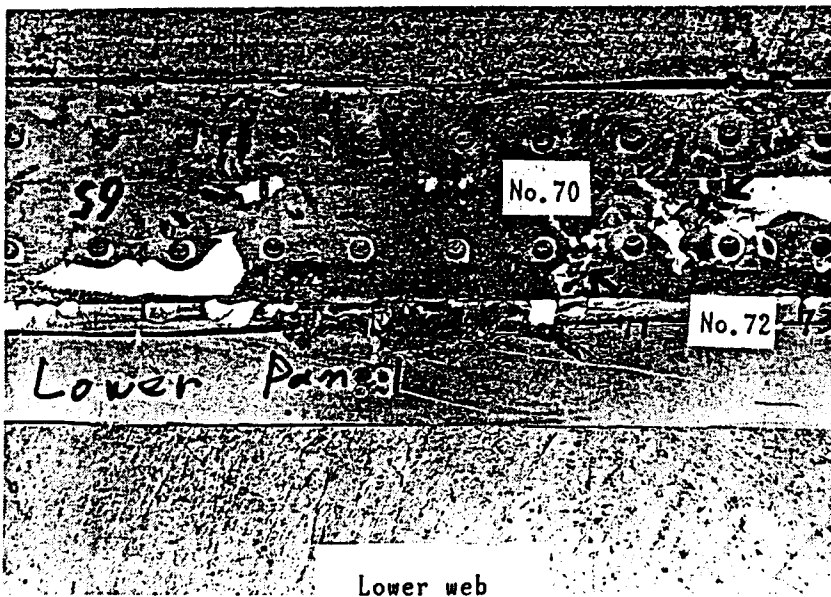
90 Aft pressure bulkhead L18 splice-adherence of tobacco
nicotine in vicinity of rivet No.70 to No.72

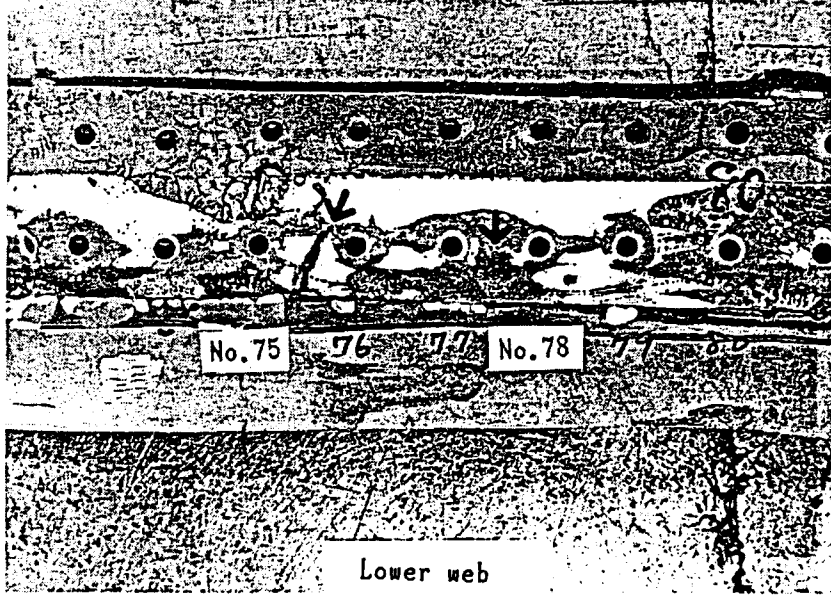
91 Aft pressure bulkhead L18 splice-adherence of tobacco
nicotine in vicinity of rivet No.75 to No.78

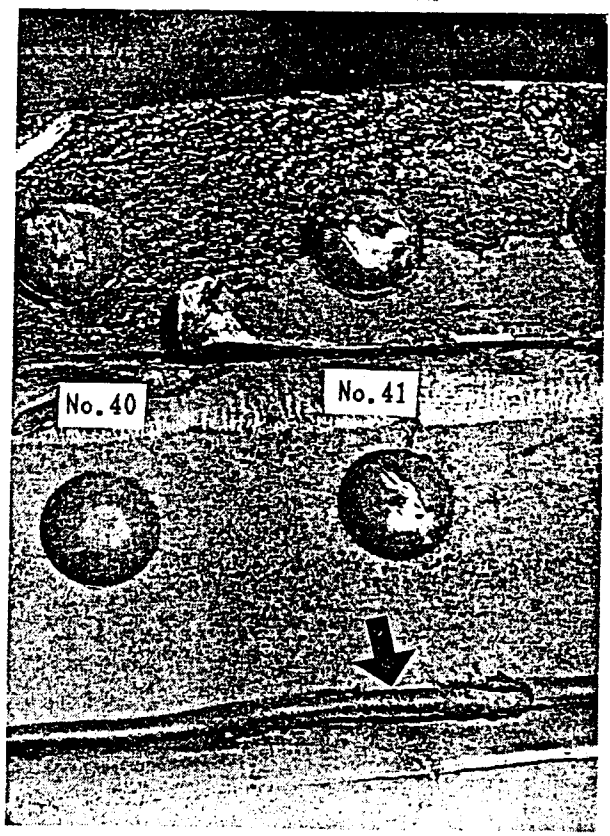
Out of the above, in the vicinity of rivets No.41 and No.50, a slight gap came to separate the lower web and the spliced plate, through which a very small amount of tobacco nicotine would have been blown out towards the non-pressurized side (see Photo-92 and -93).

92 Aft pressure bulkhead L18 splice-adherence of tobacco
nicotine in vicinity of rivet No.41

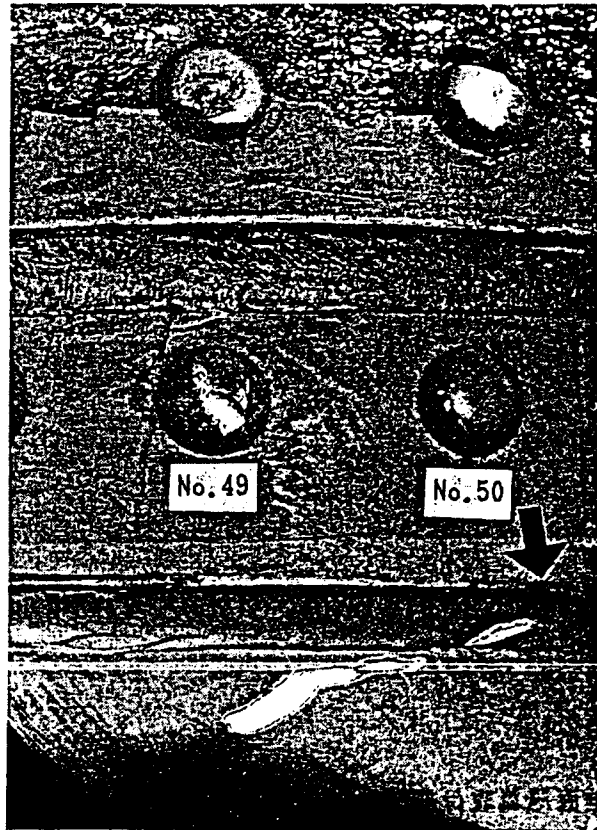
- 93 Aft pressure bulkhead L18 splice-adherence of tabacco·
nicotine in vicinity of rivet No.50

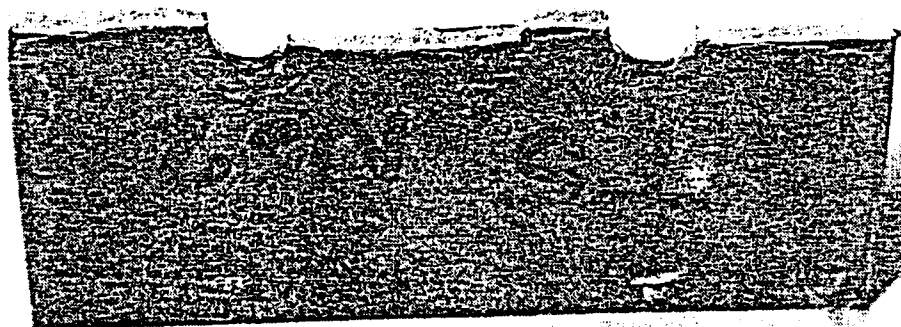
Photo-116 Fracture aspect of No.2 strap. Lower fragment of the upper strap, aft view.

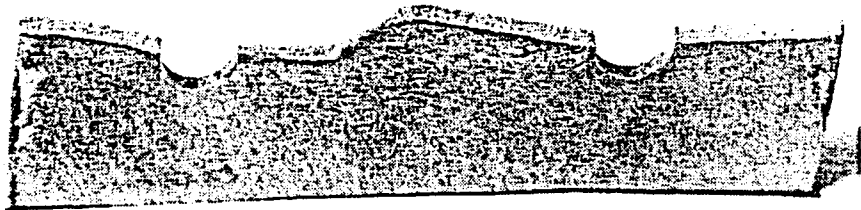
Photo-118 Fracture aspect of No.4 strap. Lower fragment of the upper strap, front view.

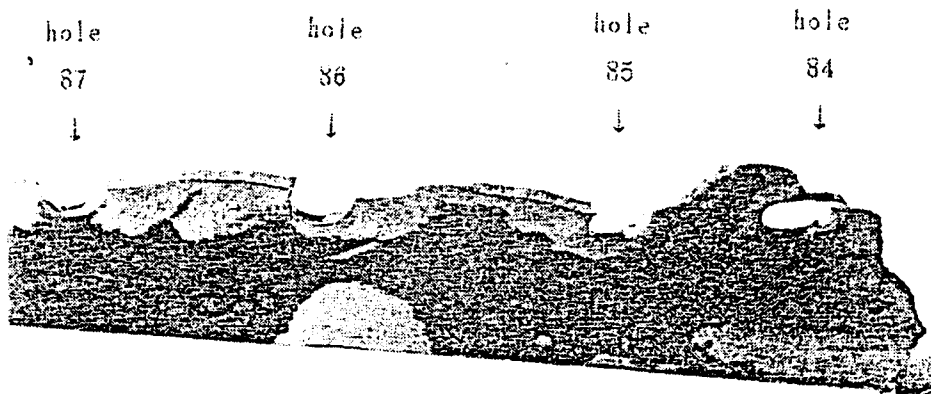
The sole fracture through rivet hole 84 to 89 of the lower web along L18 stiffener is also recognized as due to tension by overload as can be seen in Photo-123.

Photo-123 A part of failure line in lower web through rivet holes 84-89.
Observation of upper fragment, aft view.

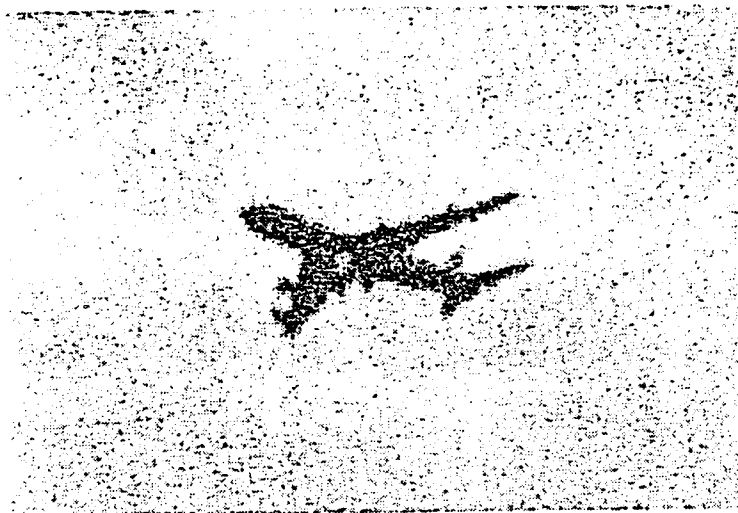
An analysis was made on the status of damage to the vertical fin of the accident aircraft, based on a photograph taken from the ground of the aircraft flying over Okutama City, Nishitama County, Tokyo at about 1850 hours, August 12. Data used were the photograph of the aircraft (see Attached Photo-124), a model of Boeing, and the damage chart of the vertical fin (see Attached Figure-27 and -28).

Photo-124 The accident aircraft flying over Okutama.

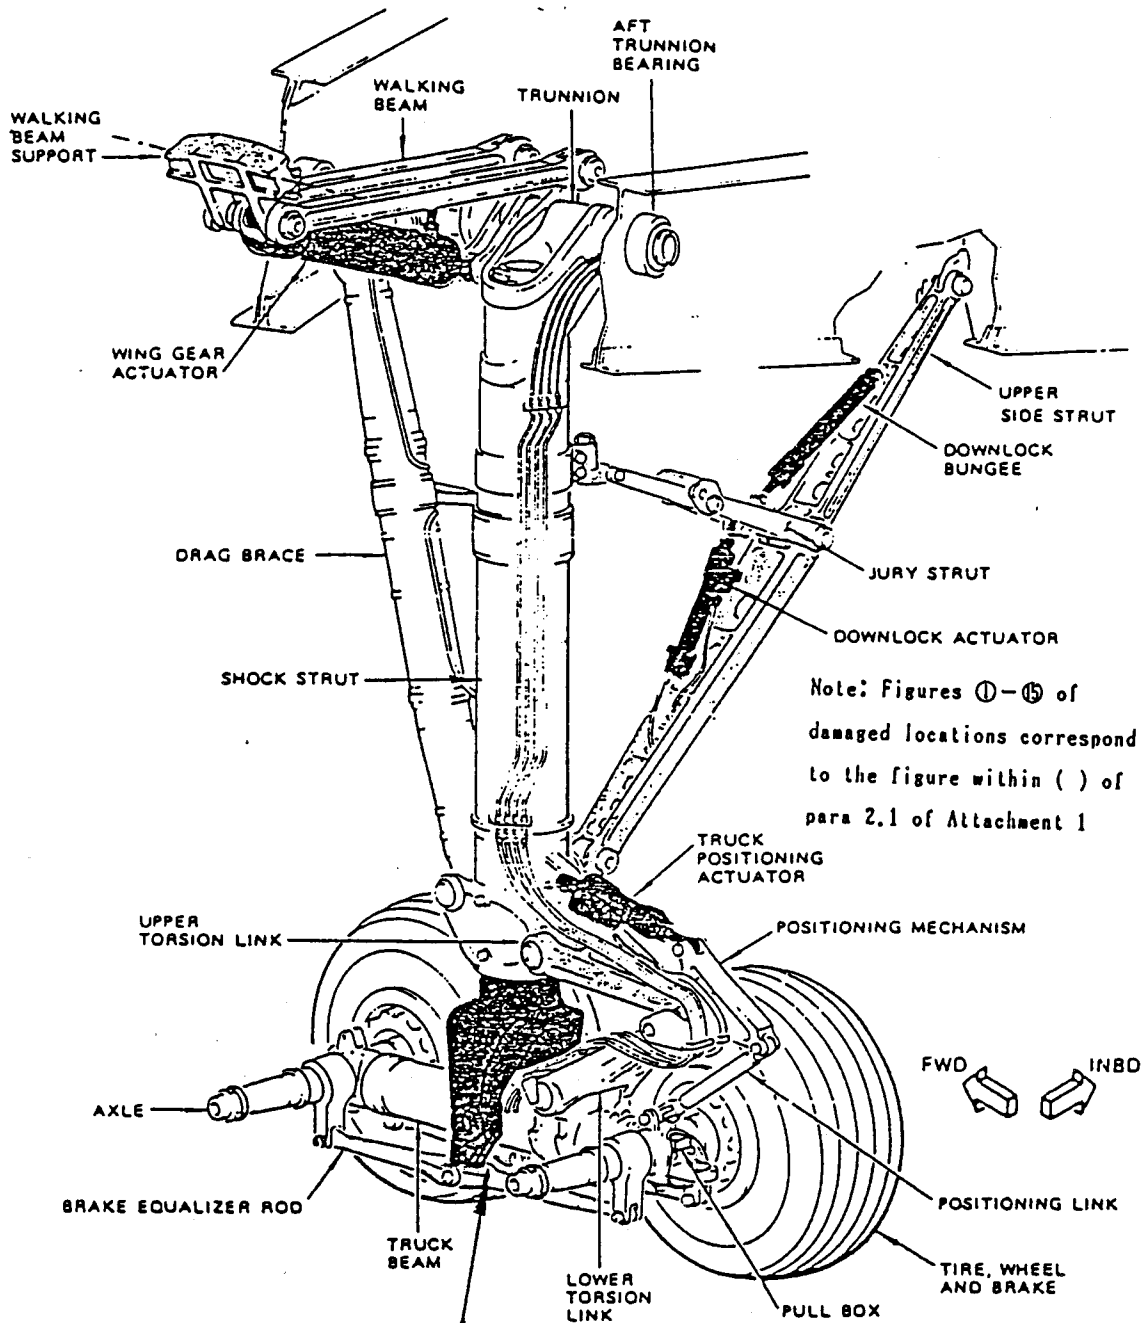
Attachment 1 Attached Figure—2
 Damaged Portions by Accident (2)

dents (8 in total for the right and left) ⑭

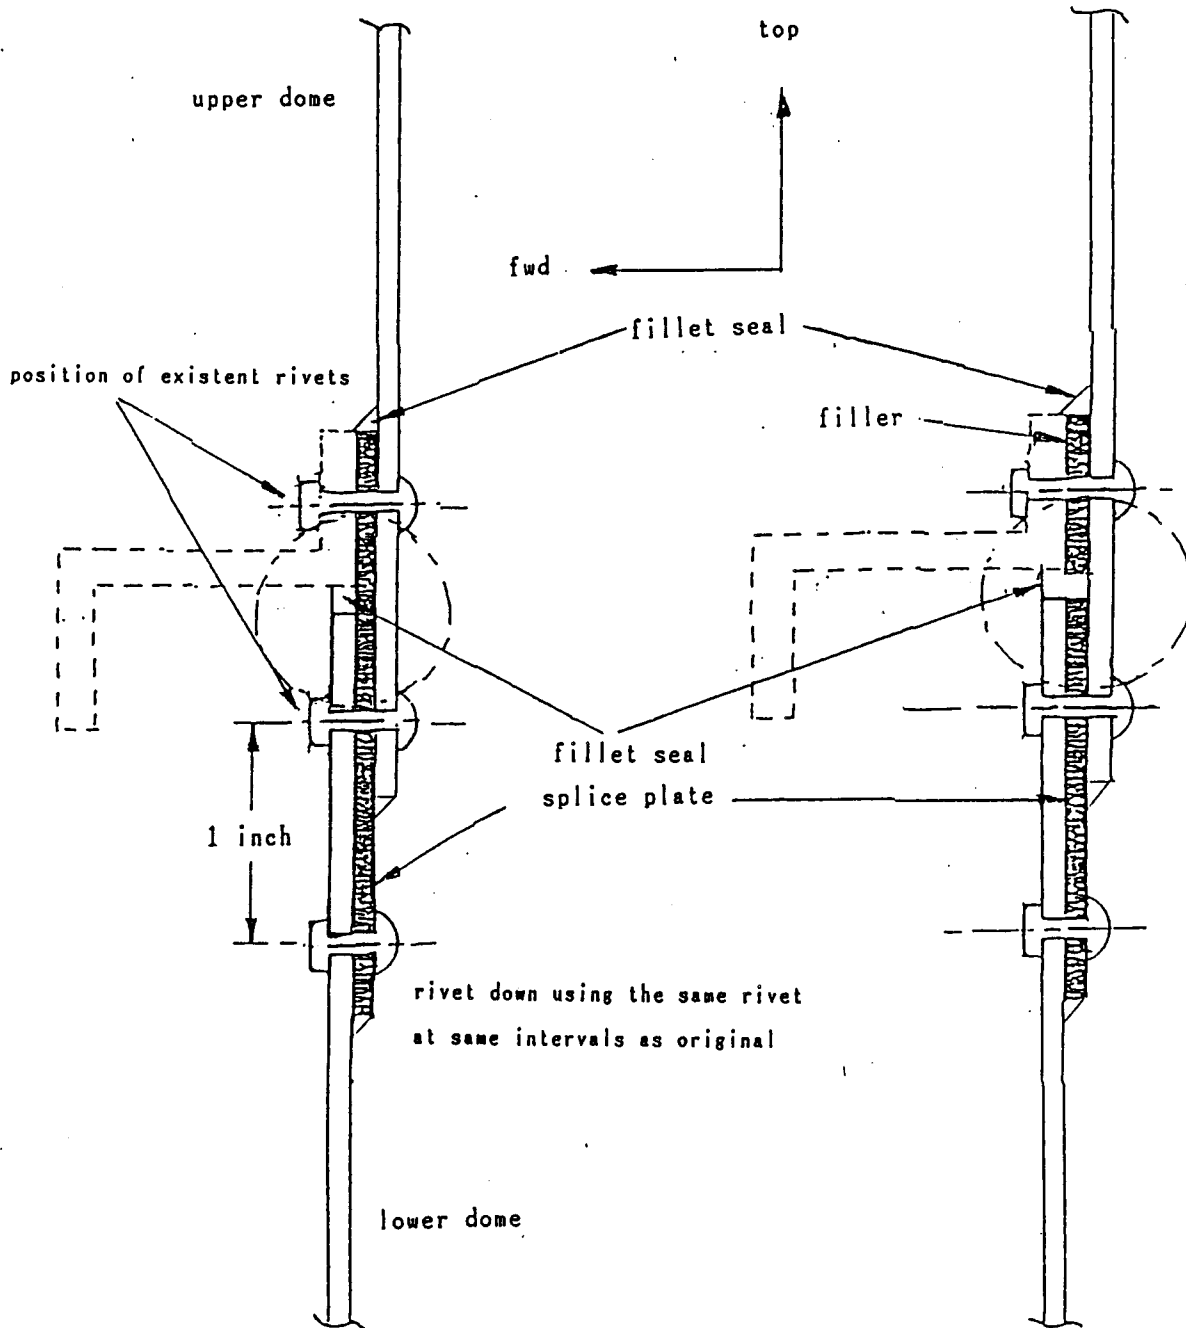
Attachment 1 Attached Figure-3
Instruction issued for correction
and actual work of splice

(5) To compensate for the discrepancy above, a rework disposition was given from the engineer of the repair team that a splice plate be inserted, as shown on the left side of Attached Figure-3 of Attachment 1, between webs insufficient in edge margin.

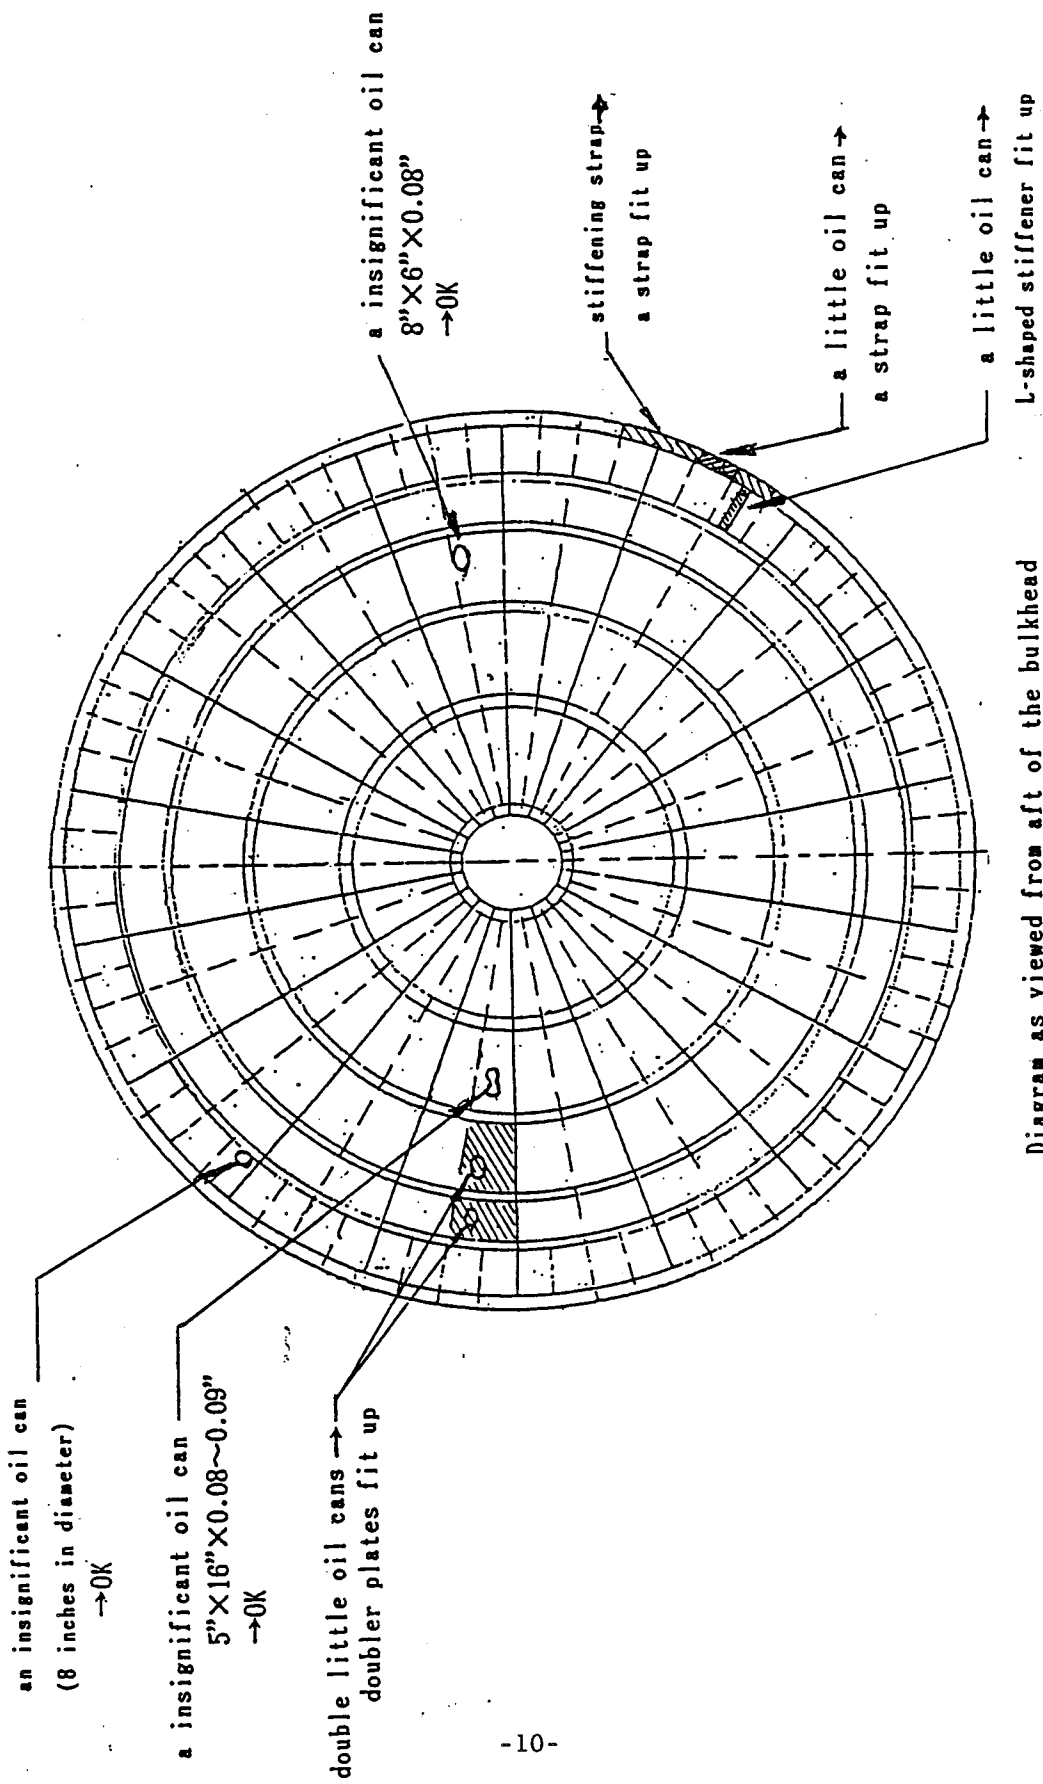
Attachment 1 Attached Figure 4 Treatment of Web Oil Cans

(8) In the inspection by the inspector of the repair team, oil canning was discovered at six locations on webs of the aft pressure bulkhead, as shown in Attached Figure-4 of Attachment 1, out of which three were within the allowance of the 747 Structure Repair Manual, but on the other three the following repairs were conducted:
